Evaluation of wide-span timber structures - results and recommendations

Summary

Following the Bad Reichenhall ice-arena collapse, the Chair of Timber Structures and Building Construction conducted two large-scale projects to evaluate existing wide-span timber structures

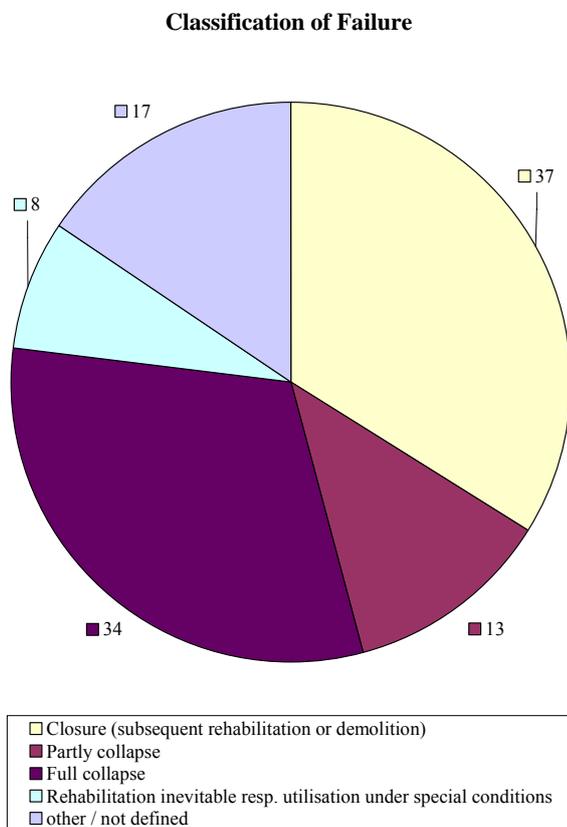
Fig. 1: Classification of Failure

In total, 109 structures were included in the evaluation. The majority of information was received for structures in Bavaria. This can be explained by strong snowfall and administrative divisions, both leading to an accumulation of structural investigations. Only investigated (or visibly failed) structures can become noticeable. All failures were classified into total collapse, partly collapse, closure (also temporary) and rehabilitation (see Fig. 1). 71% of the reported buildings included structural elements from timber (77 in total), the reason partly being the high sensitivity of authorities towards timber structures after the Bad Reichenhall ice-arena collapse, having lead to increased investigations on timber structures. In 54% of all collapsed structures, structural members in timber were the main reason for failure. 62% of the classified timber structures were glulam structures (see Fig. 2), mirroring the prevalent utilization of glulam for wide-span timber structures but also indicating problems associated with this building material (e.g. reinforcement of curved and pitch cambered glulam beams), which are nowadays mainly covered by the new code generation. Since information received was partly scarce, all diagrams include a partition "not defined". For reasons of failure, multiple answers could be given, which explains the variation in total numbers in these diagrams.

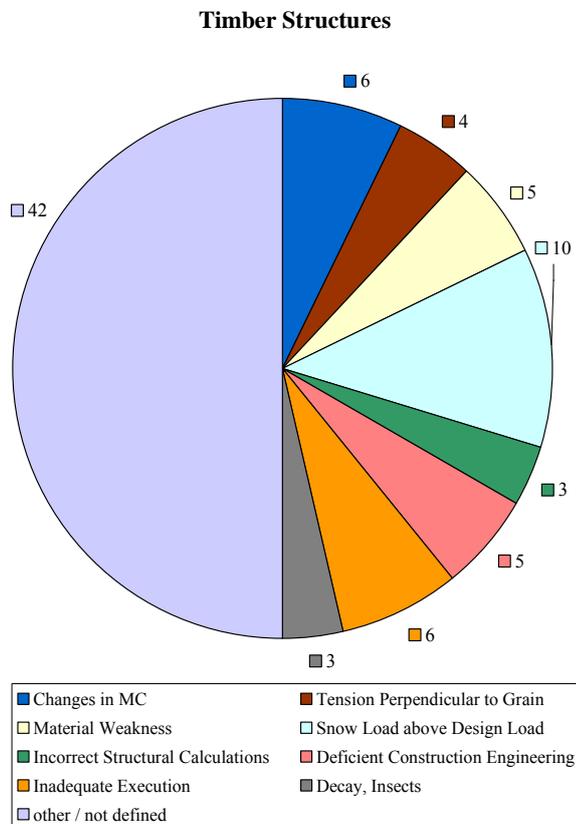
Fig. 3: Timber Structures

The most common cause of failure are errors in design, construction and maintenance due to human error (incorrect structural calculations, deficient construction engineering, inadequate execution, on-site alterations), accounting for 33%, (resp. 43% for glulam structures) of failures (see Fig. 3 and Fig. 4). The quota of failed structures in which the execution differed considerably from checked

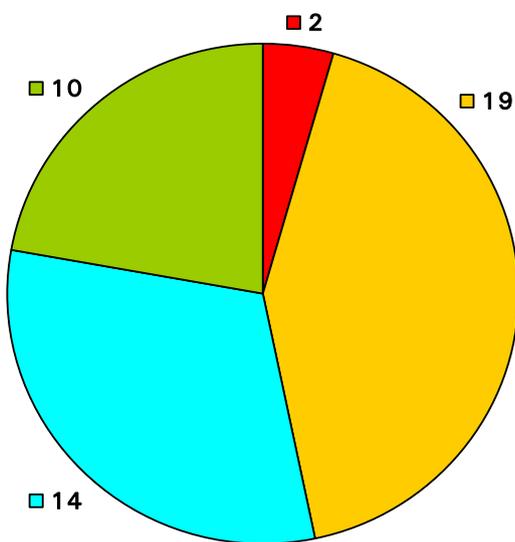
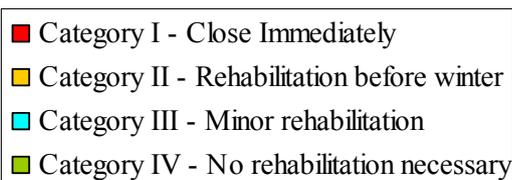
Munich Timber Structures Priority I

From 45 buildings, classified priority I, two structures had to be closed until the completion of rehabilitation measures. In both cases, the bracing system was insufficient or inexistent. 19

structures (= 42%) could remain open but had to be rehabilitated before the next snowfall (see Fig. 5). Structures in this category had shown various failures, prevalently in the structural calculations or execution of bracing systems, joints or large glulam beams.

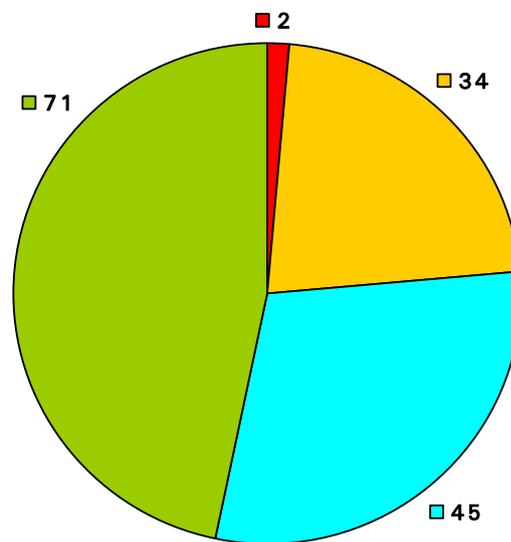
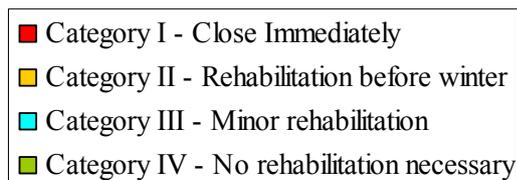
Munich Timber Structures Priorities I - III

Buildings in Priorities II and III revealed better results. Of all 152 classified buildings, the majority of buildings (76 %) fell into categories III and IV, leaving 24 % of buildings which had shown structural failures (see Fig. 6).
