Structural safety and rehabilitation of connections in wide-span timber structures - two exemplary truss systems

1. Expertise 1

2. Expertise 2

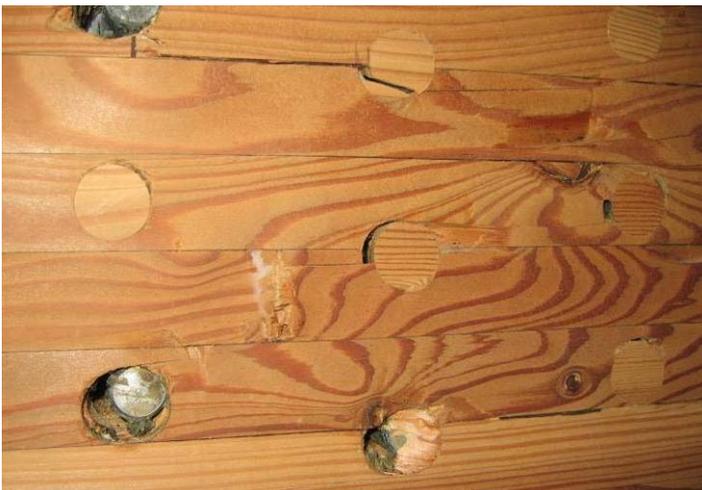
During the inspection of the lower girders inside the window strips, large cracks were identified which had developed around the steel-plate connection, forming the tension joint in mid-span (see Fig. 3 and 4). The crack pattern indicated failure due to block shear. Horizontal displacements of up to 10 mm between the connection block and the remaining cross-section of the tension member indicated that failure had already advanced considerably.

Opening the roof system to access the main joints from the outside supported abovementioned findings. Large (width 15 mm) horizontal cracks due to exceeded tension perpendicular to grain stresses could also be identified.

Fig. 3: Shear and Tension Cracks at the main joint

- The truss was calculated under the assumption of pinned connections. The calculation neglected the bending stiffness of the continuous girders as well as the rotational stiffness of the main joints. The bending moment in the girders was thereby underestimated by 50%. Combined with a higher reduction of cross-section than assumed, this led to a 65% underestimation of the tension stresses in the lower girder.

- The building code in effect during design requests, that for the verification of the timber side-member, the tension load be increased by 50% to account for bending moments due to eccentric load transfer. This verification was not carried out. It is exceeded by 51%. This excess explains the propagation of cracks in tension.

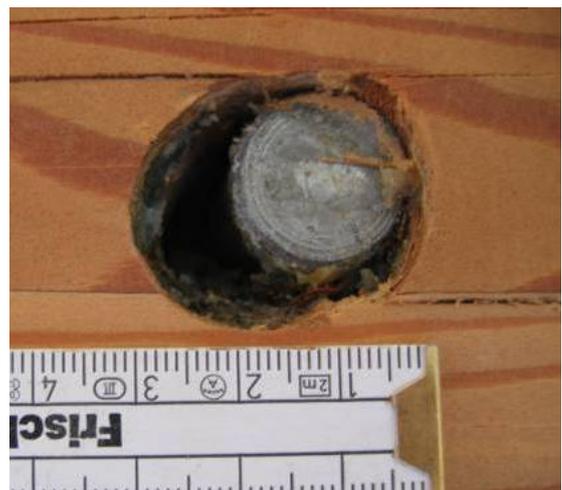
Fig. 4: Indentation of Dowel into Timber

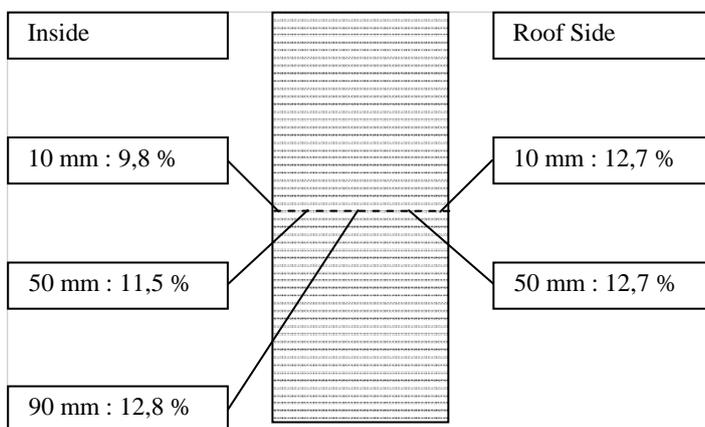
Fig. 5: Moisture Gradient in Beam Depth

- Shrinkage due to a reduction of moisture content from 15% upon erection to 9% in the outer parts of the cross-section during service reduced the tension perpendicular to grain strength and, in combination with high splitting forces from fasteners, facilitated the propagation of large cracks in grain direction (see Fig. 5).

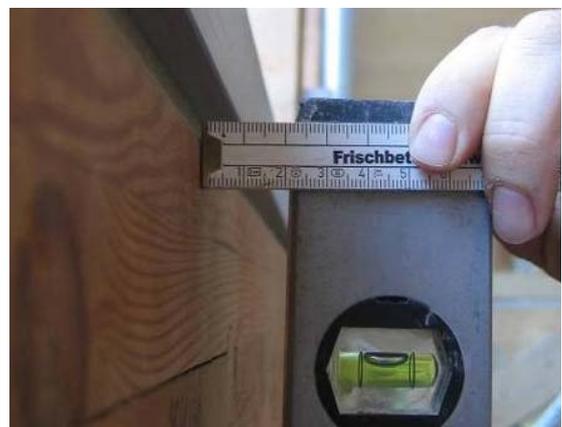
The lower girders had additionally rotated around their longitudinal axis, leading to an angle of rotation of up to 3° (see Fig. 6). This resulted in an inclination of the bottom girder which reduced the bearing area at the supports by up to 70%.

Fig. 6: Rotation of Lower Girder

- The connection of the nail-laminated timber plates leads to an eccentric load transfer, resulting in a torsional moment in the bottom girder. During design, the lateral stability of the individual girders was not considered. The reduction of bearing area due to an inclined bottom girder, established an eccentric load transfer to restore the equilibrium of stresses.

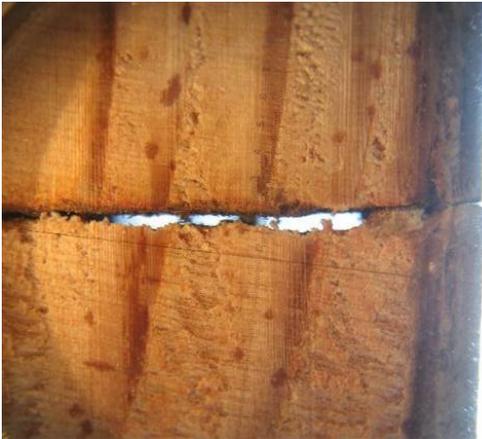
The strength of the resorcinol glue lines could be verified by testing core samples. During this assessment it was detected that cracked glue lines had been sealed during manufacture. Opening core samples at these glue lines revealed that the crack had only been covered but not filled and that the outer areas of lamellas in these areas had never been glued together (see Fig. 7 – 9).

Fig. 7: Crack in Glue Line and Seal

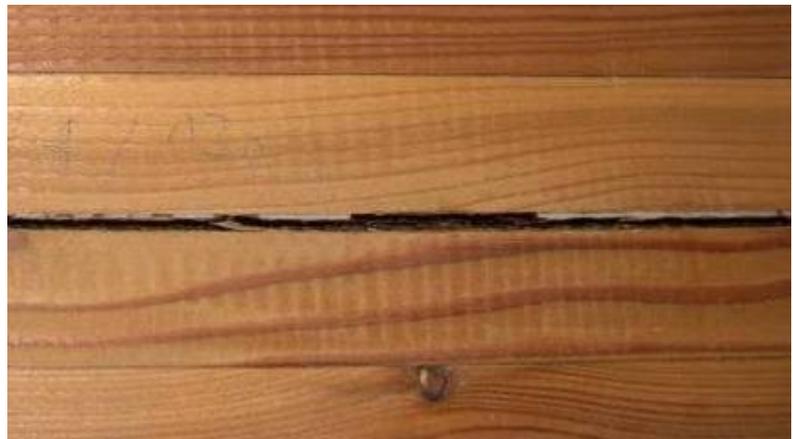
Fig. 8: Crack in formerly sealed Glue Line

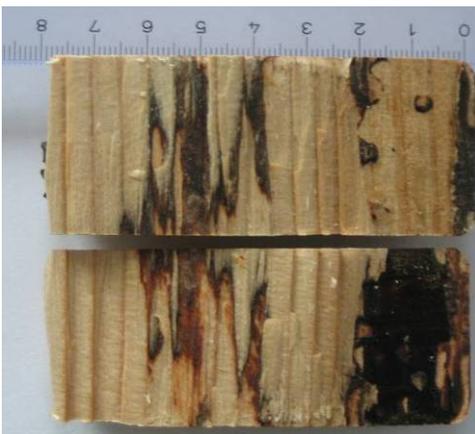
Fig. 9: Open Core Sample

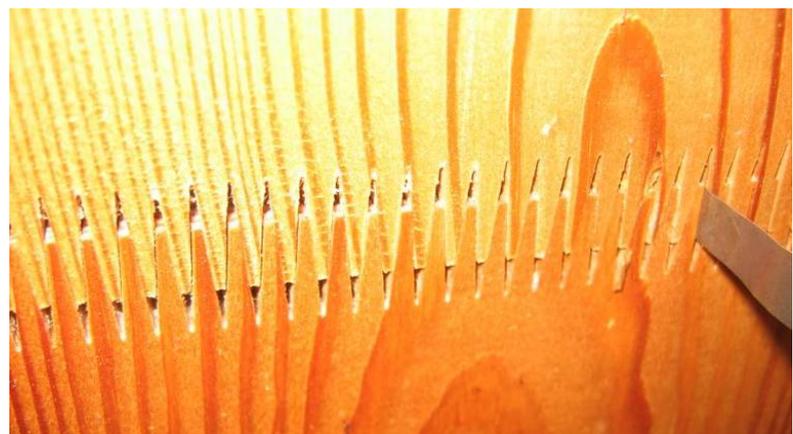
This finding implicated improper manufacture of the glulam members and was therefore followed by an assessment of the finger joints, joining two lamellas. It was found that some finger joints were open, having never been glued together (see Fig. 10).

Fig. 10: Finger Joint without Glue

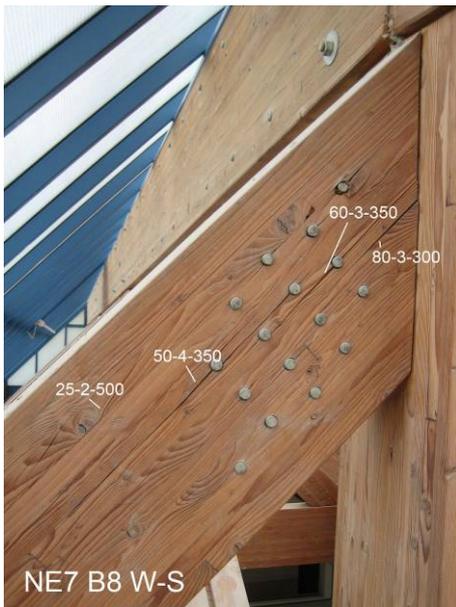
During the inspection, large cracks in the tension joints of the inclined trusses of the secondary system were identified. The deepest cracks had developed between the single joints of the steel-plate connection. Marking of the cracks, as it is demonstrated in Fig. 14, is generally done using the following systematic: depth – width - length of the crack.

The main reason for the distinct crack pattern can be explained by the dry climate conditions of the gymnasium. During the inspection moisture contents of about 7.5% at the surface of the girder and about 8.5% in a depth of 90 mm were measured. The reduction of the moisture content from erection upon to the measured values caused shrinkage in the wooden component parts. In the areas of the steel-plate connections the shrinkage actions are constrained by the joints. This results in stress perpendicular to the grain which effects stress relief by the appearance of cracks. As it is already explained in the former expertise the rotational stiffness of the tension joint in the lower

Fig. 14: Inclined Truss

Due to reasons of organisation it was decided to reinforce the structure temporarily for one winter period while allowing just a minimum of snow load. For this first step the joints of the inclined trusses were reinforced by screws with continuous threads, positioned perpendicular to the grain and the axe of the fasteners (see Fig. 16). To verify the strength of the reinforced connection, experimental investigations became necessary. Thereby, wooden components of a back-built ice arena were used as test pieces to take into account the influence of elements, which had already been stressed by load and changing climate conditions stressed. With these components, the inclined trusses including the steel-plate connections were replicated. Different crack patterns were simulated by cuts with a circular saw. These test pieces were reinforced by screws with continuous threads as demonstrated in figure 16, taking into account the unsymmetrical connection on both sides of the truss.

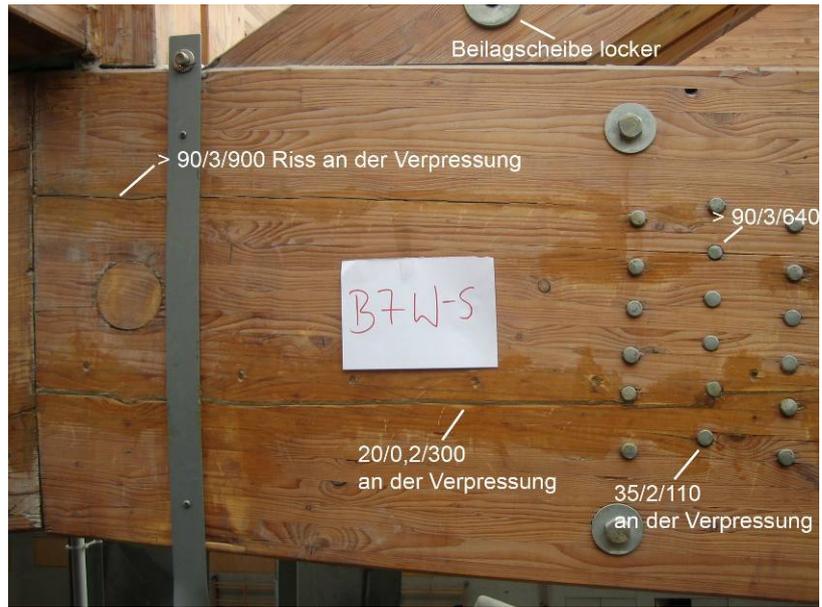
Similar damage symptoms were indicated at the tension joints of the main trusses. Once again the cracks appeared in the area of the steel-plate connections in the lower girder. Crack reinforcements with epoxy-glyue, which had previously been implemented, showed failures as well (see Fig. 15).

Fig. 15: Main Tension Joint

Furthermore the analyses of the original design showed that the verification of block shear was neglected. Considering the state-of-the-art load and safety factors, the verification of block shear is exceeded by about 50%.

Cracks in the area of the main tension joints in the bottom girder were grouted under pressure with epoxy-glu to recover the strength of the glue line. It seemed not reasonable to strength the tension joints with additional external steel plates against of block shear because of the incalculable distributions of forces between the original connection and the reinforcement. Hence, another measure was favoured, that enables the reduction of the tensile forces in the bottom girder of the truss system. Therefore each of the three main truss systems was pre-stressed by external tensile bars. These were placed on each side of the bottom girders. The pre-stressing of the bars was

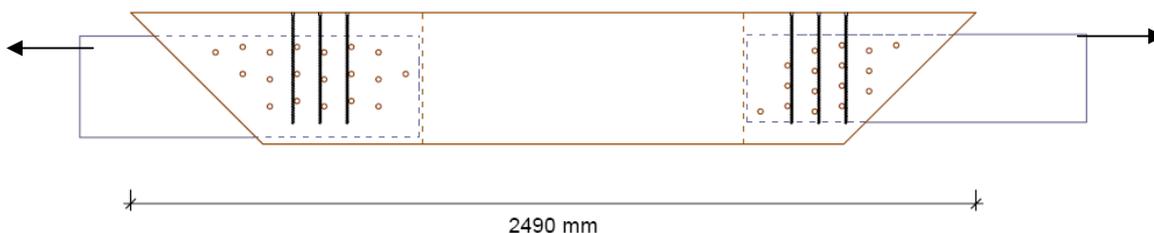
Fig. 16: Test Piece of a reinforced Inclined Truss

6 screws of continuous thread $\varnothing 8$ mm, $l_{\text{thread}} = 330$ mm
19 joints $\varnothing 16$ mm, $l = 160$ mm

6 screws of continuous thread $\varnothing 8$ mm, $l_{\text{thread}} = 330$ mm
16 joints $\varnothing 16$ mm, $l = 160$ mm

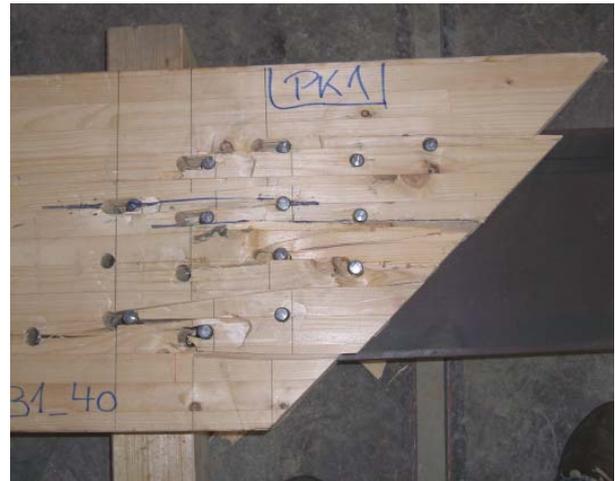
Fig. 18: Test Results

The result was that the screws could increase the strength of the joints which were damaged by cracks. Failure was always caused by block shear as it is shown in figure 18. The calculated security level according to the chosen maximum snow load was adequate to guarantee the structural safety for these components. Therefore all inclined trusses of the secondary system were reinforced by this method as a temporary measure.

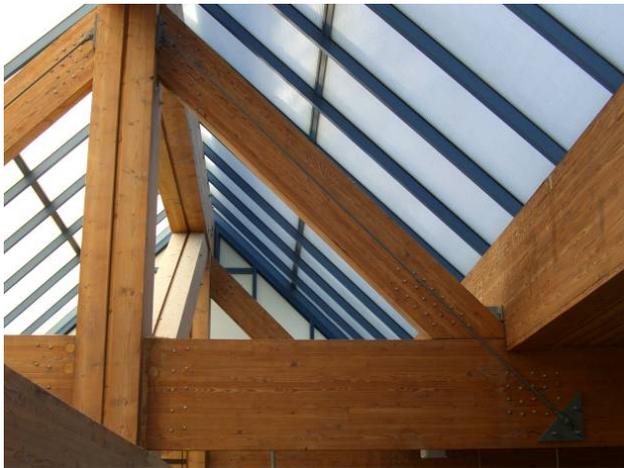
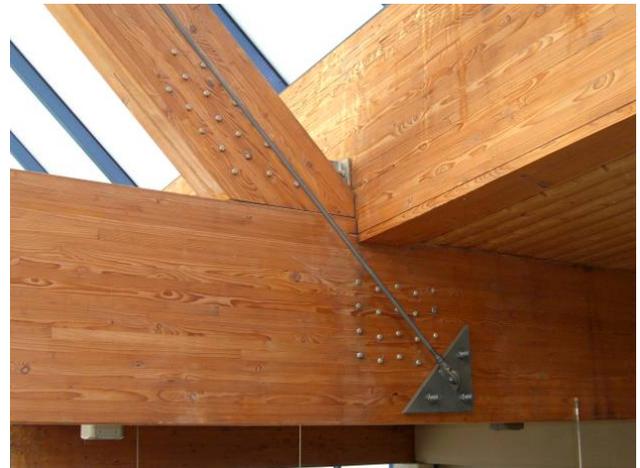
Fig. 19: Pre-stressed steel Tensile Bar

Fig. 20: Connection of the Tensile Bar

In the course of extensive rehabilitations in the following summer period further reinforcements of the components were done to enable the structure to bear the total snow load. Therefore external pre-stressed tensile bars of steel were applied next to the inclined trusses (see Fig. 19 and 20). These steel bars were designed to cover the snow load, while the original inclined trusses have to carry the dead load.

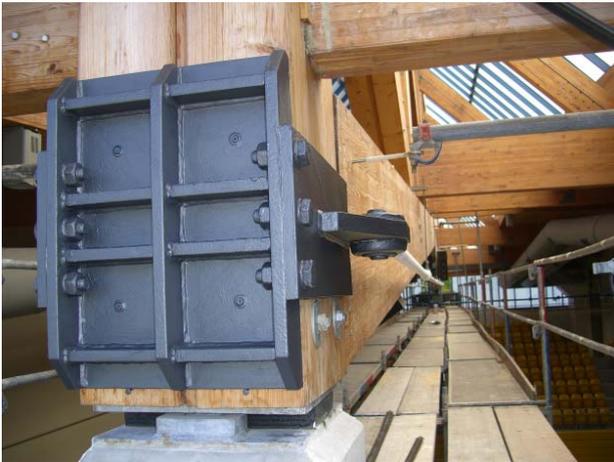
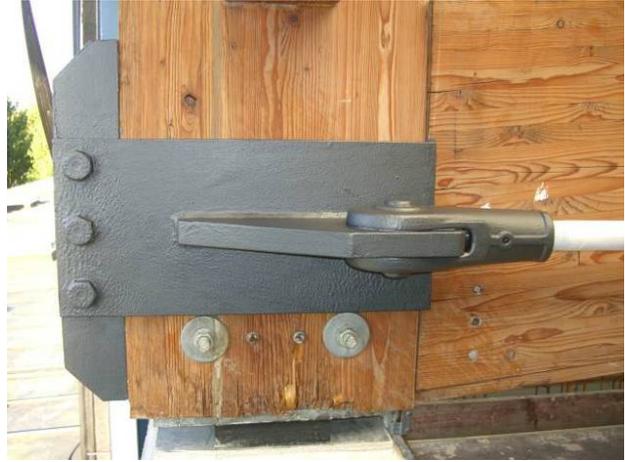
Fig. 21: Pre-stressed steel Tensile Bar

Fig. 22: Connection of the Tensile Bar

designed so that the tensile stress could be reduced to a value, which enables the verification of block shear in the main tension joint. The measures are shown in the following figures 21 and 22.
