Geological and Geotechnical Evaluation of a Landslide Prone Slope in an Informal Settlement in Medellín, Colombia

Tamara Breuninger

Complete reprint of the dissertation approved by the TUM School of Engineering and Design of the Technical University of Munich for the award of the

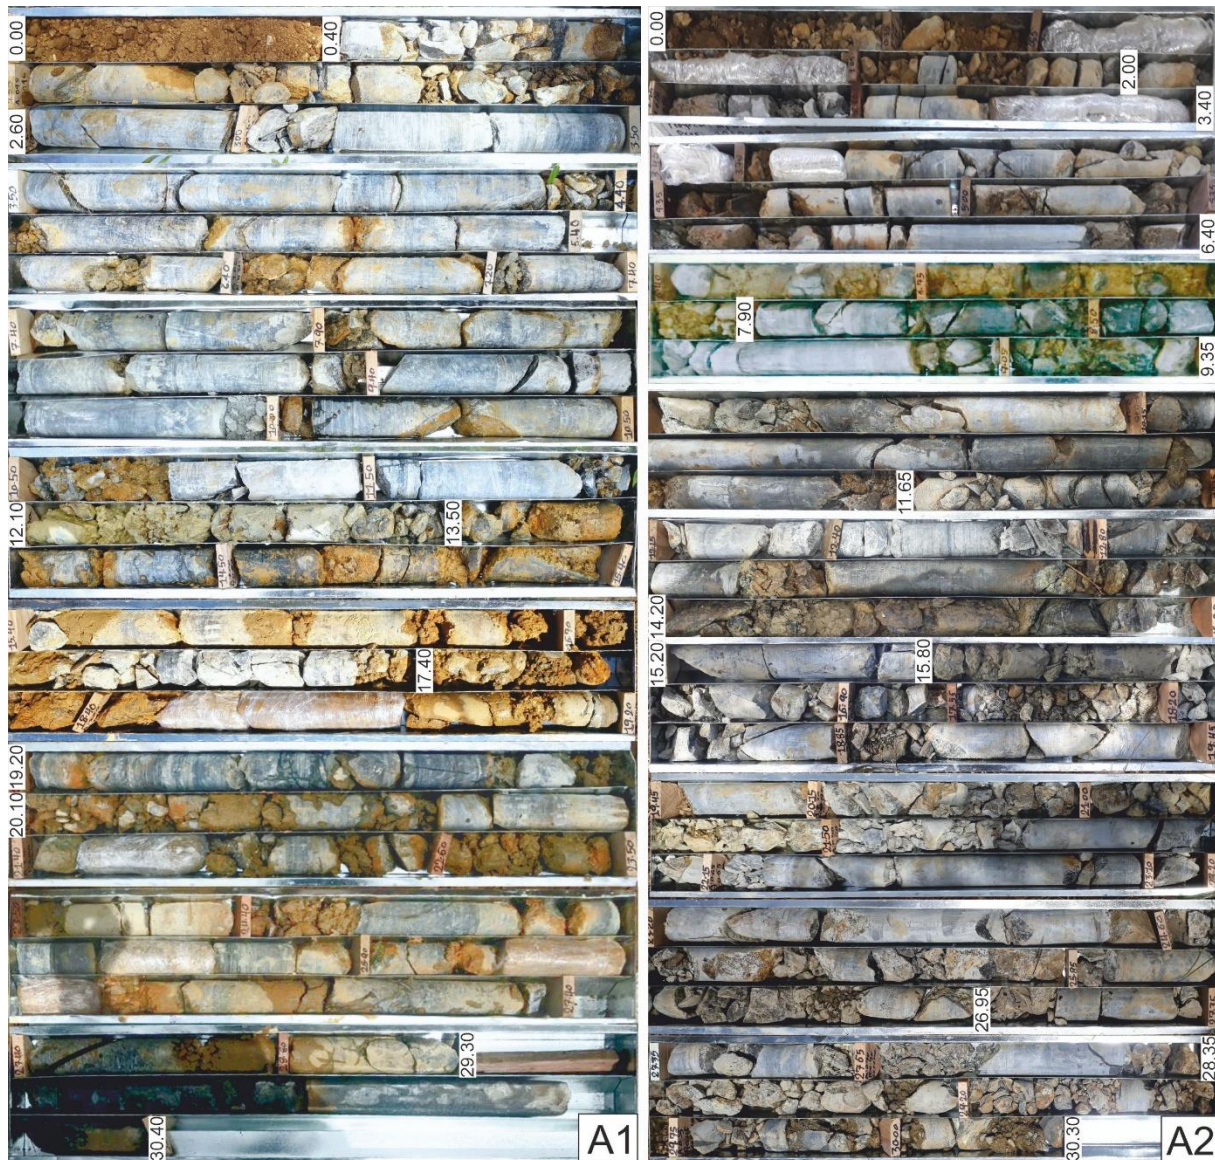
Figure 16: Drilling cores of drillings A1 (left) and A2 (right) (after BREUNINGER et al. 2021c).

The rest of the core (13.50–30.40 m) shows weathering stages III and IV, an RQD of 12–37 (poor to very poor) and mostly contains the joint sets 1 and 3, in meters 13.50–17.40 also one joint of joint set 2, leading to the homogeneous area 4. Brown weathering material dominates the core's appearance, serpentinization is not or only slightly visible. Two areas in this part of the core show a considerable better quality (19.20–20.10 m and 29.30–30.40 m) with weathering stage II and an RQD of 72 and 75 (fairly good), which results in homogeneous area 2.

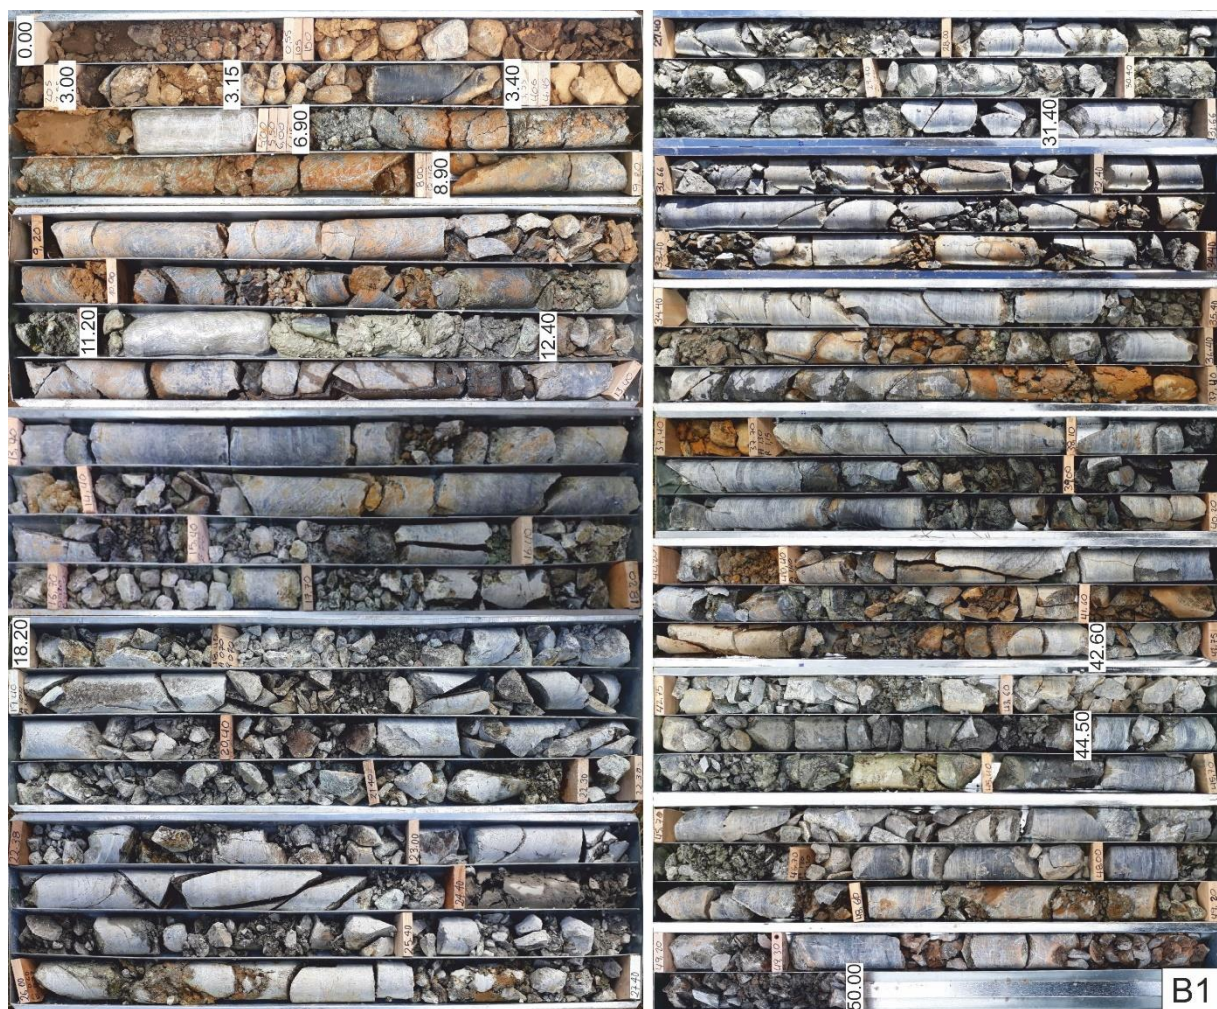
Figure 17: Drilling core of drilling B1 (after BREUNINGER et al. 2021c).

As the drilling A2, drilling B1 (Figure 17 and Figure A3) shows significant small-scale changes and extreme differences regarding the weathering type. All three dominant joint sets are present throughout the core. To a depth of 8.90 m, core loss is the dominating feature. Only 3.05 m of this section are recovered. This phenomenon is most likely caused by flushed out loose material and in the upper 3.00 m additionally by insufficiently compacted ground.

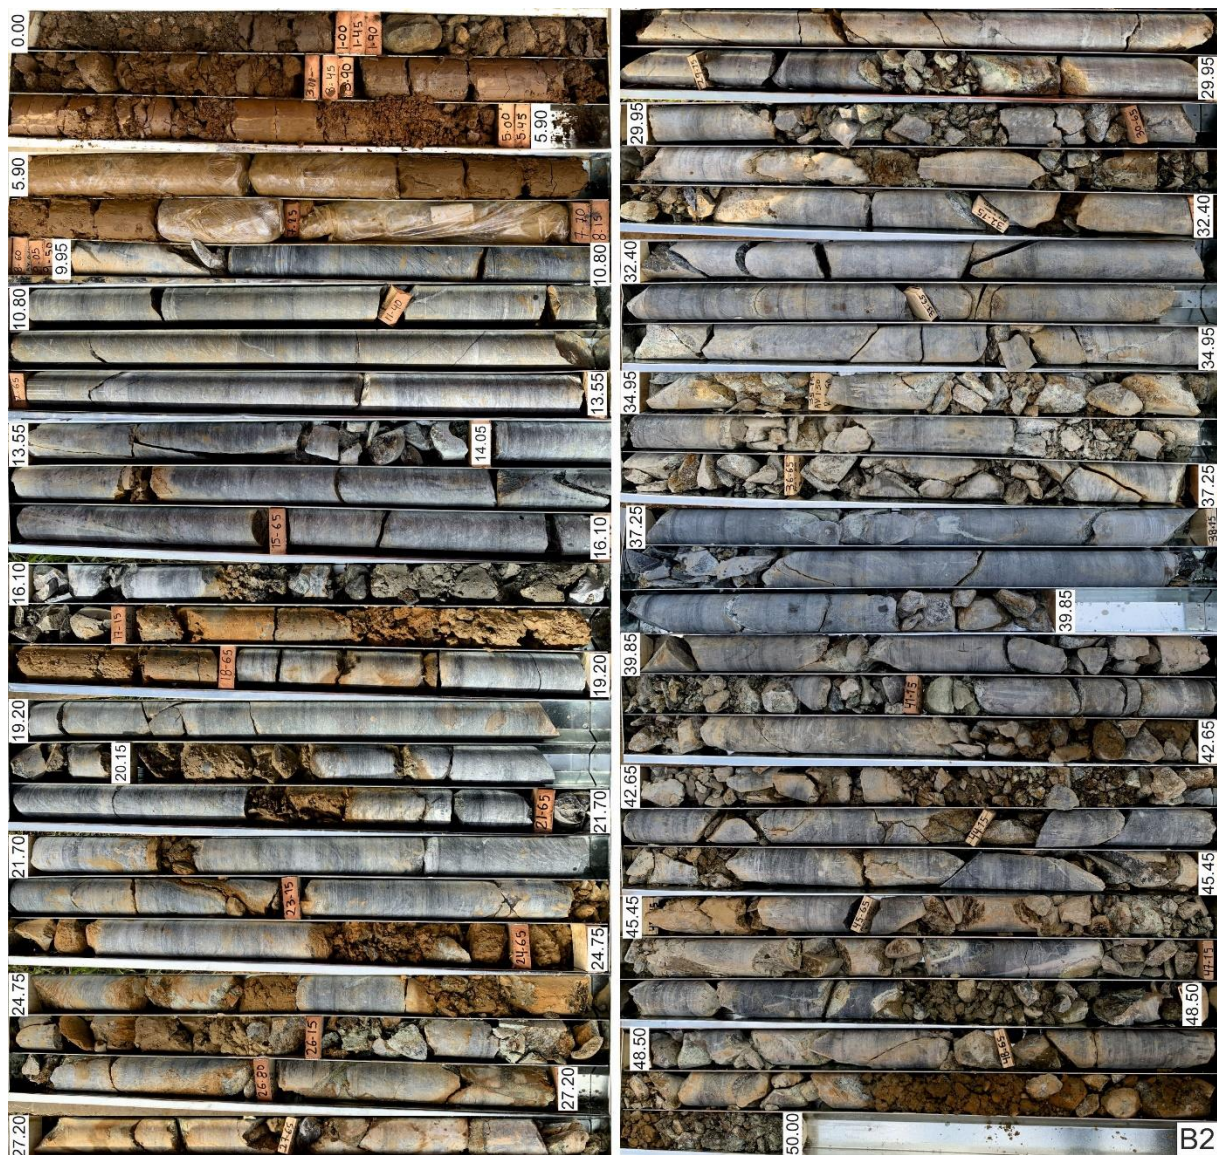
Figure 18: Drilling core of drilling B2.

The rest of the drilling core shows homogeneous areas 2-5 with strongly varying rock quality and small-scale changes (longest section of one homogeneous area < 3.00 m). In general, the drilling core shows a decrease of alteration intensity (serpentinization and oxidation) with depth, but an increase in fragmentation. As with the other drillings, drilling B2 does not reach undisturbed or unweathered bedrock.

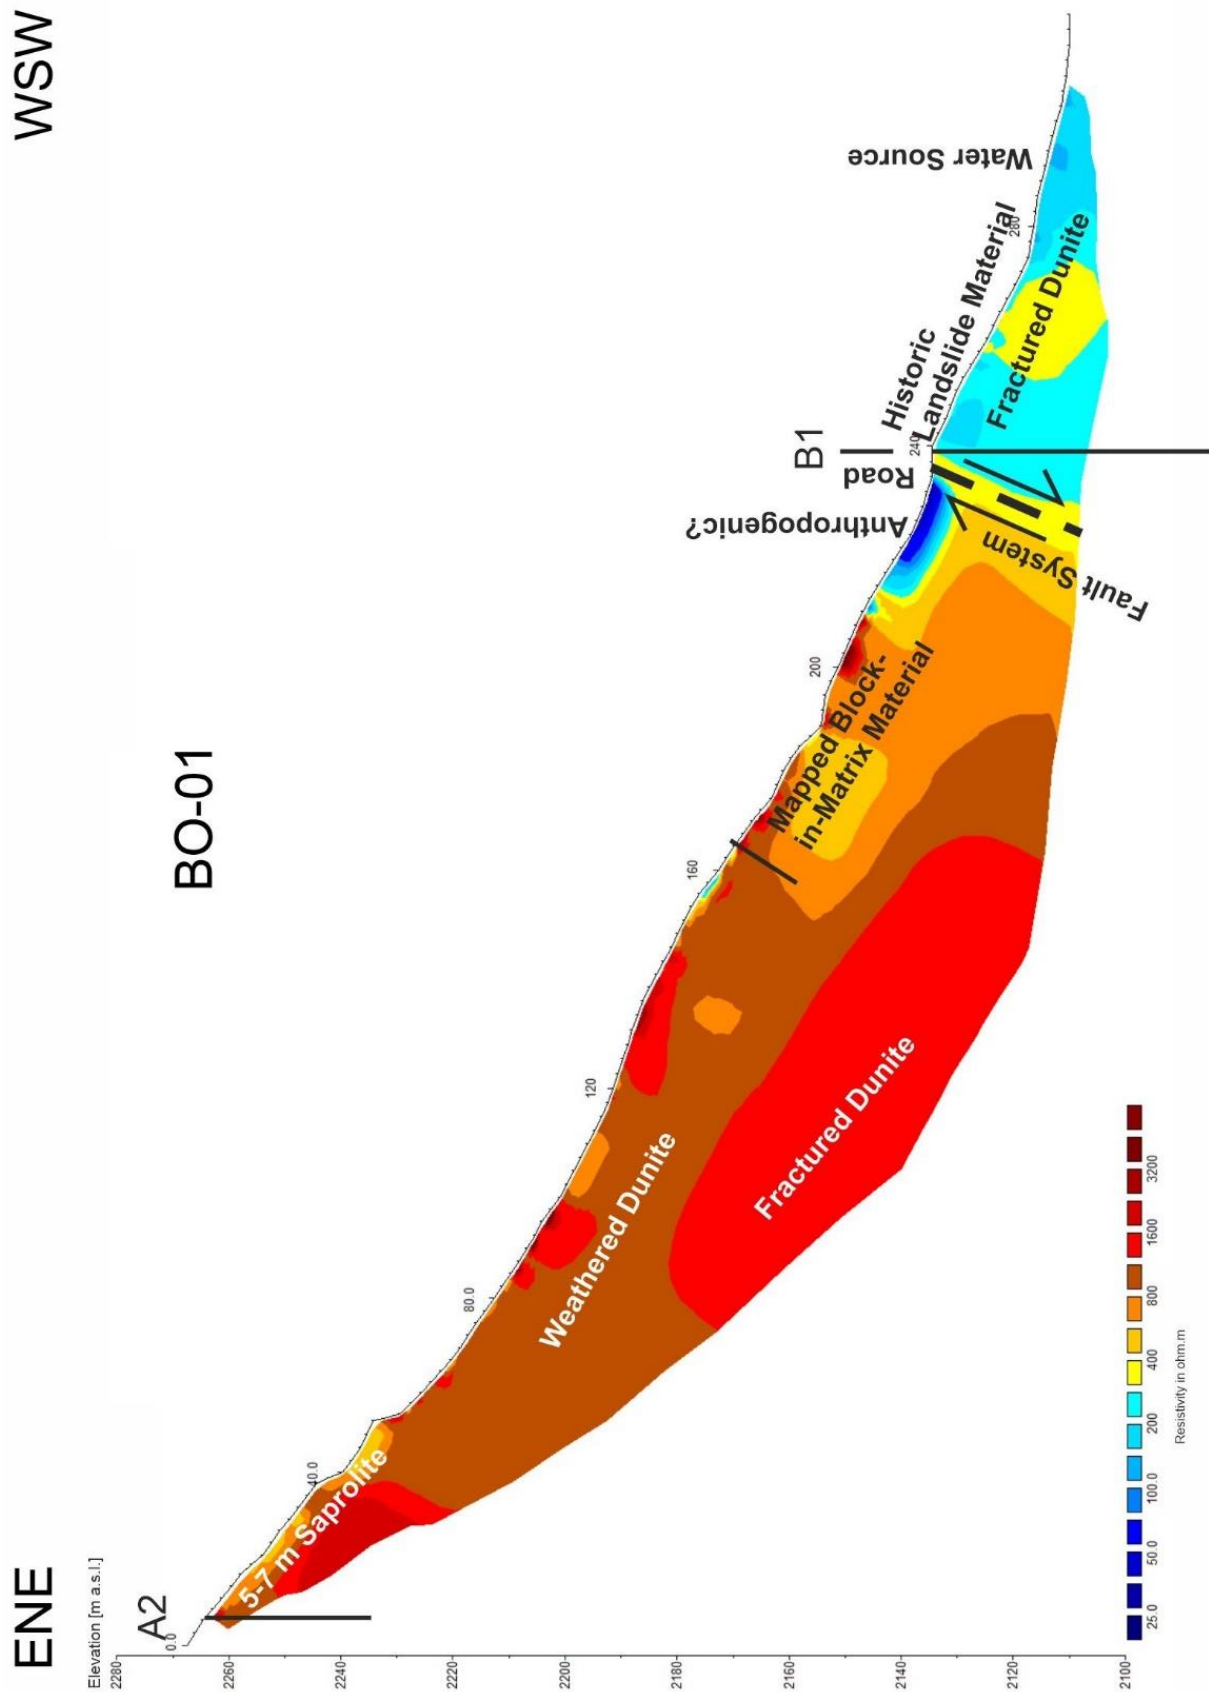
Figure 21: Result and interpretation of ERT profile BO-01 (after GAMPERL et al. in review).

The evaluation of drilling B1 was used to interpret the low resistivity values of the right part of the transect (chapter 5.3.3). Since the drilling core is highly fragmented, the low resistivity values might be explained by the condition of the Dunite at that area. The subsurface was, therefore, interpreted as fractured Dunite material. At the far-right end of the profile, a water source was recorded, suggesting a high water content at that part of the slope, which might add to the low resistivity values in that area.

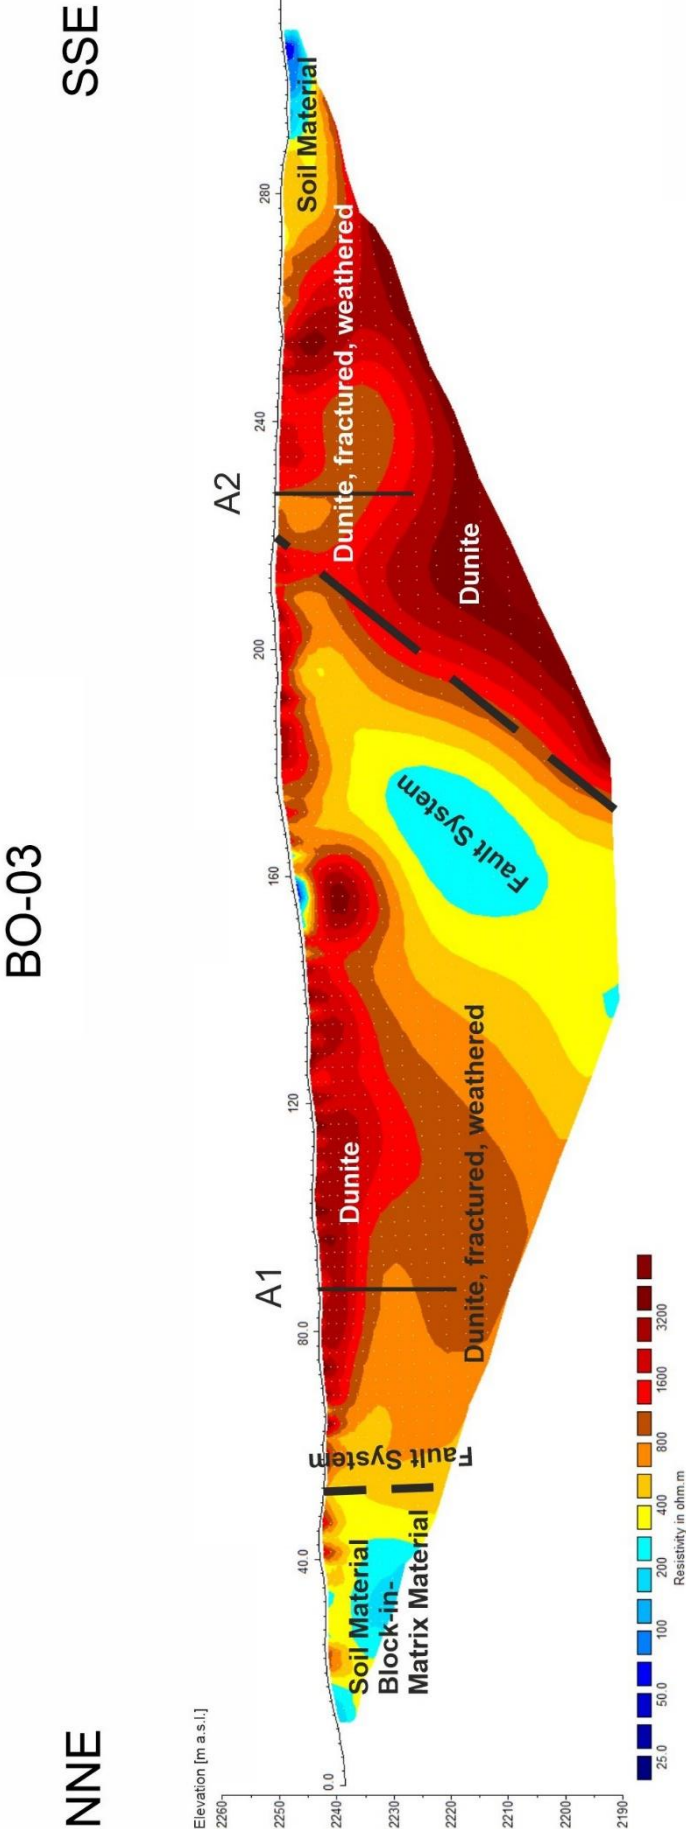
Figure 22: Result and interpretation of ERT profile BO-03 (after GAMPERL et al. in review).

The transition to the low resistivity area to the right is very sharp and was interpreted as a fault system, dipping 40-60° towards SE in the profile. This fault system might correspond to joint set 3, given the dipping angle. However, the normal dipping direction of that joint set is NW, so the fault system encountered in transect BO-04 might be a joint set standing vertically to joint set 3 but created by the same tectonic regime.

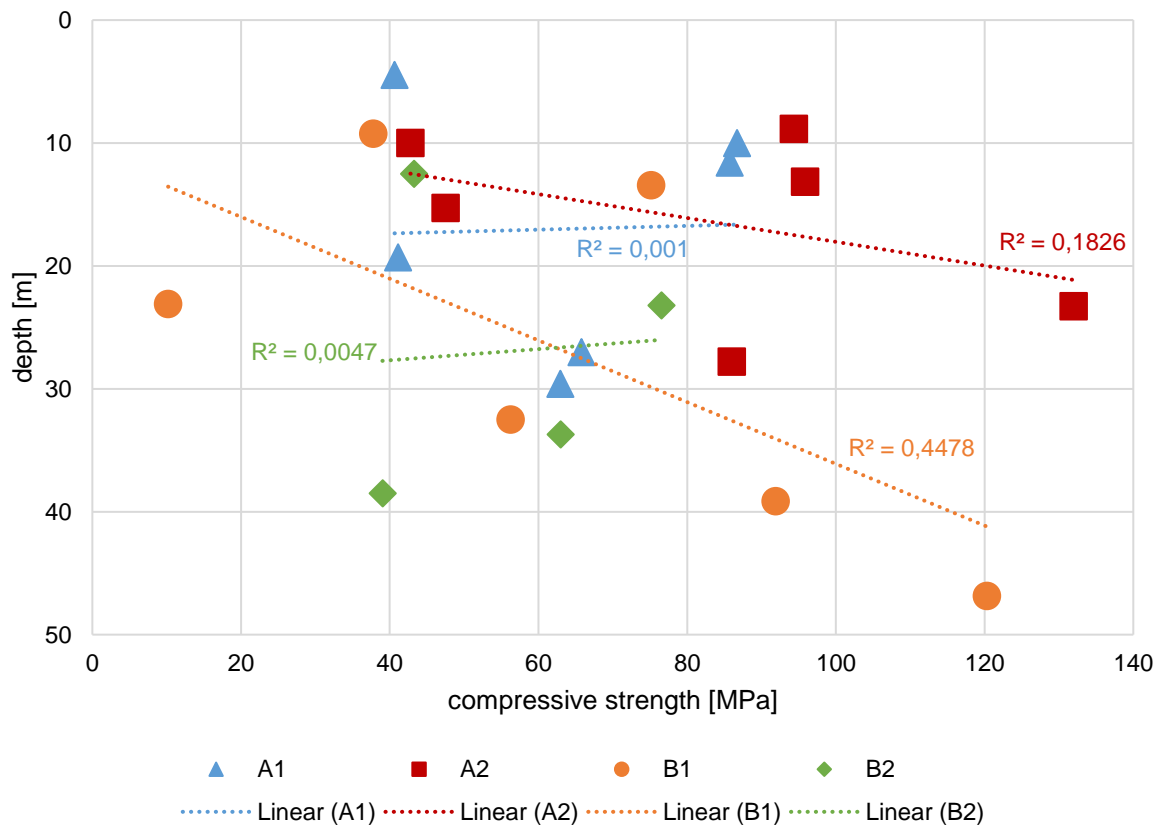
Figure 24: Uniaxial compressive strength values plotted against sampling depth of all four drillings.

An explanation of this bad correlation between depth and strength might be that the primary rock conditions are affected by serpentinization and tectonic damage already before weathering. Another one might be that the normal weathering from top to bottom could not be applied in the Medellín Dunite, most likely due to the pseudokarst present in this unit, but also due to landslides, which disturb the uppermost 2–10 meters of the unit causing a mix of top layers. Most likely, it is a combination of both.

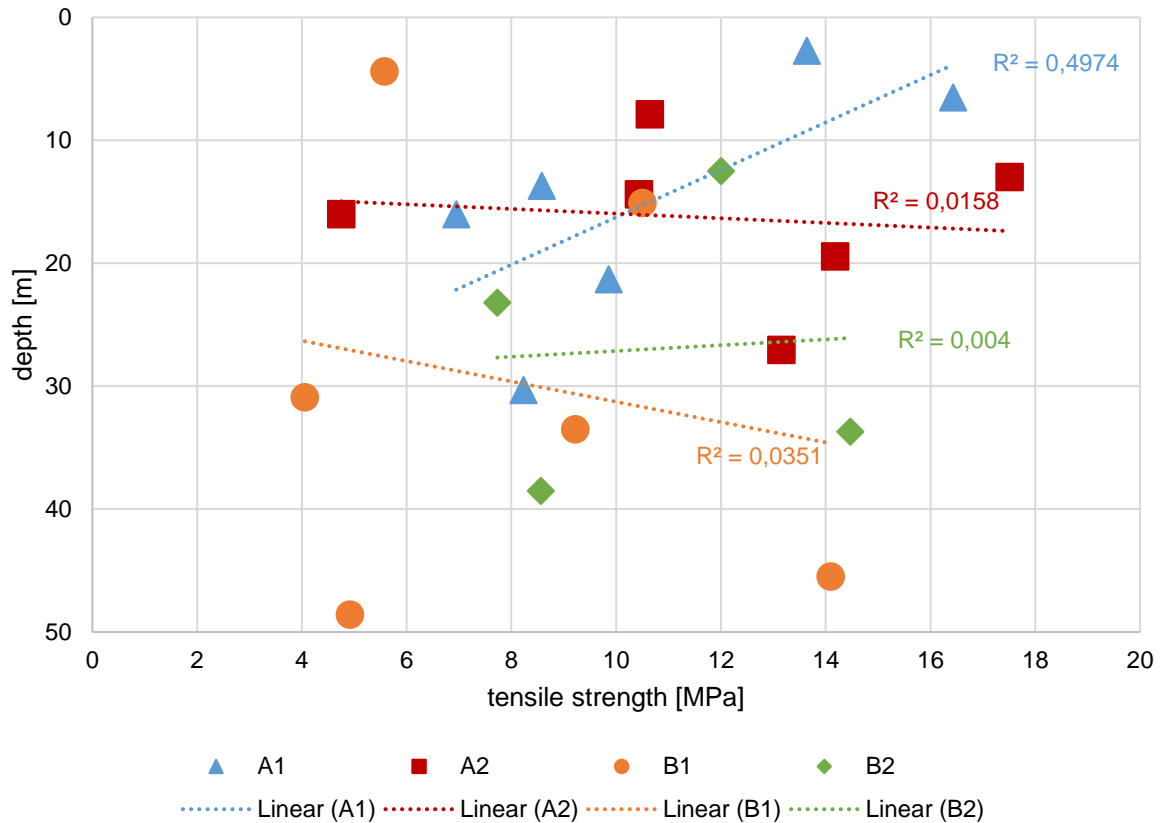
Figure 25: Tensile strength values plotted against sampling depth of all four drillings.

The results of the tensile strength test of the drilling core samples confirm the heterogenic composition of the subsurface at the study site and emphasize the factors leading to that heterogeneity. Even the intact rock sections can be highly weathered internally in great depths as both rock tests prove, since the exterior of the samples suggested similar weathering conditions.

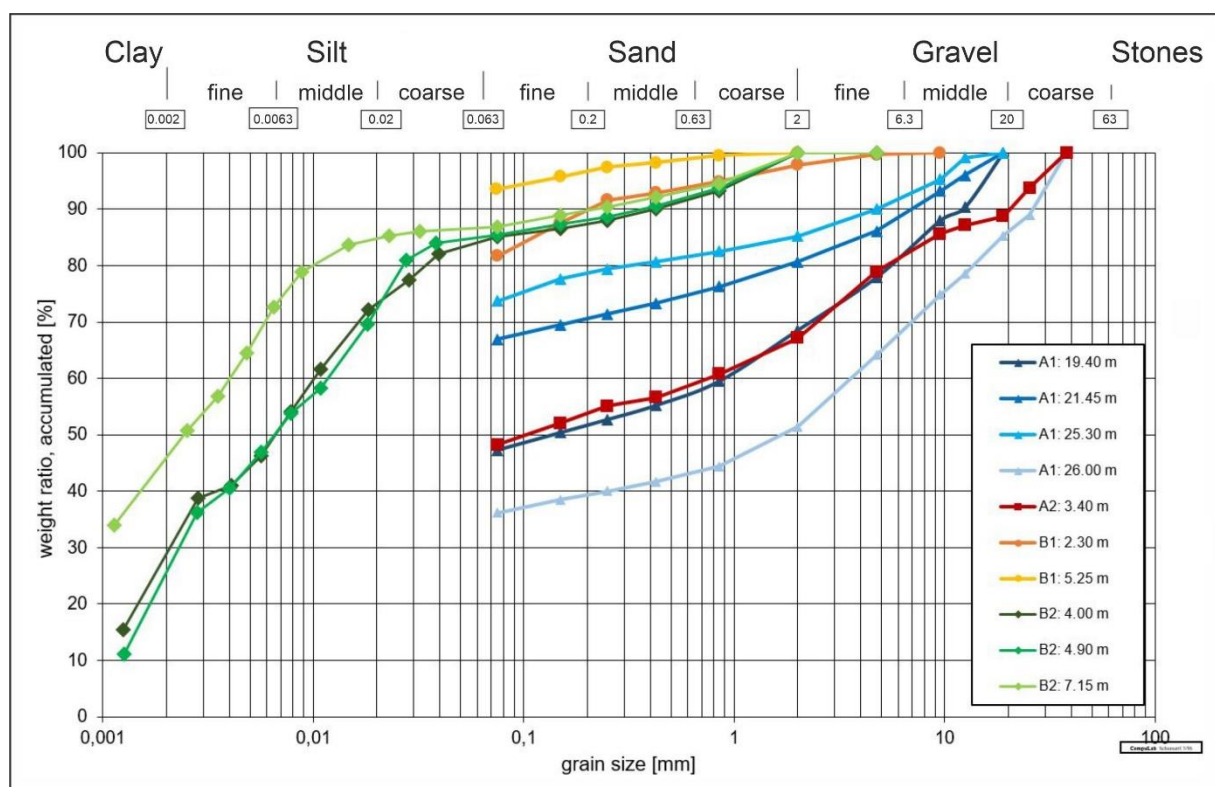
Figure 26: Grain size distribution of all drilling core samples depicted according to DIN EN ISO 14688-2 (2020) (after BREUNINGER et al. 2021c).

The grain size distribution was determined on ten samples in all four drillings, four of them in drilling A1, one in drilling A2, two in drilling B1, and three in drilling B2, which are depicted in Figure 26 and Table A2. Even though the tests were performed after INV E 123 (2013), the evaluation was done after DIN EN ISO 14688-2 (2020), due to the intercultural collaboration and because ISO standards provide an international standardization level for rock and soil testing and evaluation. Except for drilling B2, the grain size distribution on the drilling core samples was only determined using the sieving test. Therefore, the graphs end at the sand-silt border and a distinction between clay and silt cannot be made.
