### **Case report**

## QJM

# Shock whilst gardening—implantable defibrillators & lawn mowers

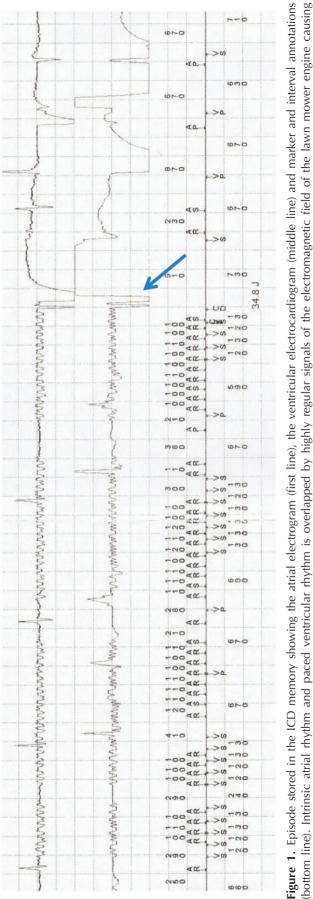
Interrogation of the ICD showed normal lead values and did not point towards any device or lead malfunction. However, the ICD Holter revealed one episode of electromagnetic interference with erroneous detection of ventricular fibrillation and subsequent delivery of a 35 J shock (Figure 1). This coincided with the reported incident. After the shock, the patient immediately kept his distance from the engine. Normal bifocal stimulation was restored. Thus, the electric impulse striking the patient did not originate from the lawn mower but from the ICD.

Upon further questioning it turned out that the patient had been using the same lawn mower for several years without any problems, however he always kept a distance of >30 cm between his chest and the engine. Without any apparent defect of the lawn mower, especially no short circuit, we advised the patient to continue using his lawn

mower while keeping his habitual safe distance to the engine. During a follow-up of 6 months no further complications occurred.
