# Damage associated with geological discontinuities on rock-cut monuments in Petra / Jordan

Kurt Heinrichs<sup>1</sup>, Rafiq Azzam<sup>1</sup>

<sup>1</sup> Dr. Kurt Heinrichs and Univ.-Prof. Dr. Dr. h.c. Rafiq Azzam, Department of Engineering Geology and Hydrogeology, RWTH Aachen University, heinrichs@lih.rwth-aachen.de, azzam@lih.rwth-aachen.de

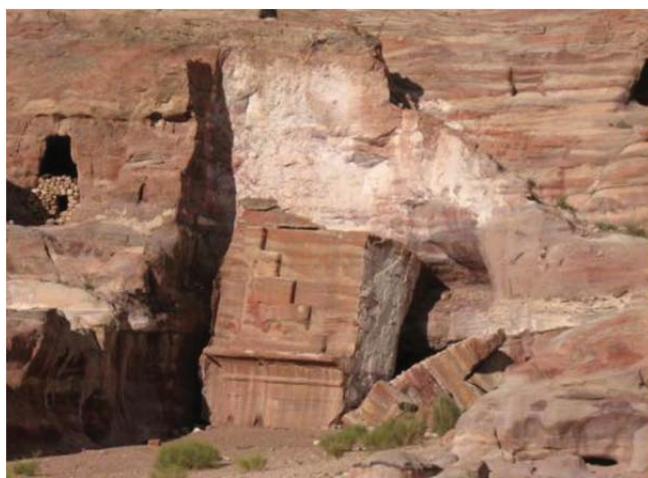
Abb. 3: Monument Nr. 609. Einsturz im März 2010.  
Fig. 3: Monument No. 609. Collapse in March 2010.

Moreover, many monuments have suffered damage from failure processes associated with geological discontinuities, especially joints. The collapse of monument No. 609 in March 2010 has again raised the awareness of this persistent threat (Fig. 3).

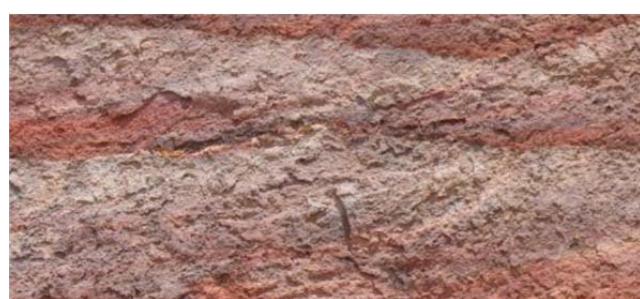
Abb. 5: Buntgebänderter Sandstein, mittlerer Teil der Umm Ishrin Sandstein Formation (Kambrium).  
Fig. 5: Multi-coloured sandstone, middle part of the Umm Ishrin Sandstone Formation (Cambrian).

The Petra region is mainly composed of sedimentary rocks of Lower Paleozoic age. The relevant stratigraphic units with respect to the rock-cut monuments are the middle and upper part of the Cambrian Umm Ishrin Sandstone Formation (mIN, uIN) and the Ordovician Disi Sandstone Formation (DI) (JASER & BARJOU 1992, JORDAN NATIONAL RESOURCES AUTHORITY 1991) (Figs. 4-7).

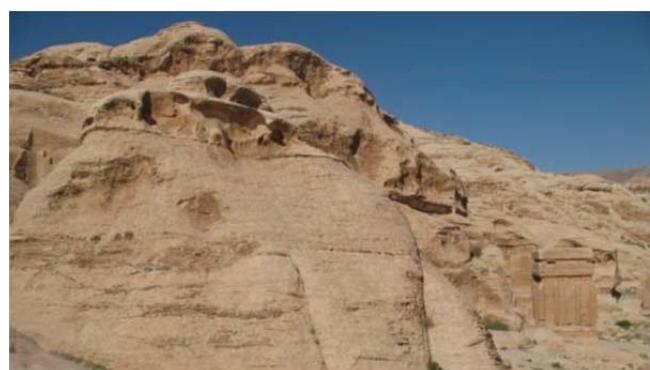
Abb. 6: Bab el-Siq Region mit dem Turmgrab Nr. 9 (rechts), Disi Sandstein Formation (Ordovizium).  
Fig. 6: Bab el-Siq region with Djinn Block No. 9, Disi Sandstone Formation (Ordovician).

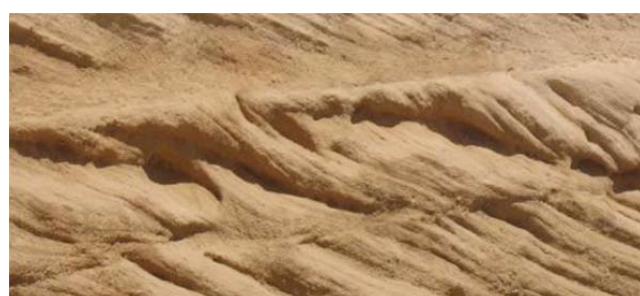
Abb. 7: Weißer Sandstein, Disi Sandstein Formation (Ordovizium).  
Fig. 7: White sandstone, Disi Sandstone Formation (Ordovician).

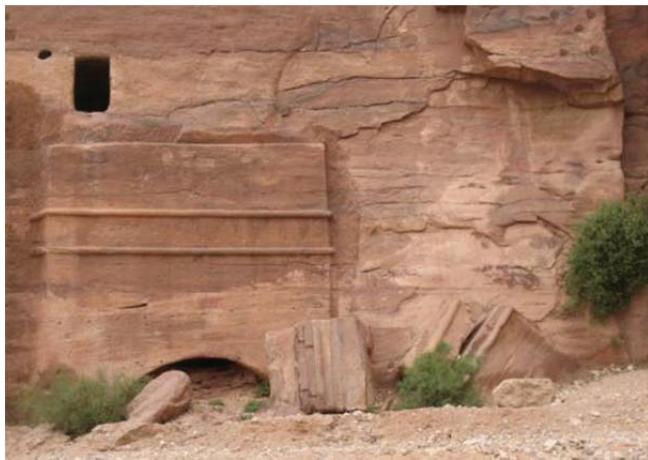
Abb. 8: Monument Nr. 831 (rechts). Einsturz infolge ebenen Gleitens entlang einer Kluft.

Fig. 8: Monument No. 831 (right). Collapse due to plane failure along a joint.

Plane failure, also called translational failure, describes the sliding of a mass of rock along a single discontinuity. The plane on which sliding occurs strikes parallel or nearly parallel to the monument surface. The dip of the failure plane is smaller than the dip of the monument surface. Two examples are presented in Figs. 8-11.

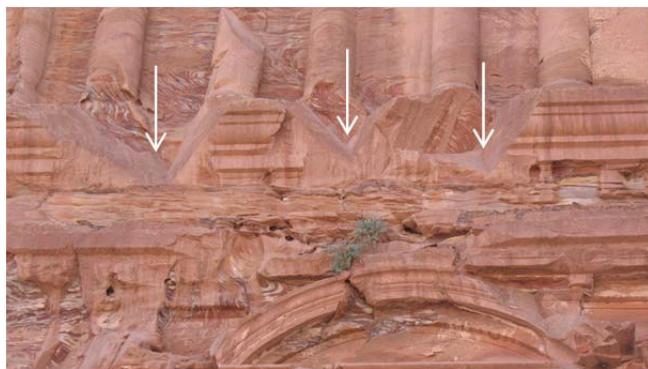
Abb. 12: Palastgrab (Nr. 765). Verlust von Gesteinsblöcken am Gesims infolge räumlichen Gleitens.

Fig. 12: Palace Tomb (No. 765). Loss of stone blocks at the moulding due to wedge failure.

Wedge failure describes the sliding of a mass of rock along two intersecting discontinuities. The discontinuities dip towards each other. The linear of their intersection dips out of the monument surface. In Petra the most common combination of such discontinuities resulting in wedge failure processes is that of two joints. An example is presented in Figs. 12 and 13.

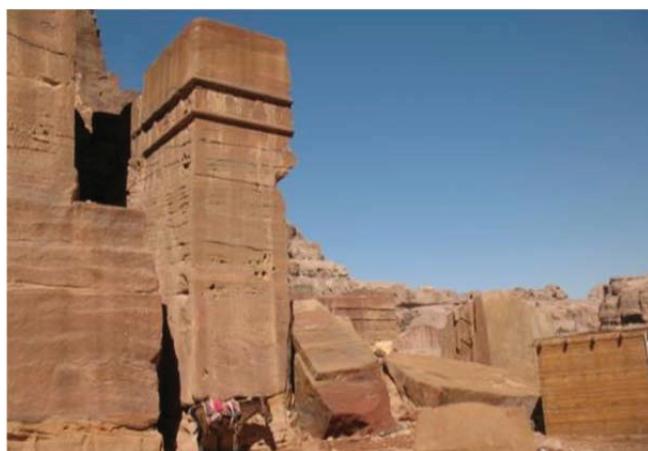
Abb. 14: Monument Nr. 73. Rechter Teil des freistehenden Monuments infolge Kippens an einer steil einfallenden Kluft zerstört.

Fig. 14: Monument No. 73. Right part of the monument destroyed due to toppling failure along a steeply inclined joint.

Toppling failures describes the fall of a rock block which is separated from the rock mass by a steeply inclined discontinuity, provided that the center of gravity of the block is brought outside its base. Toppling failure at Tomb No. 73 is shown as an example in Fig. 14.

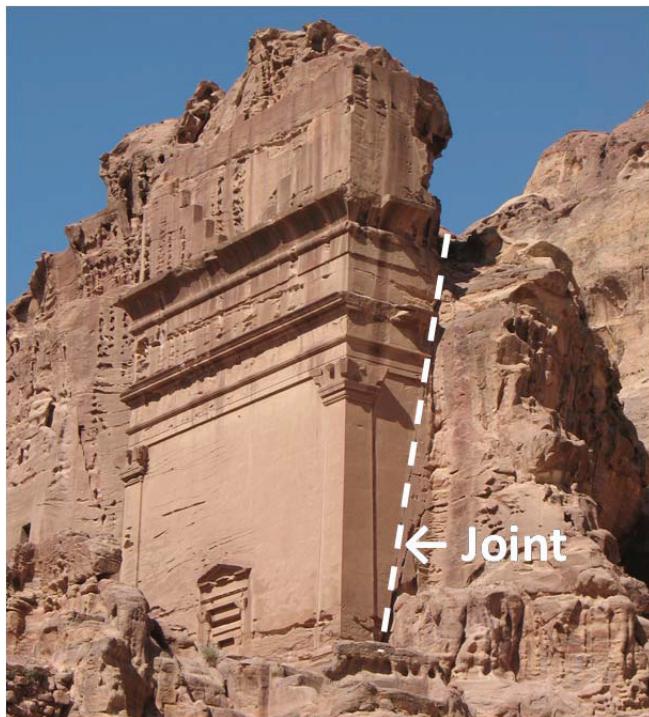
Abb. 16: Monument Nr. 808 mit markanter Kluft.

Fig. 16: Monument No. 808 with significant joint.

Figs. 16-20 document the situations with respect to discontinuities and potential failure processes for the monuments No. 808 (potential failure process: plane failure), No. 69 (potential failure process: wedge failure) and No. 138 (potential failure process: toppling) as examples.
