Methodology for diagnosis of real condition of a listed building envelope for its refurbishment

For this reason, the starting point must be the diagnosis of the real condition of the building envelope based on an exhaustive knowledge and quantification of its thermal properties and its state of preservation. This study includes thermograph analysis, thermofluxometry, blower door test and analysis of the indoor conditions of temperature and humidity according to occupant behaviour. Using this procedure we can determinate the critical points on which focus the efforts for its energy improvement. A case study of a multi-residential building registered as Modern Movement architecture is presented.

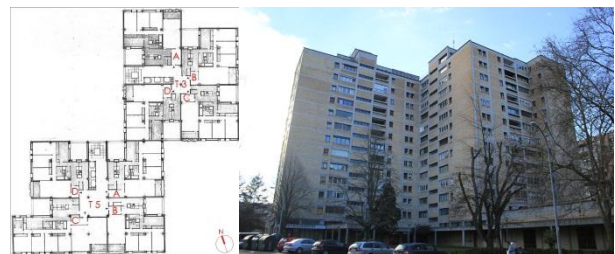
Figure 1: Plan and photograph of the current appearance of the building under study.

The building, located in Pamplona (Fig. 1), was built in 1965. It is composed by two residential towers joined at one side. They have 13 floors (ground floor plus twelve with four dwellings per floor each tower). The plant is raised diagonally to get the best orientation and an optimal exploitation of the plot.

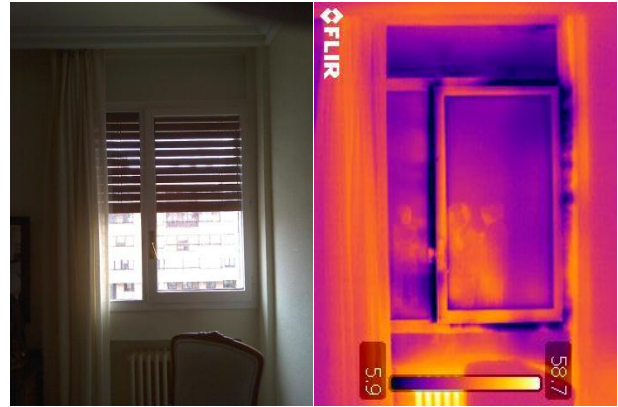
The blower door test was conducted in two different dwellings where the windows have been replaced in different times. In the first flat all the windows have been replaced by PVC ones with sun control double glazing two years ago. In the second flat two original windows remain and the others were replaced by aluminium without thermal break and wood frames with double glazing fifteen years ago. The value of n50 obtained was 2,18 1/h (Effective Leakage Area at 4 Pa= 181,6, ±3,4%) and 3,78 1/h (Effective Leakage Area at 4 Pa= 335,9, ±4,1) respectively. The main origin of the air leaks is the inefficient closing of the windows, the joint between the window frames and the facade and the head box for the exterior roll shutters as we can see in the thermograph (Fig. 5). According to these results the infiltration can be reduced considerably with airtight windows and their proper installation.

Figure 5: Photography and thermography of one window during the blower door test under depression.
