Agricultural buildings with timber structure – Preventative chemical wood preservation inevitably required?

ABSTRACT: Wood preservation is an important issue for agricultural buildings with timber structure. This is among others due to their halfway opened construction, high level of moisture release from livestock breeding or storing goods. However, regarding the possibly high moisture content in the building structure and the potential threat caused by wood-destroying organisms, there is still a substantial need for research. The latest results of the research work carried out by Technical University of Munich, in cooperation with the Bavarian State Research Center for Agriculture, show that, for the most agricultural buildings built from spruce, no preventative chemical wood preservation is necessary to ensure a durable construction.

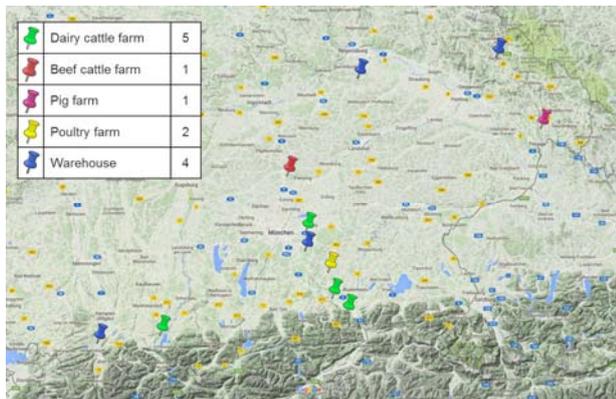
Figure 1: Locations of all selected monitoring objects

For the long-term measurements, a total of thirteen agricultural buildings with their location in South Bavaria (Germany) in the field of stables and warehouses are investigated (Figure 1). Depending on the size, the internal layout and the use of the building, individual monitoring concept was created for each building. Various conditions are recorded across the building area. These are e.g. sections with unusual climate conditions due to local moisture ingress or accumulation moist air in narrow space.

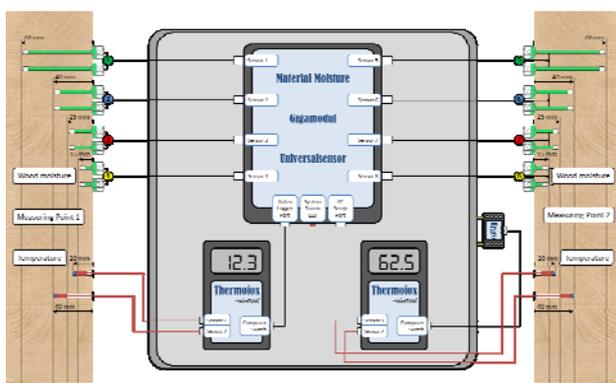
For the measuring of wood moisture content, the method of electrical resistance measurement was chosen. The measuring system illustrated in Figure 2 was used, which has been successfully applied in prior research projects [4, 5]. Depending on the situation, each measuring system comprises two to four measuring points, at which the wood moisture and the material temperature are measured at defined depths. The building indoor climate is recorded via an external sensor unit. In addition, a weather station is installed in the near of the measuring objects.

Figure 2: Schematic illustration of the measuring system

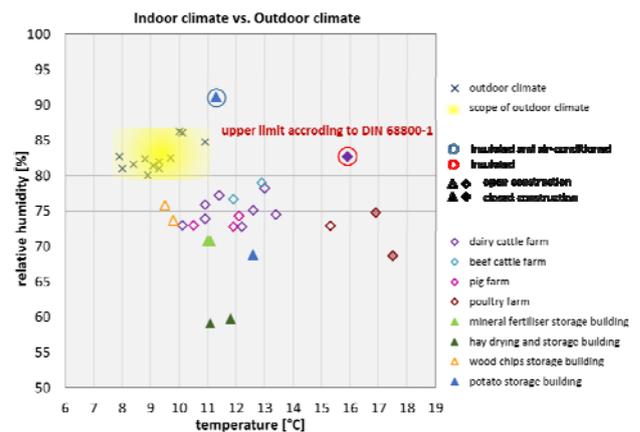
In Figure 3, the indoor and outdoor climate of the investigated objects are summarized. As additional information, the boundary of relative humidity according to DIN 68800-1 is drawn. This indicates that, with an average relative humidity of up to 85 % and no other moisture load, the wood equilibrium moisture content of 20 % should not be exceeded. It can be clearly seen that, depending on the use and constructive design of the building, the objects differ in their climatic conditions, sometimes only slightly, but sometimes significantly.

Figure 3: Climatic conditions in monitored objects

In the cattle stables, the temperatures are above and the relative humidity below the values of the outdoor climate. The outlier is the only warm stable, in which the livestock are kept tethered (red circle in Figure 3). Compared to other cold stable, higher average temperature and relative humidity are measured. The stable with tethering systems, in which the animals cannot move freely, were widespread until the 1970s and are characterized by the principle of closed construction. Recent studies on performance and animal welfare of dairy cattle prioritize the open-spaced barns with good ventilation through open construction [6].

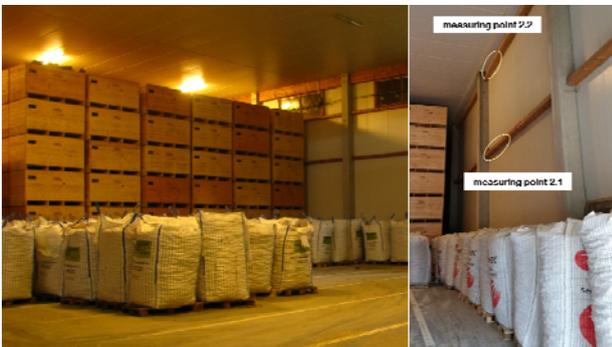
An interesting object is the potato storage building. In this building, expected temperatures and relatively low relative humidity were measured in the uninsulated, by a false ceiling from the storage room constructively separated roof area. In the closed and structurally insulated storage room (Figure 4), however, an average of 25% higher relative humidity was recorded. This is resulted from the cool and moist storage conditions that are essential for the potatoes and the necessary air conditioning of the building area.

Figure 4: Storage room of potato warehouse

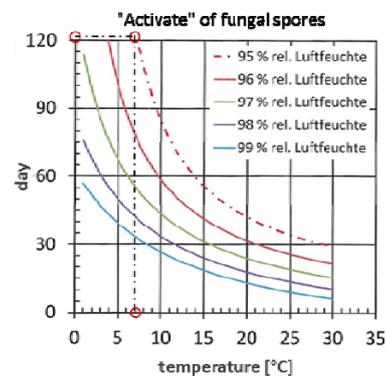
The wood-decaying model applied here is divided into two parts. On the one hand, it has to be examined which surrounding conditions have to be achieved and maintained over which period of time so that the fungal spores could be "activated". In the case of potato storage building, about 7 °C and 95 % relative humidity prevail during storage. According to the wood-decaying model, these climate conditions should be maintained for at least 120 days until the germination of fungal spores, see Figure 5.

Figure 5: wood-decaying model of Viitanen [8] – phase I: "Activate" of fungal spores

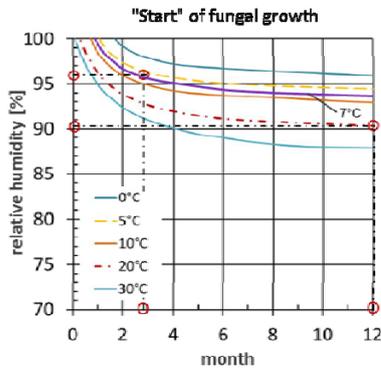
is again dependent on the surrounding climate conditions. In the same case of the potato storage building, the climate conditions mentioned above have to be maintained over a period of almost 90 days until the fungal start to growth, see Figure 6. With a reduction of the relative humidity to 90 % ($t = 20\text{ }^{\circ}\text{C}$), a period of more than 12 months would be required.

Figure 6: wood-decaying model of Viitanen [8] – phase II: “Start” of fungal growth

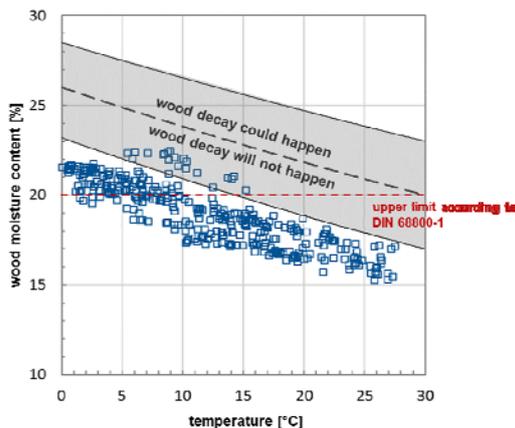
Kehl [8] derived a simplified engineering approach from the detailed wood-decaying model of Viitanen. In this approach, a boundary line is set for the surrounding climate condition, below which no wood decay would take place, even after 12 months. With help of sorption isotherms, this temperature-dependent boundary line of relative humidity was transferred to wood moisture content. Figure 7 shows that, in contrast to the upper limit according to DIN 68800-1, a temperature-dependent limit curve for the maximum permissible wood moisture content, below which fungal attack can be avoided. The gray area represents the fluctuation range, taking into account the different wood moisture contents that occur during absorption and desorption.

Figure 7: Temperature-dependent boundary for the assessment of the potential wood decay

with wood moisture content above 20 %. The wood moisture contents and their associated temperatures are plotted as point cloud in the diagram derived from the wood-decaying model, see Figure 7. These values are compared with the temperature-dependent boundary line. By means of this representation, it could be well recognized that the high wood moisture contents (over 20 %) measured in winter would not lead to wood decay. Due to the prevailing low temperatures at that time, no fungal infestation is possible.

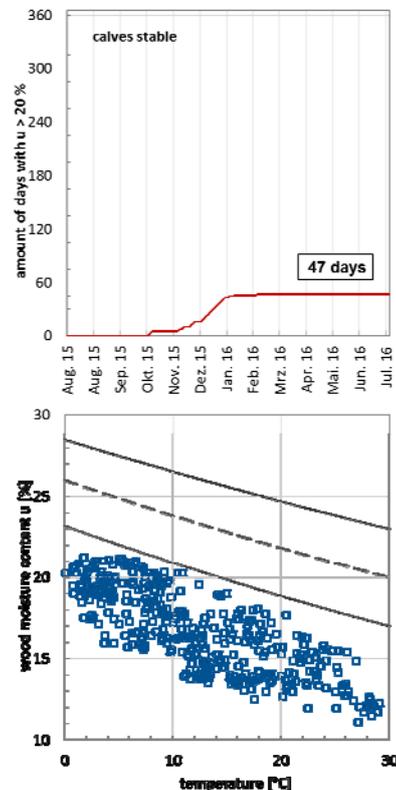
The first example is a calves stable (Figure 8), in which wood moisture contents above 20 % were measured on the side of the open eaves for 47 almost consecutive days. Considering only the upper limit according to DIN 68800, several data points crossed over the 20 %-limit, which would result in a classification of this specific building component in Use Classes other than GK 0 or 1. If one compares the measuring data with the previously presented, engineering approach, in which the temperature is taken into account, none of the data points lie within the gray fluctuation range, viz. fungal growth on the building component can be avoided.

Figure 8: Evaluation of data from calves stable

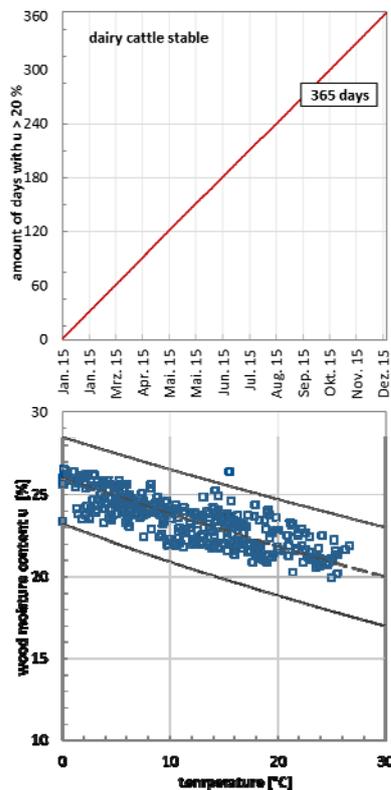
In the second example, a dairy cattle stable (Figure 9), measurements were taken on a column which lies directly in the area of a milking parlor. This area has to be cleaned regularly with a water jet. Near to the surface of this column, wood moisture content is constantly over 20 %. Also when combined with the temperature, all data points fall into the gray area where there is a risk of fungal growth. However, despite this, no fungal attack was determined on this building component. This could be due to the fact that the fungal spores wasn't been "activated", since the required air humidity of at least 95 % was not reached. On the other hand, a possible "wash out effect" is also conceivable, as a result of the cleaning process.

Figure 9: Evaluation of data from dairy cattle stable

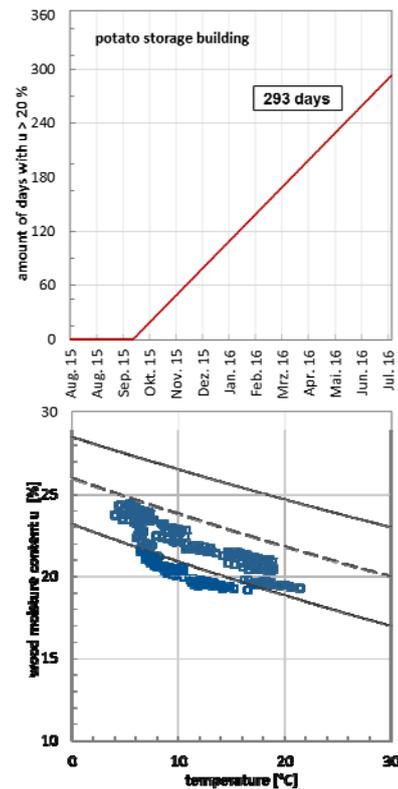
Finally, it is necessary to take a second look at the storage room of the potato storage building (Figure 10). During the storage, wood moisture contents of over 20 % were recorded for a long period. At least half of the data points fall into the gray area, in which fungal growth is possible. However, here was also no fungal attack on the building component detected. A closer inspection of the climate date shows that in the potato storage room prevailed from the end of November to the beginning of April around 7 °C and 95 % relative humidity. The relative humidity fell thereafter to about 90 % and remained at this level for the next 4 to 5 months, with temperatures ranging between 7 and 15 °C. This leads to the conclusion that, despite any possible "activation" of the fungal spores, the necessary climatic conditions after germination for "starting" fungal growth were not fulfilled for a sufficient period of time.

Figure 10: Evaluation of data from potato storage building
