Article

# Friction Behavior of Pre-Damaged Wet-Running Multi-Plate Clutches in an Endurance Test

Thomas Schneider \*

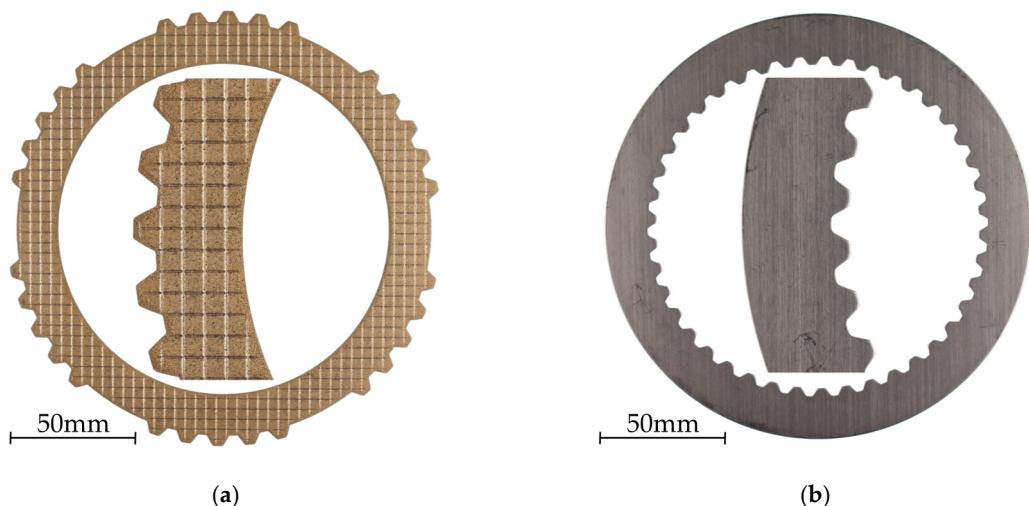
Photographs of the investigated friction plates with sintered metal friction lining, as well as the corresponding steel plates, are shown in Figure 1. The technical data is listed in Table 1. The steel plates are used as inner plates and the friction plates are used as outer ones.

**Figure 1.** (a) Friction plate; (b) steel plate.

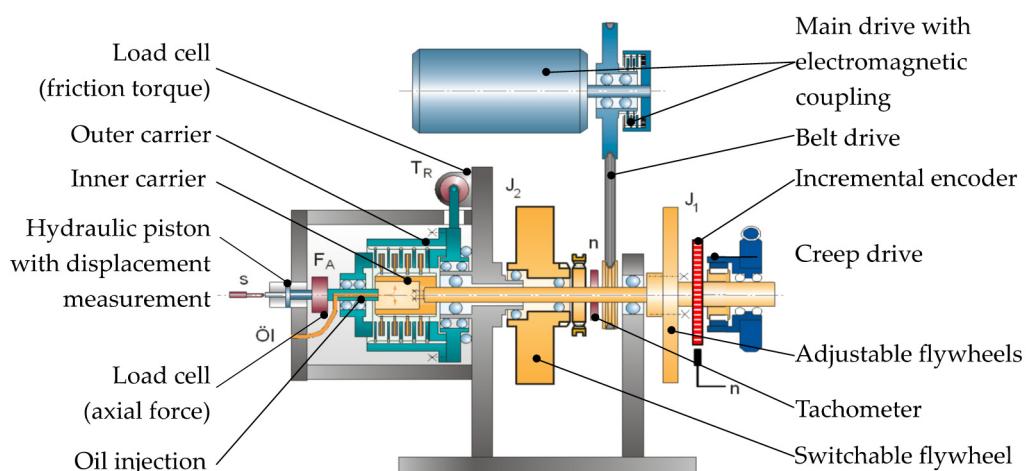
To examine the load limits concerning spontaneous damage to multi-plate clutches, step tests were carried out on the ZF/FZG KLP-260 component test bench. A sketch of the test bench is shown in Figure 2. Sketch of the test bench ZF/FZG KLP-260 according to Meingaßner et al. [22].

**Figure 2.** Sketch of the test bench ZF/FZG KLP-260 according to Meingaßner [23].

The tests were carried out on the ZF/FZG KLP-260 clutch test bench. The test bench is a brake test bench with an outer carrier fixed to the housing, as well as a rotating inner carrier [23]. In the ZF/KLP-260 test bench, a complete clutch of the transmission is installed via corresponding drivers. The inner plates are arranged on the central shaft and connected to the flywheels ( $J_1, J_2$ ). The contact pressure is applied to the outer plates, at which the friction torque of the clutch is also measured. The clutch is supplied centrally with cooling oil from the inside (defined cooling oil flow; oil temperature  $\vartheta_{\text{oil}}$  oil thermostat-controlled heating and cooling). External lubrication from above is also possible.

For each shifting test, the main shaft with internal driver and flywheel masses is accelerated by the speed-controlled main drive to the differential speed  $\Delta n$ . During the clutch test, the motor is separated from the test bench by an electromagnetic clutch. The shifting force is applied to the clutch by the hydraulic cylinder in a defined manner via the clutch-specific pressure ring. Force increase and force maximum are adjustable.

In the slip operation, a defined axial force is applied to the clutch. The specified differential speed is set in the clutch via the creep drive. The slip speed is measured via a high-resolution incremental encoder.

The mass moment of inertia  $J$  loading the clutch can be changed by flange-mounting discs of different mass moments of inertia  $J_1$  and connecting the basic mass  $J_2$ . The technical data of the test bench are listed in Table 2.

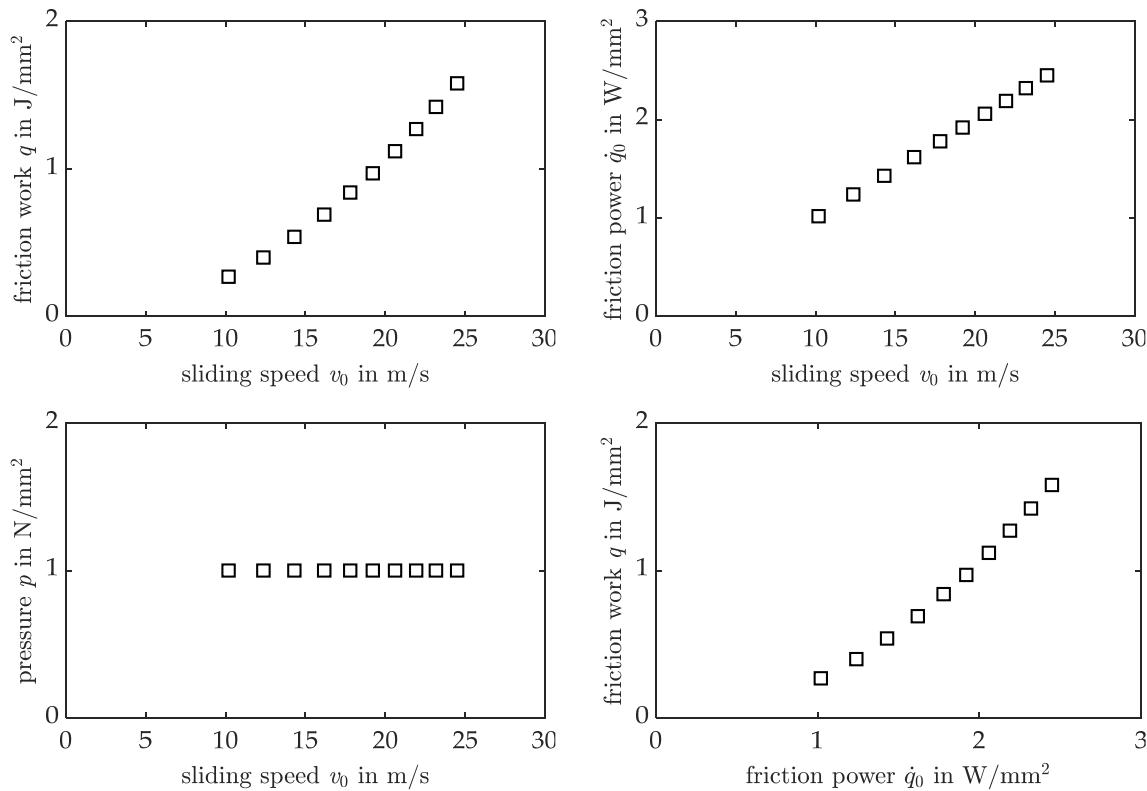
For a better overview, the loads are also shown graphically in the step-by-step test. Figure 3 illustrates the specific load levels of a step test with ten load levels. Each point represents a load level of the step test. The variation of the sliding speed  $v_0$  in the individual load levels affects the friction work  $q$  and peak friction power  $\dot{q}_0$ .

**Figure 3.** Load levels of the step test.

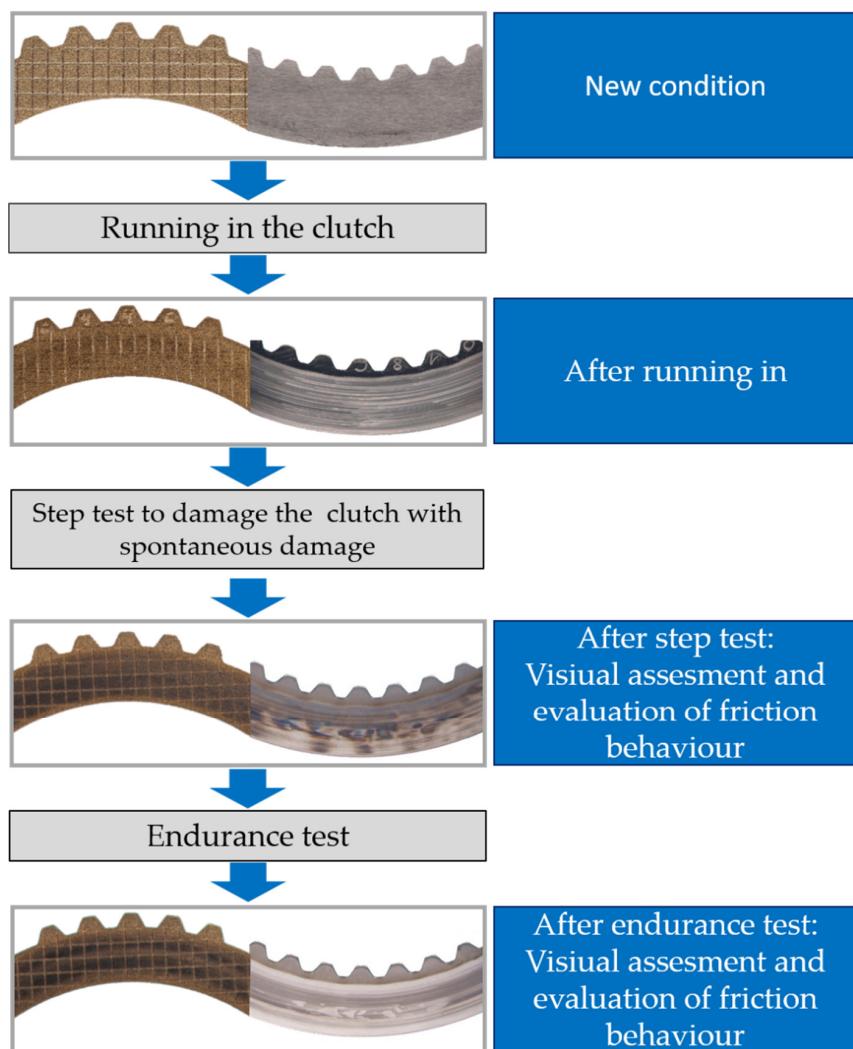
To aid understanding, the experimental method is shown in a schematic diagram in Figure 4.

**Figure 4.** Experimental method.

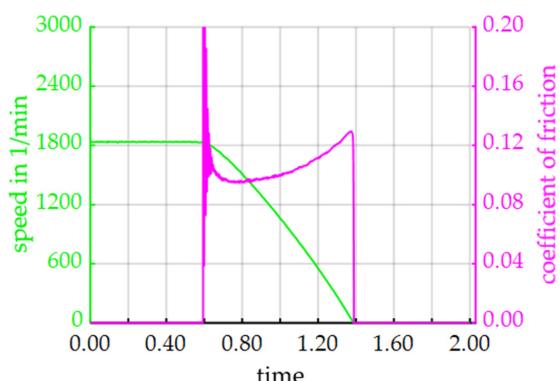
For the test LL-03, the step test was run up to load level 3 (cf. Table 4). These loads caused the first local discolorations on the steel plate. No fluctuations in the friction coefficient of a cycle were observed at load level 3. Figure 5 shows the friction coefficient curve for a shift at load level 3. The step test was followed by the endurance test.

**Figure 5.** Friction coefficient curve for a shift at load level 3.

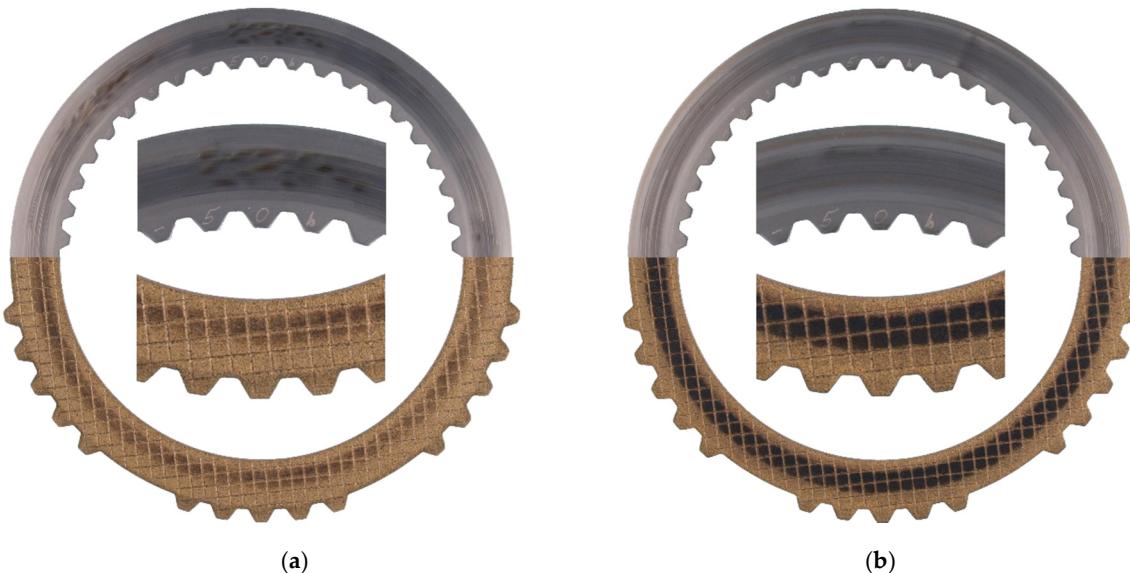
Figure 6a shows the steel and lining plate directly after the step test by pre-damaging the package. First discolorations on the steel plates can be observed. On the right-hand side (Figure 6b), the condition of the plates after the endurance test is documented. The photographs show that local discoloration on the steel plate is no longer visible after the endurance test. The friction plate shows a stronger discoloration after the 10,000 shifts of the endurance test.

**Figure 6.** (a) Photos of the pre-damaged plates after load level 3; (b) photos of the pre-damaged plates after the endurance test.

In the step test, the different load levels cause varying forms of damage. Local discoloration, sinter transfer and friction coefficient fluctuations can be observed. After the endurance test, local discoloration and sinter transfer are no longer visible on the steel plate. This shows that this local discoloration, which is also described in the literature as oil-cracking products [13], is removed again due to wear mechanisms during the endurance test. It is also assumed that the sinter transferred is also removed due to wear during the endurance test. In the areas with very strong discoloration before the endurance test, specked brightening is visible after the endurance test. This brightening indicates structural changes as described by Kasem, Fairbank and Strel [8,11,25]. These structural changes in the material cannot be visibly altered by wear mechanisms. A visible darkening of the lining plates in the continuous shifting test is caused by oil deposits and oil-cracking products in the pores. This was also observed by Acuner [26].

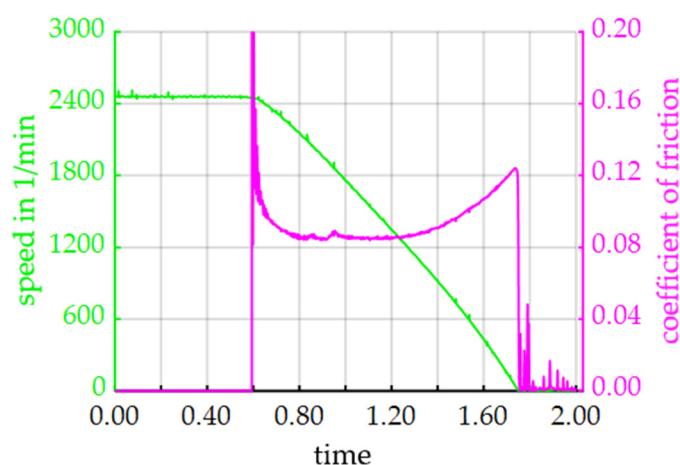
For the test LL-06, the step test was run up to load level 6 (cf. Table 4). The step test is carried out until local discoloration and a recognizable amount of sinter is transferred to the steel plate. At the same time, friction coefficient fluctuations as a result of seizing occur during the shifting process (Figure 7).

**Figure 7.** Friction coefficient curve for a shift at load level 6.

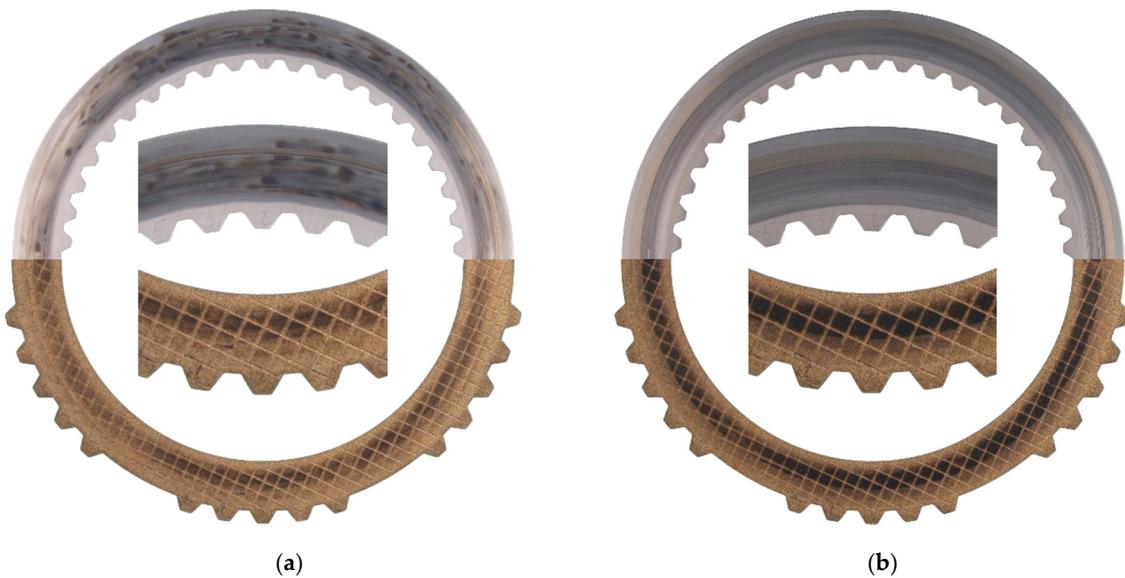
Figure 8a shows the steel and lining plates directly after the step test by pre-damaging the package. On the right side (Figure 8b), the condition of the plates after the continuous shifting test was documented. The photographs show that local discoloration and sinter transfer are no longer visible on the steel plates after the endurance test. The friction plate shows a stronger discoloration after the 10,000 shifts of the endurance test.

**Figure 8.** (a) Photo of the pre-damaged plates after load level 6; (b) photo of the pre-damaged plates after the endurance test.

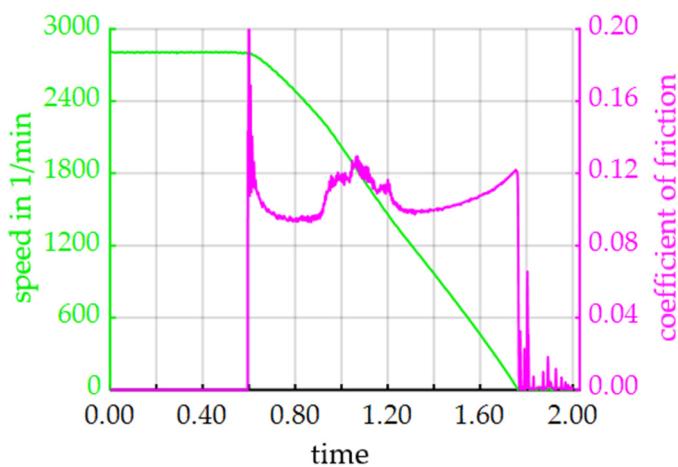
For test LL-08, the step test was run up to load level 8 (cf. Table 4). These loads resulted in local discoloration and a recognizable transfer of the sinter on the steel plate. In the friction coefficient curve of exemplary engagements at load level 8, a strong increase in the friction coefficient as a consequence of seizing can be seen (Figure 9). The step test was followed by the endurance test.

**Figure 9.** Friction coefficient curve for a shift at load level 8.

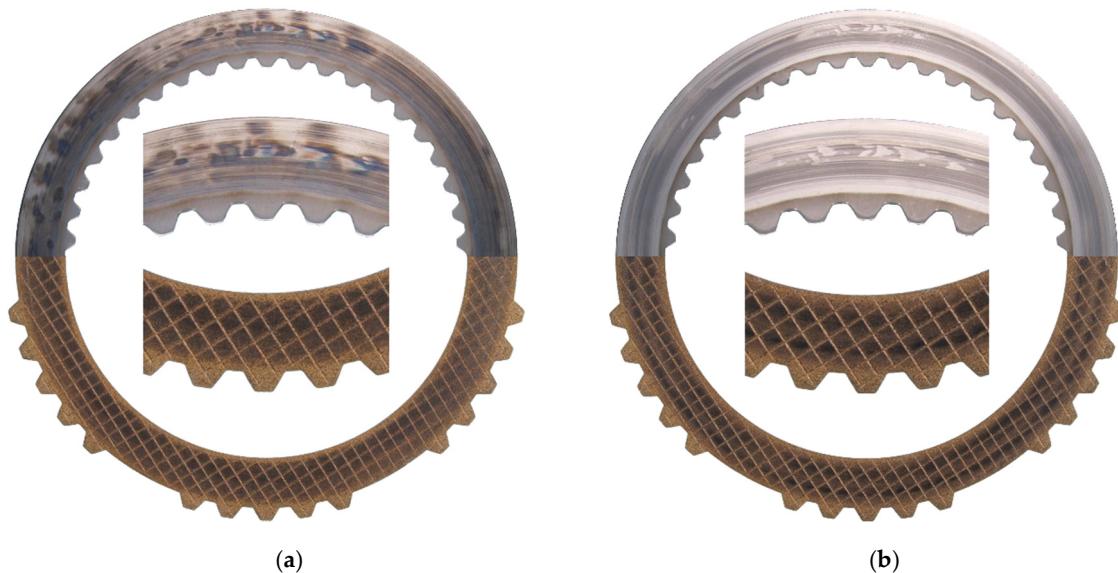
Figure 10a shows the steel and lining plates directly after the step test by pre-damaging the package. On the right side (Figure 10b), the condition of the plates after the continuous shifting test is documented. The photos show that local discoloration and sinter transfer are no longer visible on the steel plate after the endurance tests. In the areas of very significant discoloration on the steel plate prior to the endurance test, selective brightening can be seen after the endurance tests. The friction plate shows a stronger discoloration after the 10,000 shifts of the endurance test.

**Figure 10.** (a) Photo of the pre-damaged plates after load level 8; (b) photo of the pre-damaged plates after the endurance test.

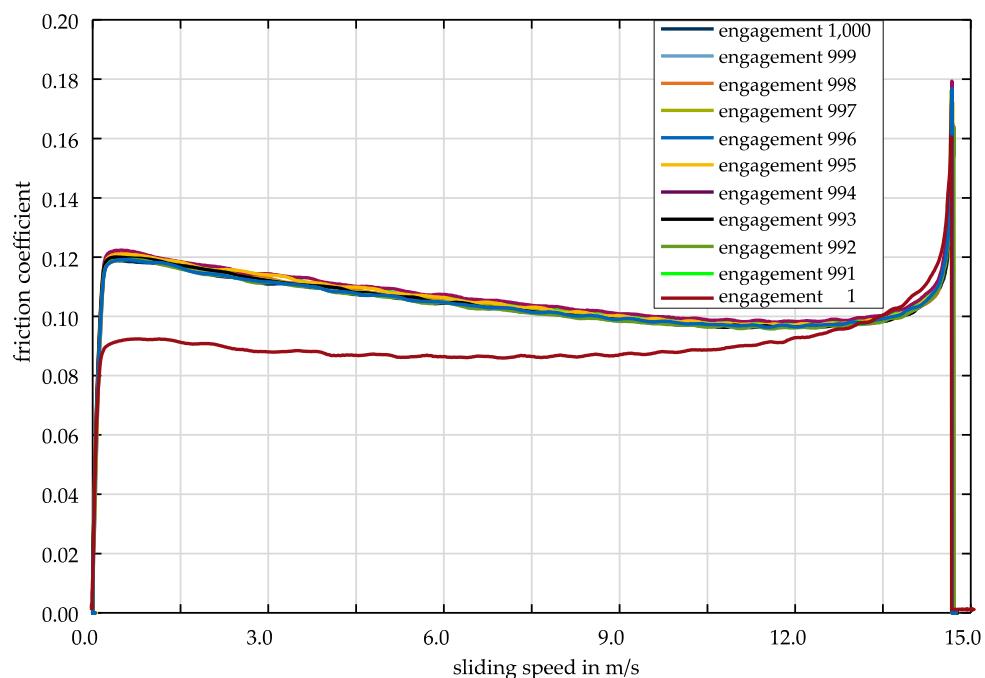
Figure 11 shows the friction coefficient curves of the last 10 engagements and the first engagement during the running in for test LL-03. It can be seen that the friction coefficient curves of the last 10 engagements differ slightly compared to the first engagement. This knowledge is relevant for evaluating the following measurement records.

**Figure 11.** Friction coefficient curves of the last ten engagements in the run-in for test LL-03.

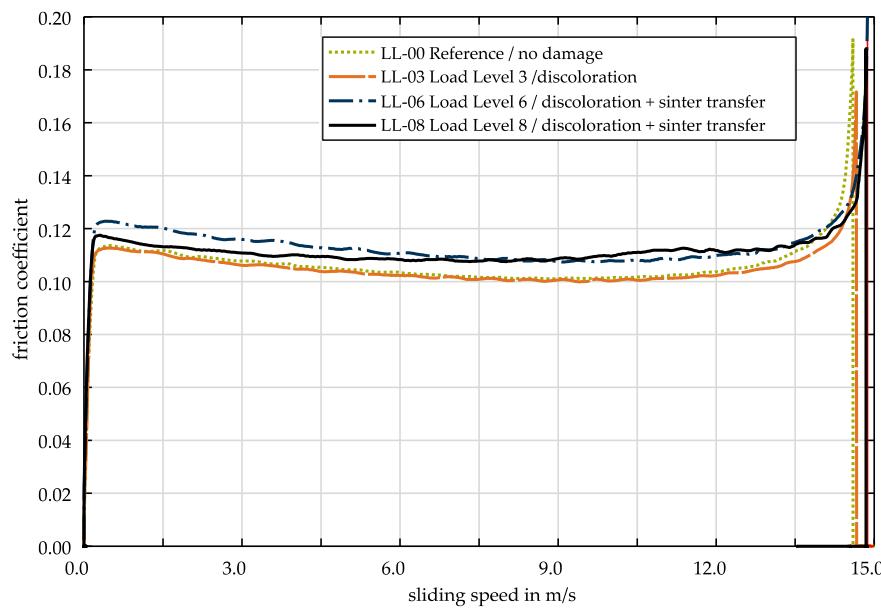
Figures 12–14 show the friction coefficient curves of three pre-damaged clutches (LL-03 to LL-08) and one reference clutch that was not pre-damaged (LL-00) for selected shifts in the endurance test. For shift 1 in the endurance test, the coefficients of friction over the entire speed range of the heavily pre-damaged clutches (pre-damaged at load levels 5 and 8) are slightly higher than with a slightly pre-damaged clutch (pre-damaged at load level 3) and a clutch that was not pre-damaged (cf. Figure 12).

**Figure 12.** Single engagement comparison of previously damaged and non-damaged clutches (engagement 1 in the endurance test).

At the start of the endurance test, the values of coefficients of friction over the entire speed range of the heavily pre-damaged clutches are higher than with the slightly pre-damaged clutch and the clutch that had not been pre-damaged. Thus, the sinter transfer on the surface of the heavily damaged steel plate has an influence on the friction coefficient.

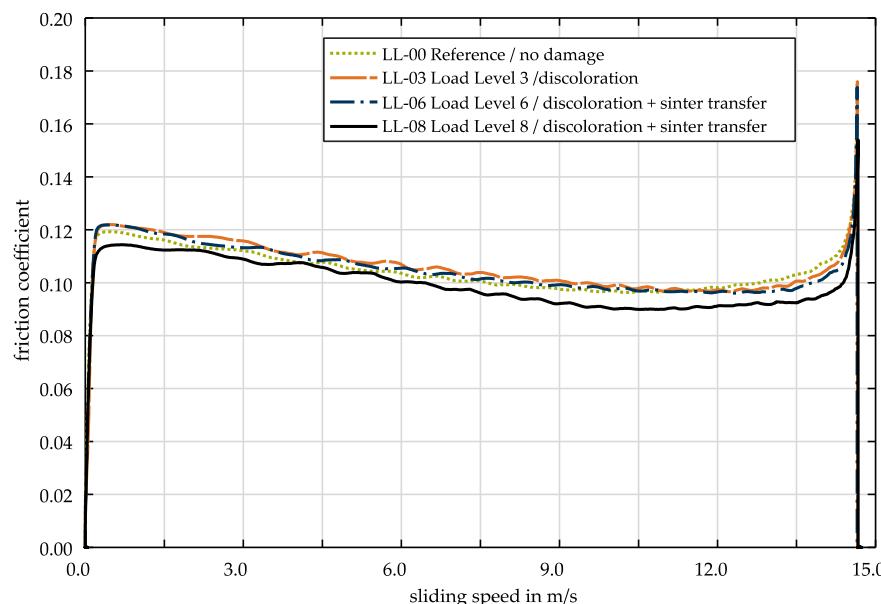
**Figure 13.** Single engagement comparison of previously damaged and non-damaged clutches (engagement 5000 in the endurance test).

Figure 13 shows values of the friction coefficients over the sliding speed for shift 5000 of the endurance tests. Clutch LL-08 shows a lower coefficient of friction level in comparison to the other clutches. In addition, the gradient of coefficient of friction over sliding speed with decreasing sliding speed is greater in the pre-damaged systems than in the reference clutch. This means that with decreasing sliding speed the coefficient of friction increases more strongly in the pre-damaged clutch than in the reference clutch. The speed-dependent fluctuations in the coefficient of friction of the pre-damaged clutches have increased in the endurance test compared with shift 1 (Figure 12).

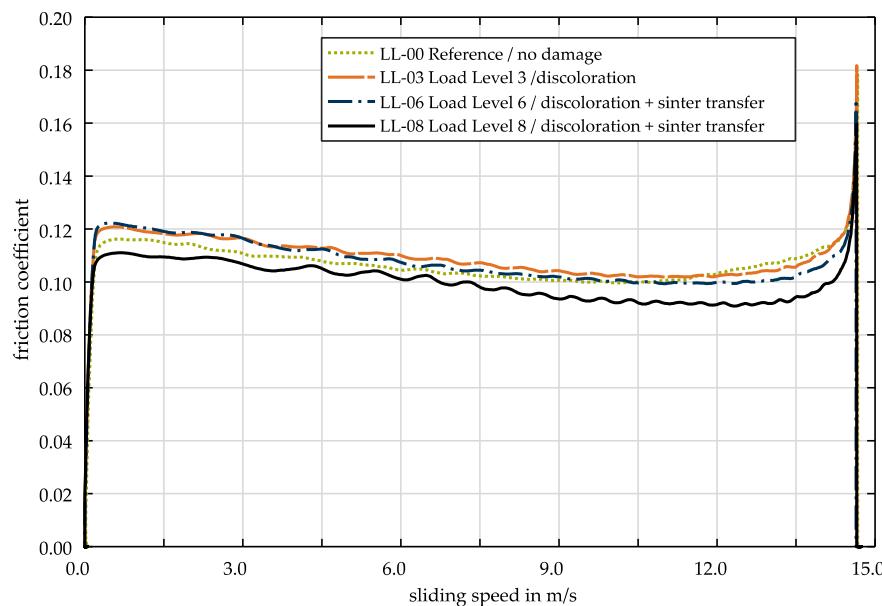
For cycle 10,000 in the endurance test a similar picture as for shift 5000 appears (Figure 14). The increase in the coefficient of friction with a decrease of the sliding speed can be observed in the pre-damaged clutches. In addition, a stronger speed-dependent fluctuation of the coefficient of friction can be observed in the pre-damaged systems. The coefficient of friction level for clutch LL-08 is below

the level of the other clutches. This is strongly related to the fact that the friction coefficient level is very low in relative terms at the beginning of the shifting process. The coefficient of friction over sliding speed gradient behaves similarly to clutches LL-03 and LL-06.

**Figure 14.** Single engagement comparison of previously damaged and non-damaged clutches (engagement 10,000 in the endurance test).

At the end of the endurance test it can be observed that with increasing pre-damage, the values of coefficients of friction at the beginning of the shift are lower. In the case of carbon synchronizer, this behavior was justified by the friction lining becoming smoother due to oil deposits [26]. It is assumed that this phenomenon also occurs here and that the pores are partially clogged up and smeared due to the damaging engagements.

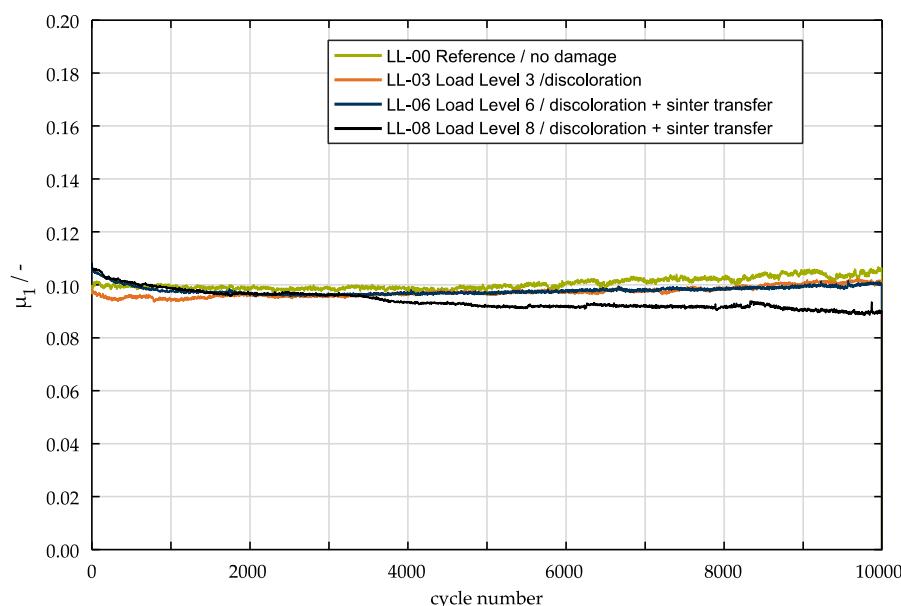
In addition to the individual shifts, Figure 15 shows the trend curves for  $\mu_1$  of the four clutches investigated in the endurance test. The friction coefficient  $\mu_1$  corresponds to the friction coefficient at 85% of the maximum sliding speed [26]. The trend curves show that  $\mu_1$  in the reference clutch rises minimally during the endurance test. For clutches LL-03 and LL-06,  $\mu_1$  decreases at the beginning and then rises slightly. LL-08 shows a continuous drop in the value  $\mu_1$  over the duration of the endurance test and shows a clear difference to the other tests at the end.

**Figure 15.** Trend comparison of  $\mu_1$  over 10,000 shifts in the endurance test.
