## DIGITAL IMAGE PROCESSING IN THE MONITORING OF WIDE-SPAN TIMBER ROOF STRUCTURES

In order to achieve a simple, robust and economical system to continuously monitor the deformations of wide-span timber roof structures the methods of digital image processing were employed. The practical applicability of the system was tested in a pilot project.

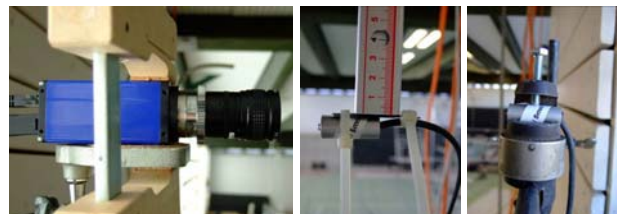
**Figure 1:** Preliminary tests, arrangement of system components: Camera (K), LED-target as measuring point (M) and LED-target as reference point (R)

**Figure 2:** Preliminary tests, system components: Camera (left), movable LED-target as measuring point (center) and LED-target as reference point (right)

To test the proposed procedure, preliminary tests were conducted in the lab and later in the gym hall of the pilot project described below. The test setup is pictured in

Figure 1. The individual components can be seen in Figure 2. During the preliminary tests, the measuring point was moved vertically in single millimetre increments and recorded after each step. Figure 3 shows four different images of the test. The writing in the lower left corner indicates the current millimetre setting; the orange lines are measurements within the image.

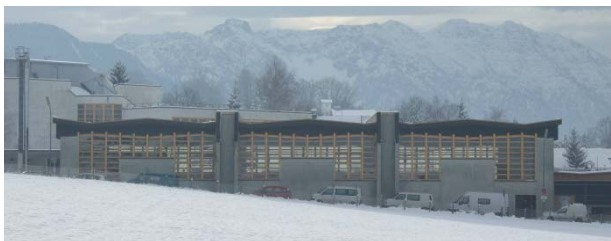
The basic concept of the solution proposed here was already presented at WCTE 2008 [1]. In the meantime the suitability of the method for daily use was verified in a research project [2]. For this, the school gym of the Staffelseegymnasium in Murnau in the district of Garmisch-Partenkirchen in Southern Bavaria was chosen as pilot project. (Figure 4)

**Figure 4:** School gym in Murnau, district of Garmisch-Partenkirchen, Southern Bavaria

The snow load determining for this building was increased from  $s_0=1.50 \text{ kN/m}^2$  (DIN 1055-5:1975-06) to  $s_k=3.78 \text{ kN/m}^2$  (DIN 1055-5:2005-07) with effect from 1.1.2007. In the light of the new snow load guidelines, the operating ratio for the main supporting beam works out at  $\eta = 1.09 > 1.00$ . In other words the roof structure is under excessive strain (amounting to a 9% overload) and its structural safety is inadequate.

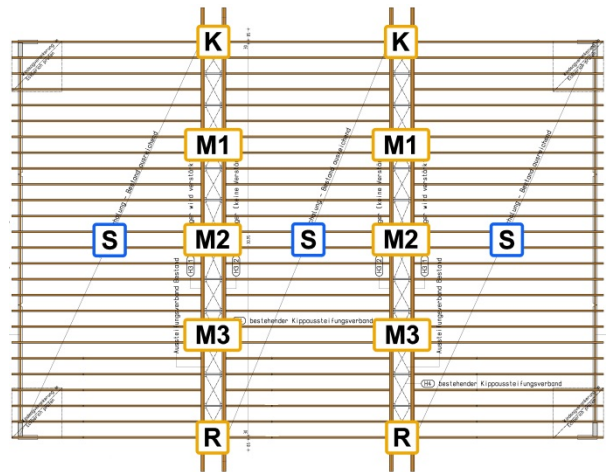
**Figure 6:** Plan of roof structure and main components of monitoring system: Camera (K), LED-targets as measuring points (M1, M2 and M3), LED-target as reference point (R) and snow load measuring units (S)

Additional control measurements can be carried out with a permanently installed laser gauge. To observe correlations between the climate and deformations, a weather station was installed with snow cushions (S) and sensors for air temperature, air humidity, global radiation, wind direction and wind speed. An overview of the location of the individual components is shown in Figure 6.

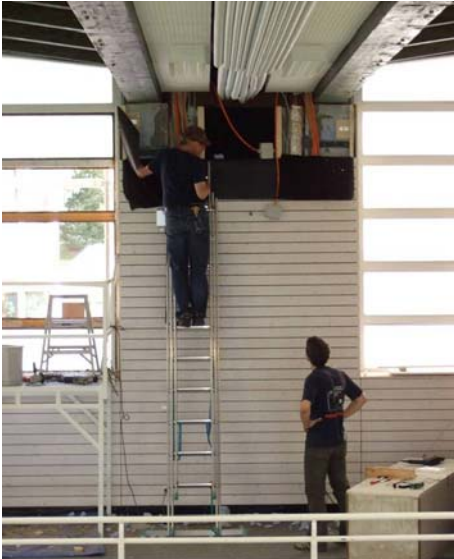
**Figure 8:** Cameras during installation

The cameras were mounted on the south side of the gym directly below the bearings of the main beams shielded behind the existing wood cladding (Figure 8, Figure 9). The LEDs of the measurement points are protected by a solid steel casing and mounted to the bottom side of the main beams (Figure 10). The LEDs of the reference points were mounted on the north side of the gym beneath the bearings of the main beams, also behind the wood cladding (Figure 11).

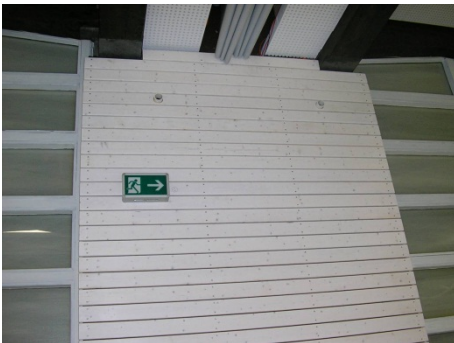
**Figure 9:** Cameras hidden behind cladding

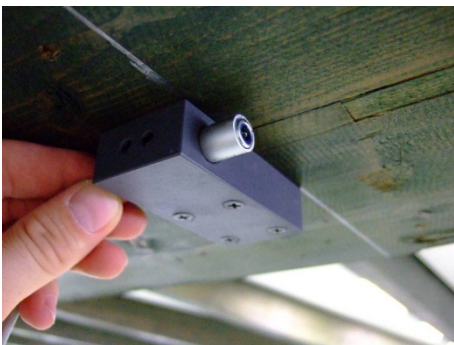
**Figure 10:** Measuring point on main beam

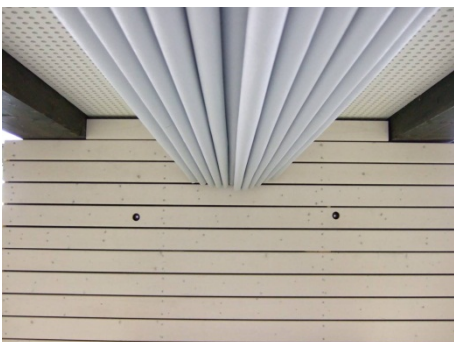
**Figure 11:** Reference points hidden behind cladding

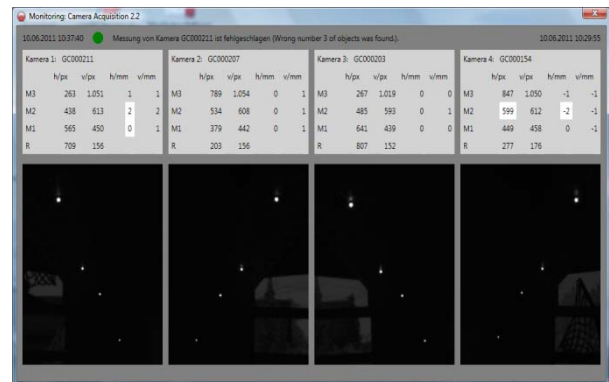
**Figure 12:** Screenshot of measuring-software: At the bottom four pictures, each showing one of the four main beams of the gymnasium, on each picture the four LED (three measuring points and one reference point) can be located as bright spots, above each picture measurements in vertical and horizontal direction are displayed for each point using pixel and millimetres as units

All data are stored and processed on a local central computer with remote access via the internet. Specially designed software analyses data and displays the resulting information. This software controls the cameras, manages the measurements and records all data in a SQL database. Additionally, the program displays warnings, measurements and images as seen in Figure 12. The measurements are displayed in pixel (raw data without modifications) and as deformation in mm relative to a fixed absolute zero. The frequency with which the system records, is linked to the speed and extent of the deformation.

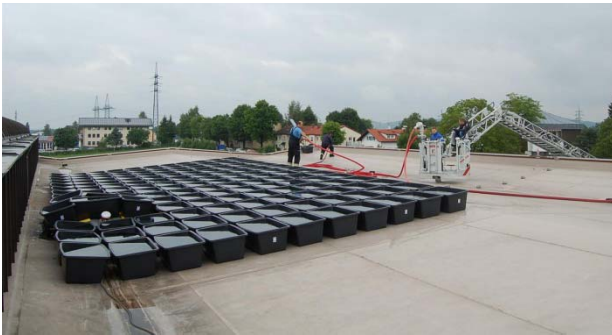
**Figure 13:** Artificial load on the roof of the school gym in Murnau, consisting of 154 buckets of the size of 90l, filled with water

During tests with artificial loads (Figure 13), the actual bending stiffness of the main beams was determined. Based on these findings, deformation boundaries were

specified which, if reached, lead to control actions or cause an alarm.
