# Thermal Comfort in the Pedagogical College of the State University of Maringá, Brazil

*ABSTRACT: The construction of the Pedagogical College (CAP/UEM) of the State University of Maringá, Brazil was part of a nationwide project, called Centres for the Integral Care to Children and Adolescents – CAICs, created in the 1990s. The initial design, conceived by João Filgueiras Lima (a.k.a Lelé), was acknowledged for its concern for the environmental comfort of users in their activities. Current paper evaluates the thermal comfort of the CAP/UEM building and verifies the performance of passive strategies that promote the students' indoor thermal comfort and thermal feeling. Methodology consists of a project analysis for the identification and the characterization of passive solutions for comfort and the measurements of environmental variables measurements that were undertaken concurrently with the application of a questionnaire to students during the summer. Results show that, despite the passive strategies observed in the facades' shading system and in other devices to enhance crossed ventilation, the roof of the building practically causes large thermal gain and dissatisfaction in use

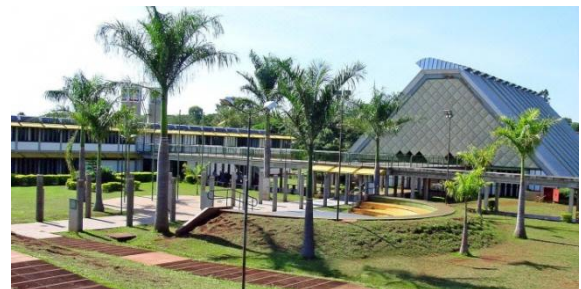
Figure 1: Pedagogical College on the campus of the State University of Maringá

Owing to his accumulated knowledge and practical experience with rationalized structural mortar systems, the architect João Filgueiras Lima (a.k.a Lelé) was invited to develop the building project [3]. However, political issues impaired the participation of Lima's team in the experience except for the execution of two prototypes and the preparation of the projects, which were later modified to such an extent that the initial project design was actually de-characterized [5]. Lima and his team had a plan to make the projects locally adapted, but due to their remoteness, it was not done and the schools all over Brazil were made in a very similar way, which does not meet sustainable design. Featuring fastness in building and low costs, Filgueiras Lima created several devices for the users' thermal comfort in an architecture which became the hallmark of the governmental program (Fig. 1).

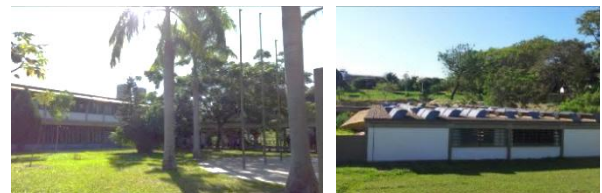
Figure 3: Vegetation (a) and roof openings (b)

Passive strategies were identified by site visits and project analysis. They included surrounding vegetation (Fig. 3a), natural illumination produced by several protection devices to ward off direct sun radiation (Fig. 4a) and the correct establishment of natural crossed ventilation, specifically northeast in Maringá (Fig. 5). The whole building is equipped with sheds for illumination and ventilation through the ceiling (Fig. 3b), and with horizontal brise-soleil or sunlight breakers over the windows (Fig. 4a). Further, the design of the window frame is actually a movable sunlight breaker (Fig. 4b).

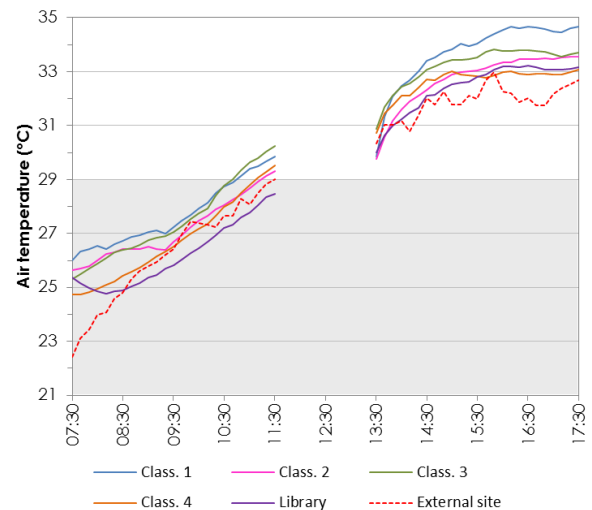
Temperature rates revealed similar behaviour during the three days of observation. Figure 8 shows mean temperatures and dotted line represents temperature and humidity data measured at the external site. No measurements were undertaken between 11h30 and 13h30 and a gap may be seen in the graph. The gray area on the graph shows the acceptable temperature band for naturally conditioned spaces, following ASHARE 55 (2010) which, according to calculations for the climate in Maringá, lies between  $21^\circ$  and  $29^\circ\text{C}$ .

Figure 8: Graph showing air temperature

In the morning, up to approximately 10h30, temperatures were within the acceptable band, according to ASHRAE 55 [1]. No temperature was acceptable at any time during the afternoon since temperatures were over 30°C. It is highly relevant to note that the external temperature in the afternoon is lower than that in the classrooms. Therefore, if students had lessons at the shade outside, they would have felt more comfortable during the period.

Analysis of graphs showing mean temperature at the different places under analysis demonstrated that, albeit with similar behaviour, Classrooms 1 and 3, facing a northeast direction, had slightly higher temperatures. Classrooms 2 and 4, facing a southwest direction, showed slightly lower temperatures than those given above. The lowest temperatures among the rooms were registered at the library facing a northeast direction. Although during the morning the library registered lower temperatures than those on the outside, in the afternoon the external temperatures were lower and indicated a critical situation for students and teachers. Since the same direction provides the highest and the lowest temperatures, it may be stated that the highest heat gain is provided by the premise's roof.

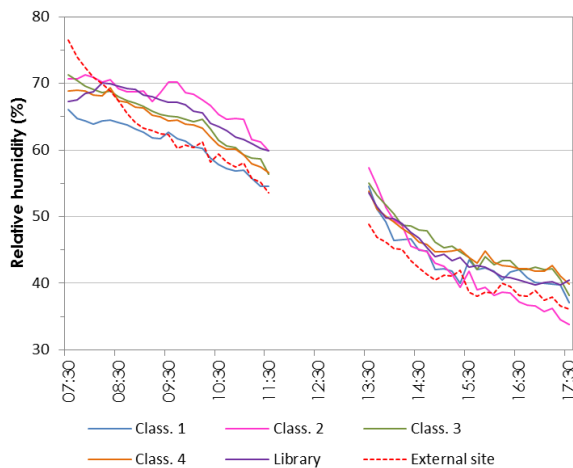
Maximum external relative humidity reached 79.9% on the 3<sup>rd</sup> day at 07h30 (Fig. 9) and minimum humidity was 31.8% at 17h of the same day, with a 47.9% variation. On days 1 and 2 maximum external relative humidity rates were 72.2% and 77.7% at 07h30; minimum humidity for the same days reached 36.8% at 17h30 and 37% at 15h10, respectively. Heavy rate decrease in relative humidity throughout these days was due to high solar radiation levels which evaporated water particles in the air and caused a rise in temperature.

Figure 9: Graph showing relative air humidity

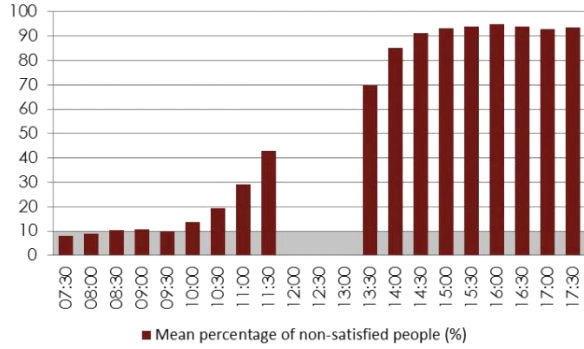
Predicted Mean Vote (PMV) and Predicted Percentage of Dissatisfied (PPD) indexes were calculated from data on air temperature, mean radiant temperature, relative humidity and air speed. They revealed a comfort bracket up till 10h00 in which  $-0.5 < PMV < +0.5$  and the percentage of non-satisfied people (PPD) was less than 10%. It is very difficult to feel comfortable with external temperatures higher than 30°C in the afternoon without the use of other complementary systems.

Figure 12: Graph showing PPD

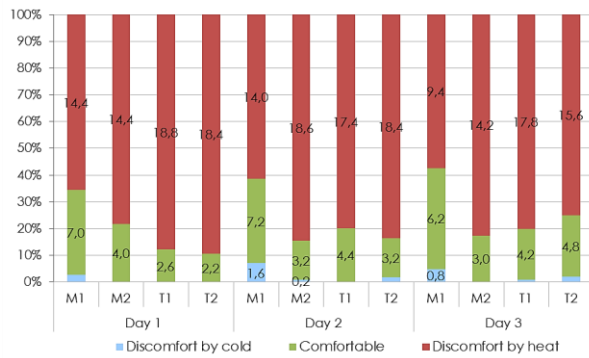
Responses from the questionnaires indicated heat discomfort (Fig. 13). However, the percentage of people feeling comfortable during the early morning period (M1) was higher than that for the rest of the day where heat discomfort was prevalent. The above fact may be corroborated by the comfort bracket for air temperature, PMV and PPD until approximately 10h30. When asked about thermal preference (Fig. 14), most preferred a cooler environment (between -3 and -1). Greater preference was again given to the early morning period (M1) with no desire for change since the students felt comfortable.

Figure 13: Mean thermal feeling – questionnaires
