MEASUREMENT SYSTEMS TO DETECT THE TIME-DEPENDANT DEVELOPMENT OF CONCRETE SPALLING UNDER FIRE EXPOSURE

Richter R. (1), Dehn F. (2), Schmidt J. (2), Juknat M. (2), Grosse C.U. (1)

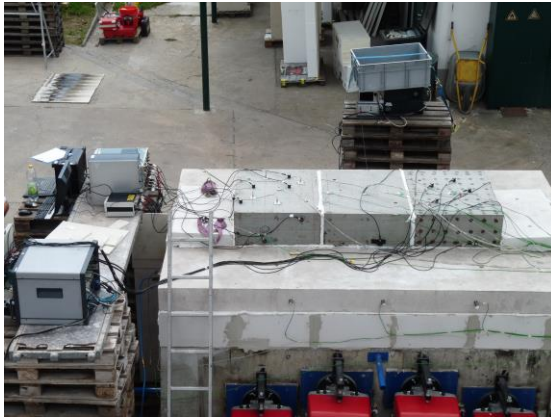
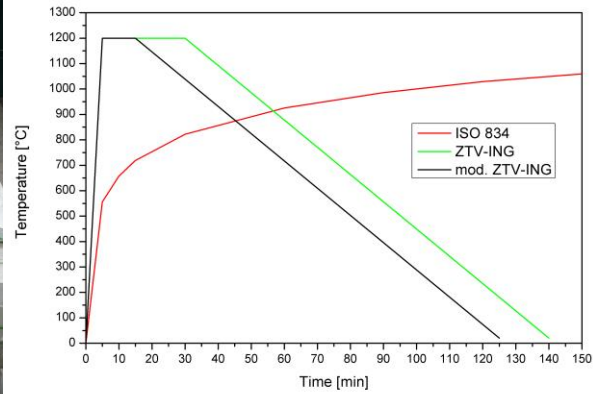
Figure 2: Specimens on top of the furnace with the connected measurement systems (left) and the used temperate-curves (right). The specimens were tested according to the ISO 834 and the modified ZTV-ING.

In the experimental program, concrete with and without polypropylene (PP) fibres were tested. The oil-burner-furnace at the MFPA Leipzig were controlled after the ISO 834 and the modified ZTV-ING temperature curves [Figure 2 right]. In every experiment specimens with a size of 70x85x30 cm³ have been used. Figure 2, left, show the specimen on top of the surface and Figure 3 the damaged specimens after the experiment. In the concrete mix with PP-fibres, no spalling occurred. On every specimen bending cracks were observed.

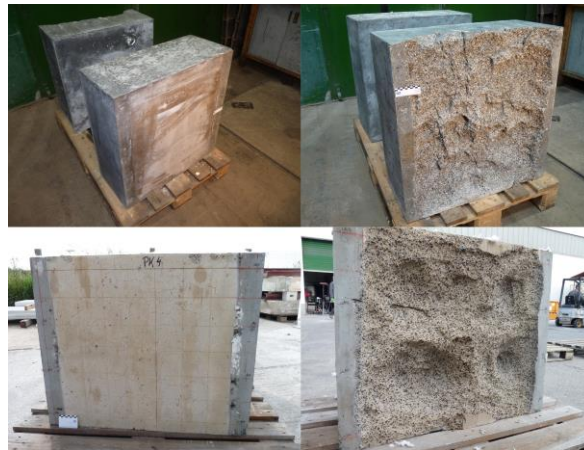
Figure 3: Specimen with 1 kg PP fibres per m³ concrete after the experiment (left), specimen without PP fibres showing damage due to spalling (right).

Looking at an experiment with and one without PP-fibres the difference can be seen in the events with high energy. By using PP fibres, no spalling but cracking could be observed [Figure 3, left]. It seems that it is possible to discriminate spalling effects on the basis of this method. So signals of lower energy would represent micro cracking and bending cracks. This corresponds with the obtained results because the pattern in this area seems to be mostly equal in the two experiments.
