Strengthening measures for historic timber domes

individual and monument-friendly solutions

Jörg Rehm
Dr.-Ing. Architect
Lecturer, Technical University Munich, Germany

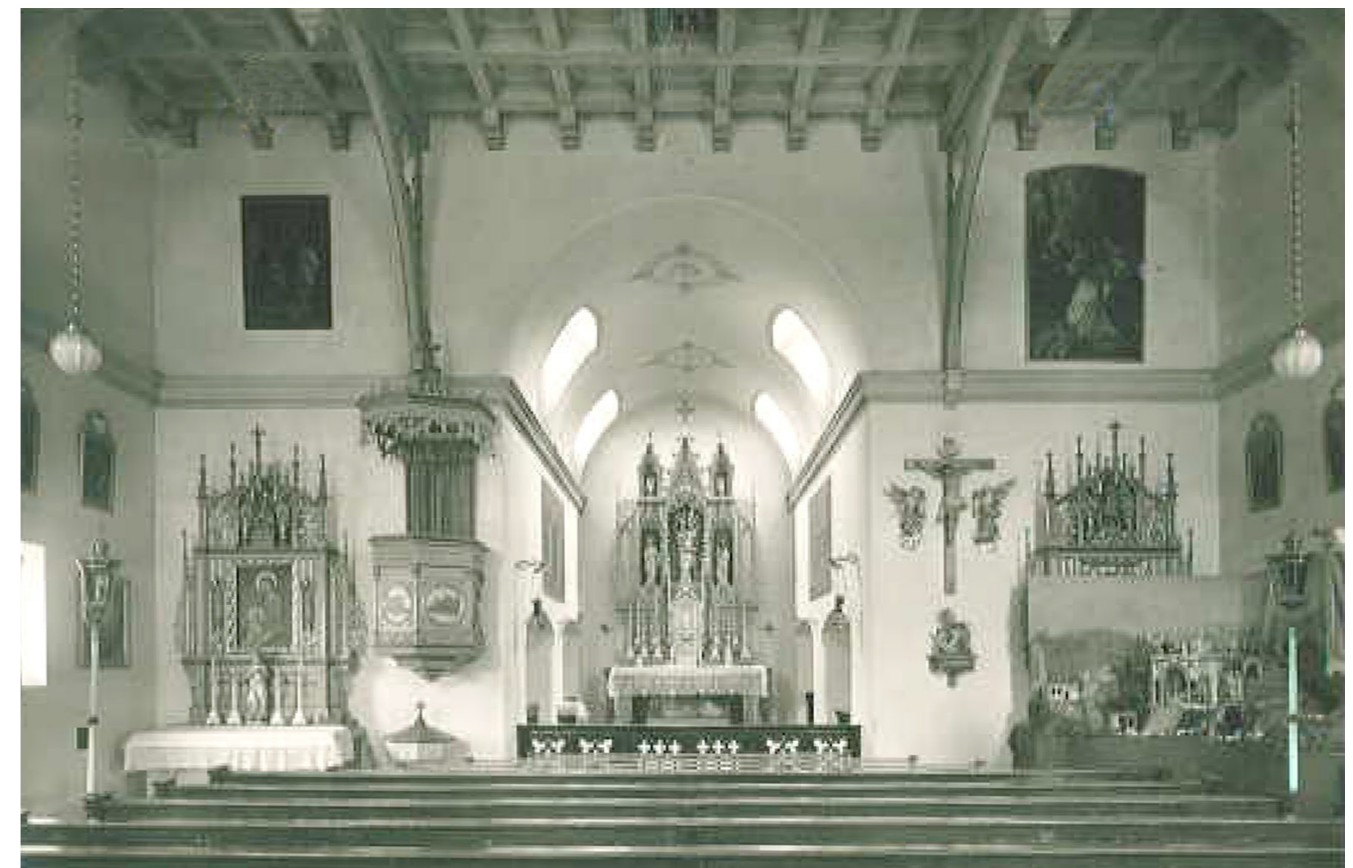
Fig. 4: Interior view after 1859, Ramsau (Archiv Staatliches Bauamt Rosenheim)

new central space of the nave, a layer of beams overlaid in a tight grid and the lower chords of the dome construction were formed as visible parts of a coffered, wooden, flat ceiling. The highlighted main axes of this coffered ceiling accommodated the square dome opening and were tectonically emphasized by corbels that descended to a perimeter cornice (Fig. 04 photo Gothic condition). The neo-Gothic furnishings were in some ways at odds with the overall Baroque design of the existing spatial concept, which was composed of basic geometric forms such as the barrel and cube.

These added features were removed in the 1950s and 1970s and replaced by partly original baroque features from the former chapel. Overall, the densely furnished interior space was thereby significantly simplified in appearance and baroquized in accordance with the taste of the time. The strongly articulated coffered ceiling and the inner sides of the dome were clad in simple forms with relatively flat surfaces, and the colour scheme was also redefined with pastel tones. In the process, the considerable deformations resulting from the dome construction, which had already become defective shortly after the reconstruction of 1859, were concealed.

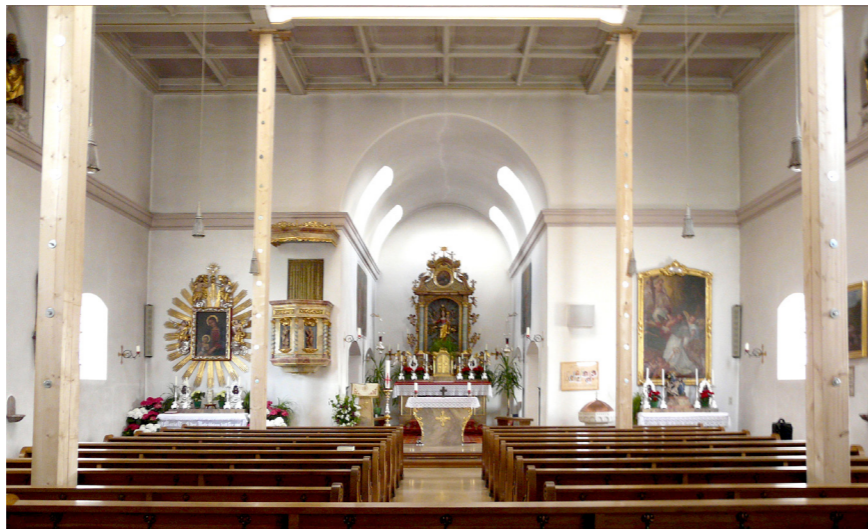
In the case of Maria Loreto, it was a routine static inspection commissioned in 2011 by the Rosenheim State Building Authority on behalf of the Munich-Freising Archbishop's Office that revealed considerable defects and damage to the dome structure. Both the dome and the associated coffered ceiling showed considerable deformation. The dome was slightly tilted. Findings on the ceiling cladding from the 1950s revealed even greater deformations of the remaining structure from 1859. Load-bearing elements were defective due to overloading, connections had become loose or were ineffective. Immediate emergency action was taken in the form of four massive timber

Fig. 7: Emergency bachup, Raumsau

supports under the corners of the dome. In the process, the friction connection to the actual dome structure had to be ensured two days before Christmas Eve. The emergency structure also served to safeguard the structural stability during the repair work. (Fig. 07 photo emergency backup).

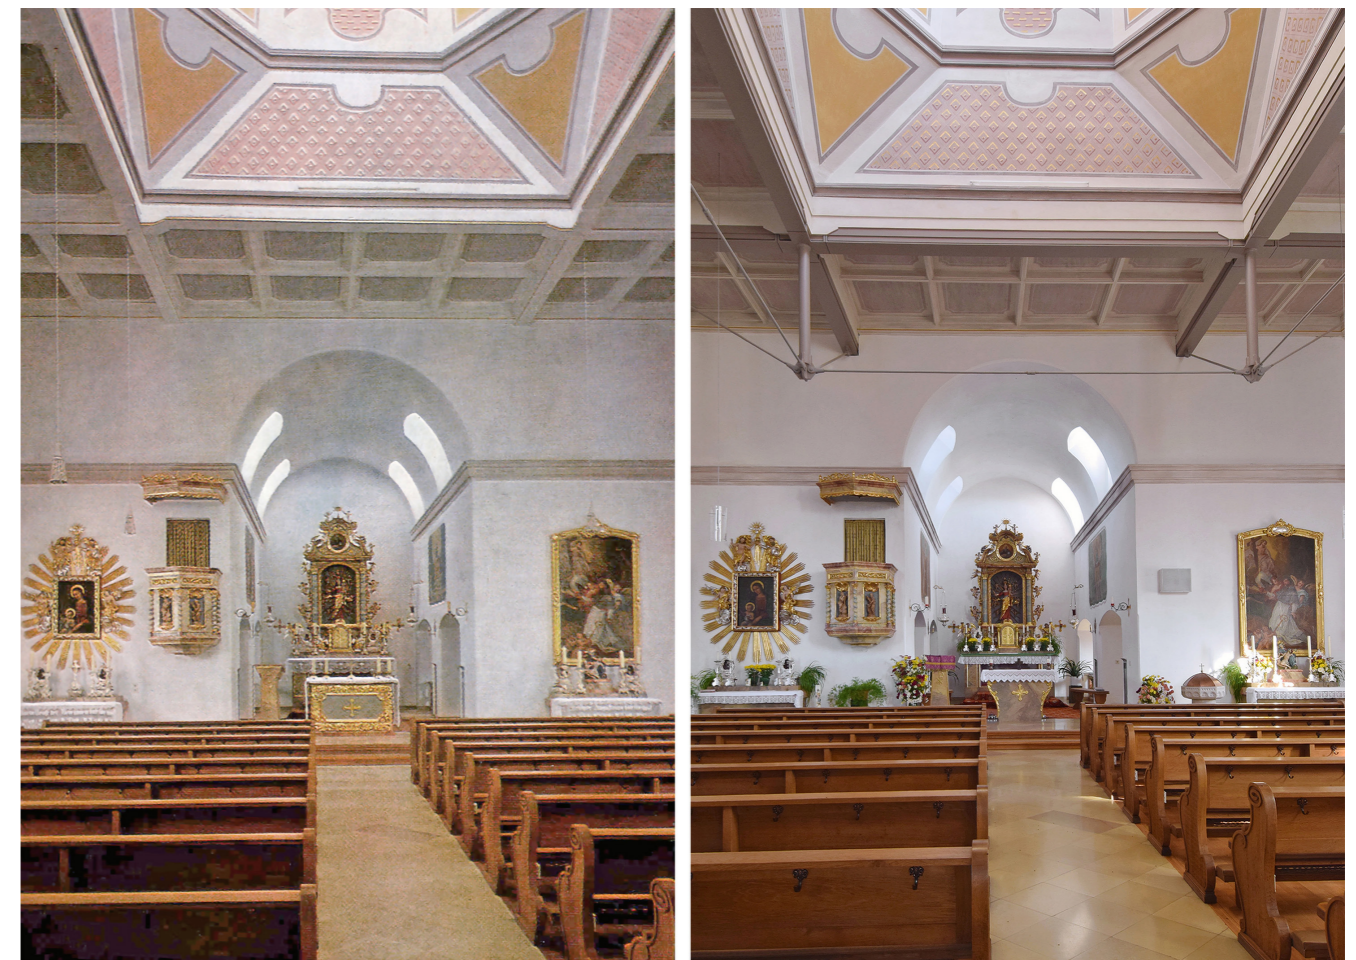
Fig. 10: Interior view in comparison before and after repair (Peter Kifinger)

Instead of a hard break between old and new, an attempt was made to find sensitive detailing for a coherent transition. All structural elements in the ceiling were provided with a partial cladding that continues the existing structure and whose appearance is based on the profiles of the existing wooden ceiling. The soffits of the steel girders remained uncovered. The installation height of the steel structure had to be

based on the lowest point of the deformed ceiling. Because of the considerable drop of around 15 cm, the distance to be bridged became considerable. To ensure that the effect of the girders was not too massive compared with the finely profiled coffered ceiling, the cladding recedes in steps into the web area of the steel girders; the resulting shadow gaps take on the scale of the existing structure. The multi-layered, overlapping cladding leads to a pleasant lightness of the overall impression due to the resulting profiling. By leaving the bottom chord visible, the structural disposition and materiality of the reinforcement

can be read. The differentiated colour schemes are based on the existing structure. At the same time, shadow lines were used to emphasize ornamental elements such as the nodes or head plates.
