FIRENWOOD

Improved fire design of engineered wood systems in buildings

Sub report D3.4 Test series 2

Deliverable Number: D3.4

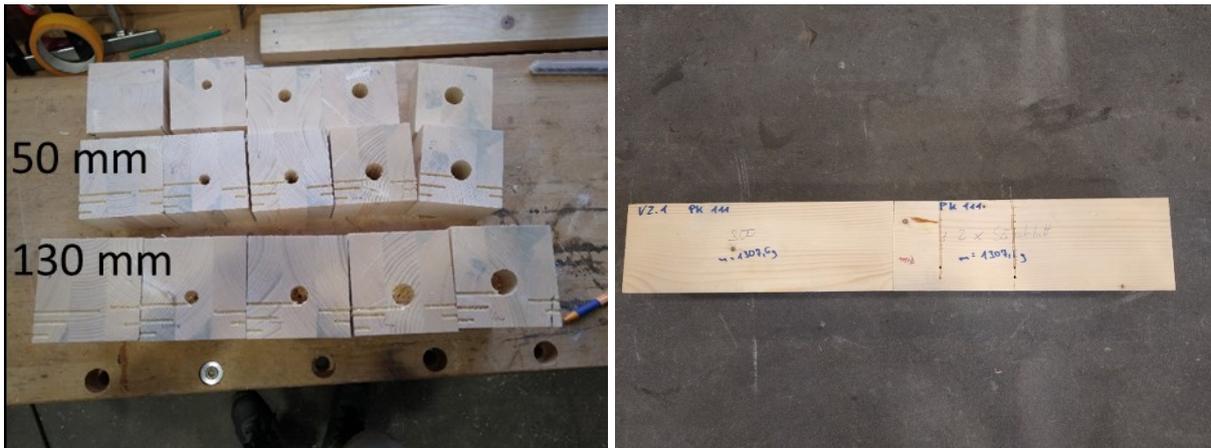
Figure 3: left: View of the specimens after milling, right: Channels on the side of the specimen

After the drilling, the separation into three parts took place at a height of 50 mm and 130 mm on one specimen half. The channels for the thermocouples were milled into the two lower sections. These are located 6 mm, 12 mm, 18 mm, 24 mm from the surface exposed to fire and at the edge of the borehole. The length of the groove was increased by 2 cm the deeper the milled channel was located, starting with a depth of 2 cm (see Figure 2 and Figure 3). The measuring point is where the two stripped wires touch first. Since the twisted tips of the thermocouples each had a length of 1 cm, the first measuring point was at a depth of 1 cm. In the case of test specimen 131, at a distance of 130 mm from the joint, the milling channel was set incorrectly, not at a depth of 30 mm but at a depth of 24 mm, so there was no measuring point at the edge of the borehole. The same error occurs with test specimen 101 at a distance of 50 mm from the joint. The measured values were assigned to the depths of 24 mm accordingly. The grooves were made perpendicular to the lamella direction of the glulam. Since the adhesive joints of the lamellas are aligned at right angles to the fire exposed side, individual layers should be prevented from falling off.

Additional channels for the thermocouples were also inserted laterally to guide them to the side unexposed to the fire (see Figure 3).

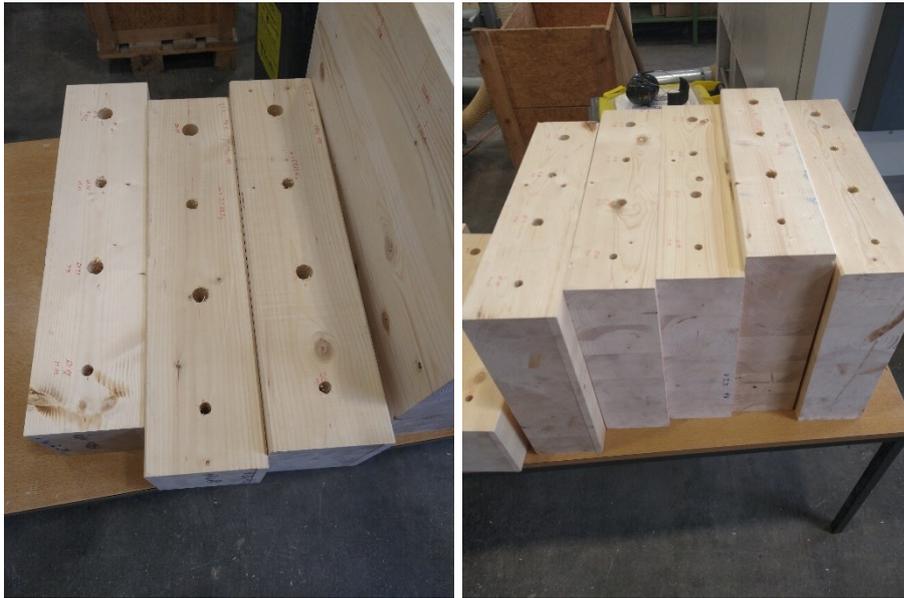
Figure 6: Drilled specimens 1 -3 on the left and 4 – 8 on the right

After cutting and weighing the test specimens, the boreholes for the rods were drilled in the appropriate diameters (14 mm, 18 mm, 22 mm, 26 mm) with the help of a drill stand and Auger bits. For the test specimens with lengths of more than 450 mm, drilling had to be done from both sides for the 18 mm and 26 mm diameters because of the maximum available Auger bit length of 350 mm. The prepared specimens are shown in Figure 6.

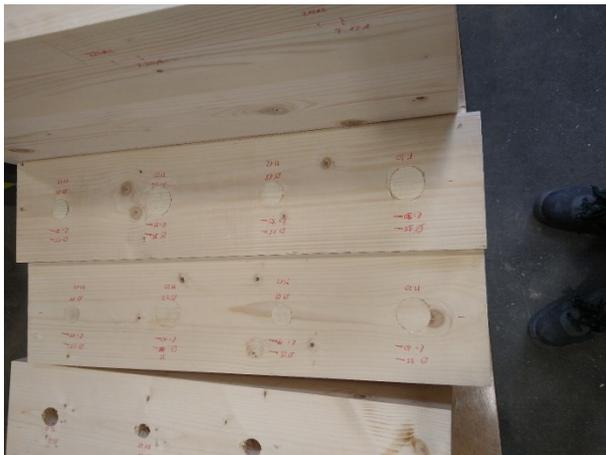
Figure 7: Specimens with inserted wooden plugs

The wooden plugs required for the test specimens 2, 3, 5 and 6 consisted of prefabricated spruce wood plates with a height of 10 mm and a diameter of 25 mm or 35 mm each. The smaller diameter was used for the M12 rods. After drilling the holes for the rods, Forstner bits were used to enlarge the existing hole on the side exposed to the fire to 25 mm or 35 mm in diameter and the necessary depth of 10 mm and 30 mm. Afterwards, the small plates were glued into the grouts. For the 30 mm long wooden plugs, three plates each were glued together before inserting them (see Figure 7).

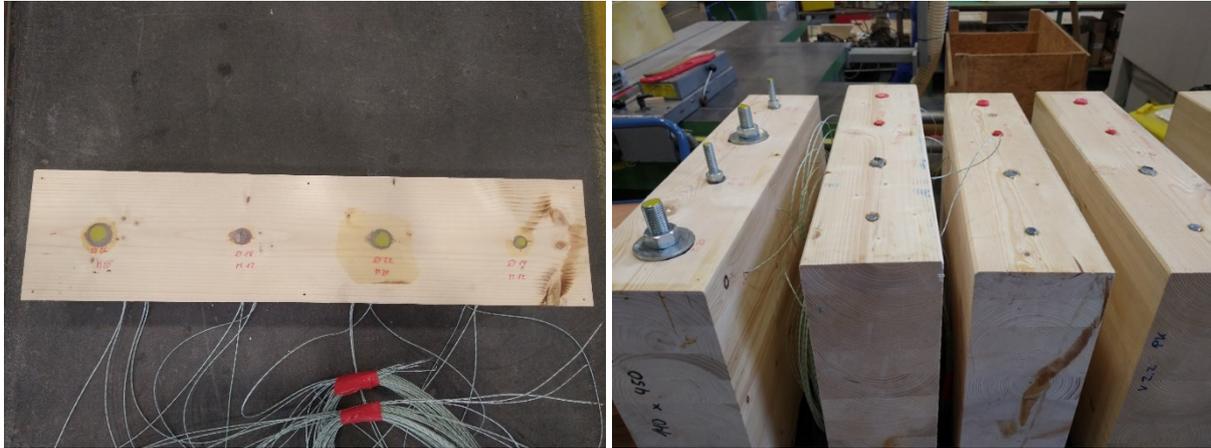
Figure 9: Surfaces of the specimens after gluing and removal of the oriented strand board

borehole. In order to avoid falsifying the results on the side exposed to the fire, the cover of the plastic cap was cut off so that only the ring was pushed over the rod and the rod surface was directly exposed to the temperature load without being covered. For this reason, red caps are only visible on the unexposed side (see Figure 9). The drying time before removing the oriented strand board and the adhesive tape was seven days.

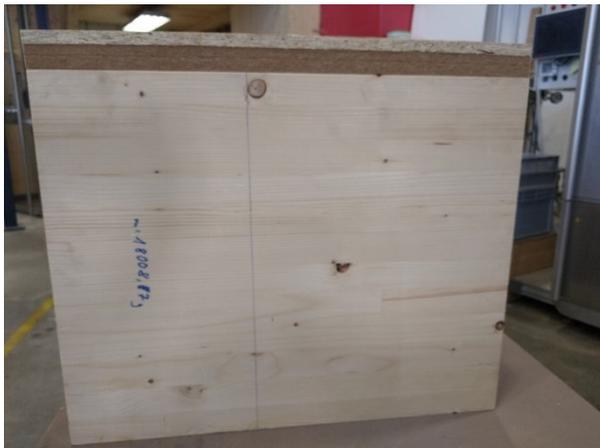
Figure 11: left: Finished Specimen, right: Screw spacing for the plasterboard and the oriented strand boards

A wood fiber board and an oriented strand board were finally attached to the unexposed side to prevent a possible fire or smoke leakage through the boreholes during the test. The oriented strand boards and the gypsum plasterboard in test specimen 7 were screwed with ten screws at a distance of 140 mm. The edge distance was 20 mm each (see Figure 11).

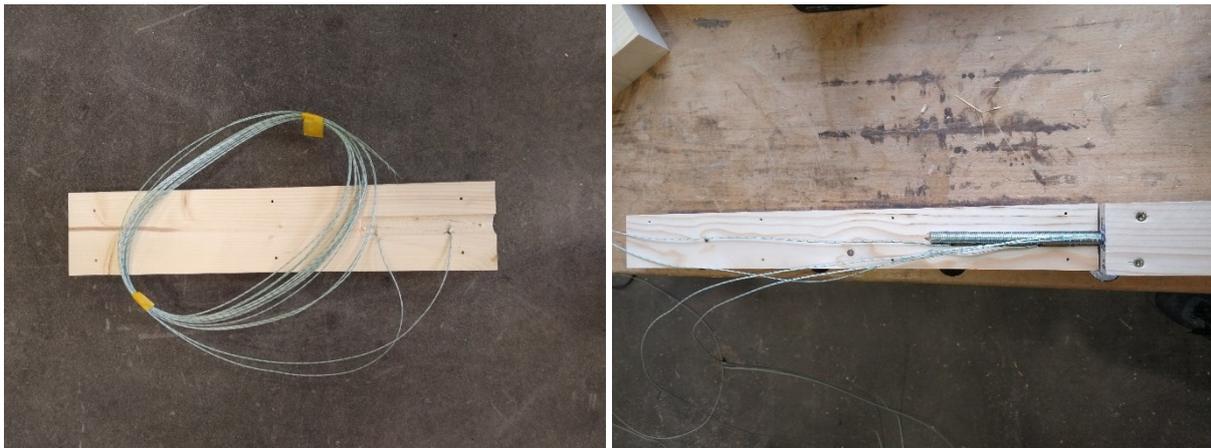
Figure 13: Inserting of the thermocouples

The two halves were screwed together again to drill the holes for the rods with a diameter of 14 mm and 22 mm centrally into the wood with the help of an Auger bit and a drill stand. Afterwards, the screws were removed again. The thermocouples were fixed with staples in the borehole on one side of the specimen halves. Reducing the side length on one side reduced the wood cover in this area by 1 mm. The thermocouples were guided outwards along the grain direction via a milling channel in the center of the test specimen (see Figure 13).

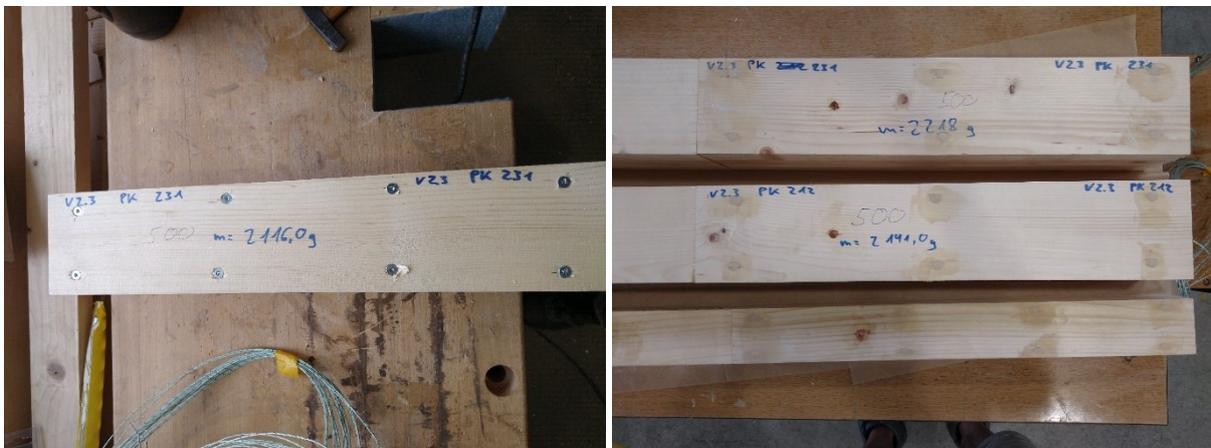
Figure 14: left: Screwing together of the two specimen halves, right: Sealing of the screw holes

Finally, the screw holes were filled with Conlit to prevent fire penetration into the test specimens (see Figure 14).

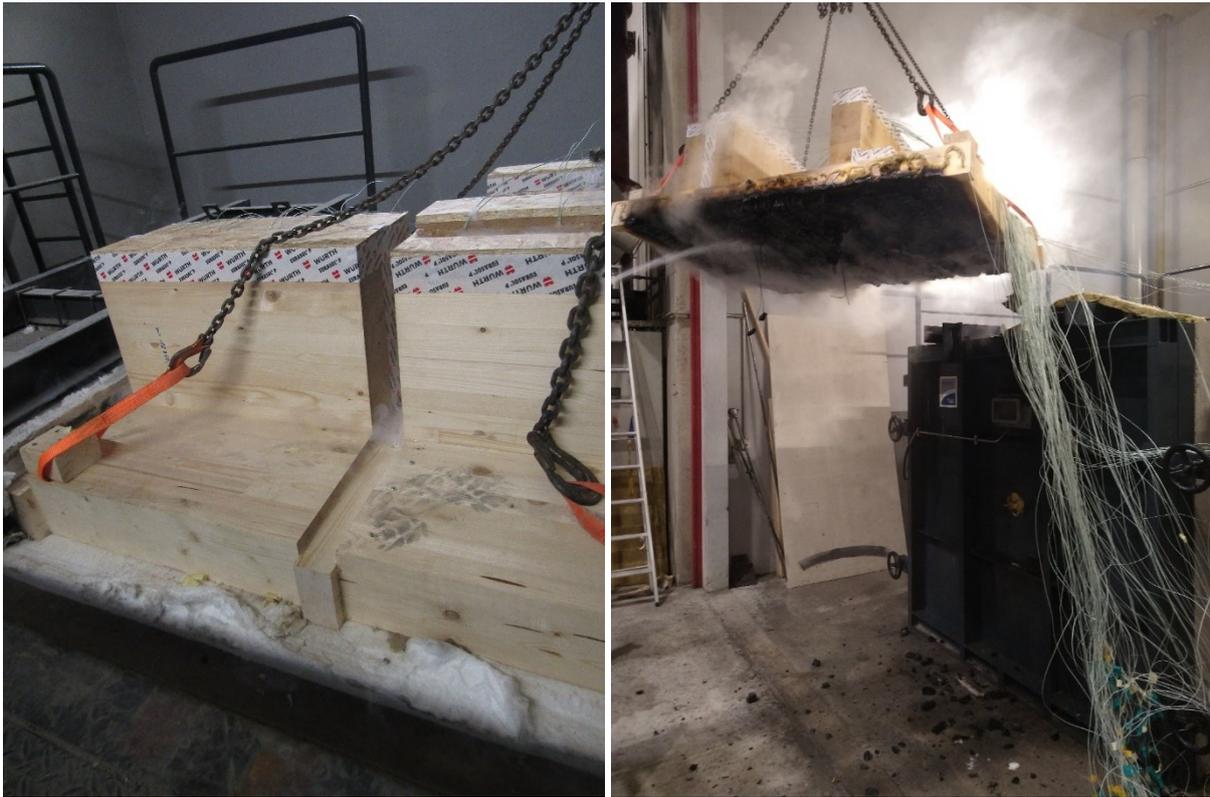
Figure 20: left: Specimen during the fire test with slight plumes of smoke; right: Lifting of the ceiling after the fire test

During the test, smoke was passing through some joints. This was reduced by covering the relevant areas with mineral wool mats. After 61 minutes the burner was switched off. The ceiling was lifted off the furnace and extinguished on the bottom side, which was exposed to the fire with a water hose. After extinguishing the bottom side, the test specimen was put on the ground to extinguish it from the top (see Figure 20).

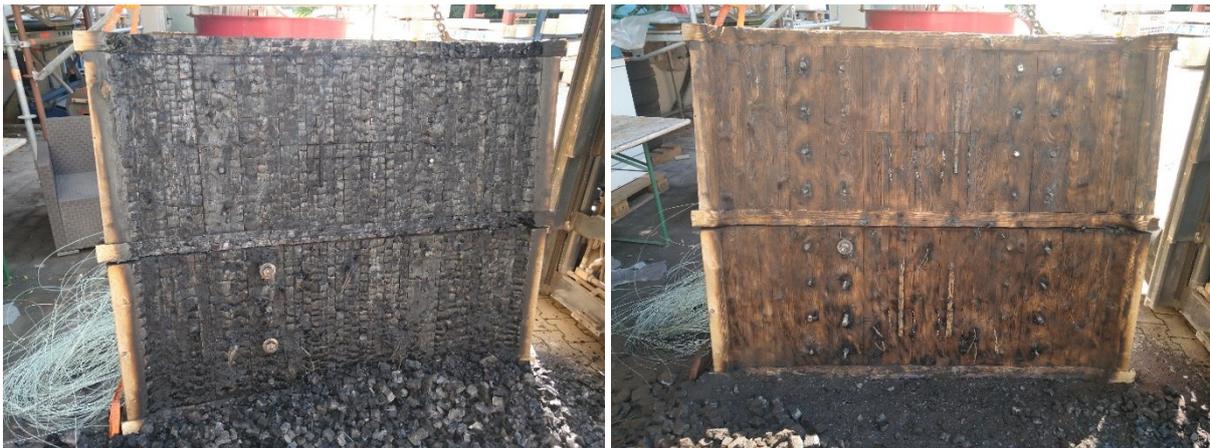
Figure 21: View of fire exposed side after cooling on the left and after cleaning of the charcoal layer on the right

After cooling, the charcoal layer was removed after seven days for a follow-up examination of the individual test specimens using a steel brush attachment on a drill. It was already evident that all the rods in test series 2.1 and 2.2 were visible at the surface and there was no longer any wood covering (see Figure 21). The test specimens from test series 2.3 were already entirely burned during the test, so an examination was not possible.

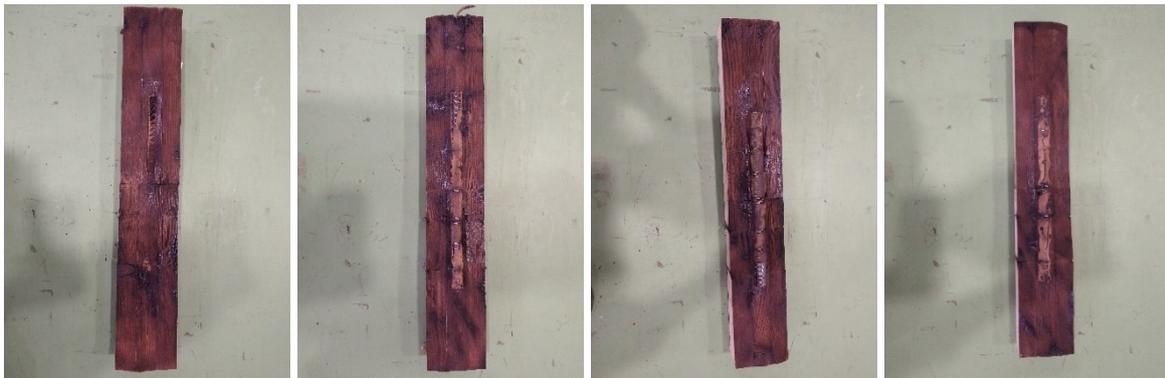
Figure 23: View of test specimens 111 – 141 (from left to right) after cleaning

Specimen 111 is also the only specimen in which the rod was present in the borehole after the fire test, but fell off when the charcoal layer was removed (see Figure 23). The remaining specimens are shown in Appendix B.3.

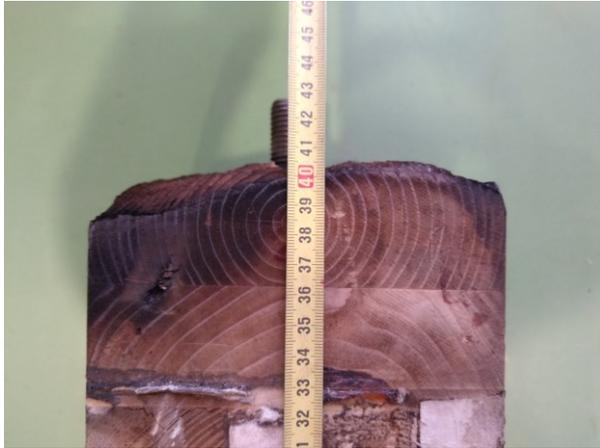
Figure 30: View of side 2 of specimen 6 with higher charring on the edges

Since test series 2.1 showed higher charring on the side surfaces of the test specimens, which were also present in this test series, side surfaces 1 & 3 were excluded from the determination of the average charring rate. The following figure shows side 2 of test specimen 6 with a borehole diameter of 26 mm. In this section, side 1 is on the left edge and side 3 is on the right edge of the specimen. A larger charring depth can be seen at both edges (see Figure 30).
