Monitoring and Assessment of 100 year Old Alzbrücke Seebruck

Abstract Alzbrücke Seebruck has been erected in 1933. It is a RC bridge using gerber hinges. These gerber hinges had been deteriorated over time in a significant way and the bridge was foreseen for replacement by a new structure. During preparation of the new structure the bridge should be kept open to the traffic for some 3 years. A monitoring concept has been established that allowed to check and assess the structural capacity in real time including check of traffic loads, alarm functions and all that based on static analysis. This paper shows the structure, the static details of the hinges, the monitoring concept and its results over time and lessons learned.

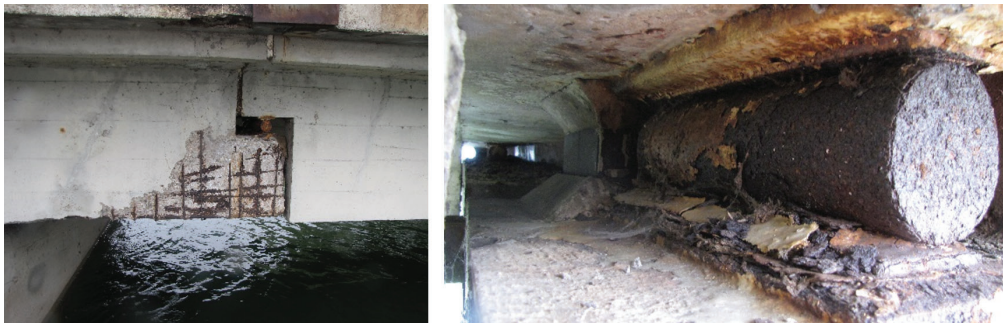
Figure 3: Strongly corroded reinforcement at the girders (left); Detail: corroded bearing between two girders (right)

Following a structural evaluation of the load bearing capacity of the Alzbrücke there had been a weight limit of 12 t imposed in 2018, and plans were under way for a replacement structure by the bridge owner (the local road authority Staatliches Bauamt Traunstein). However, a further assessment in July 2018 revealed extensive damage in the superstructure, with hinges between girders showing strong concrete spalling as well as corrosion in the exposed reinforcement bars and numerous cracks in highly stressed regions of the hinges, s. Figure 3.

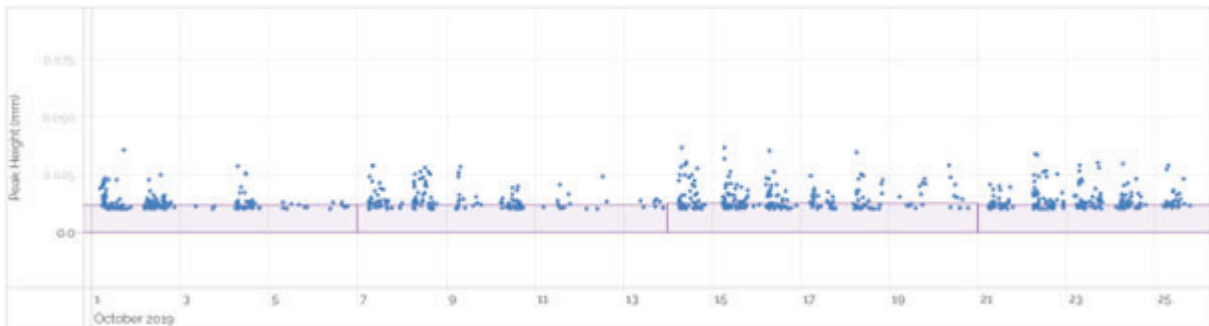
Figure 7: Recorded peak heights as displayed on a website in real-time

a website where peaks could be examined by all persons involved in the project, s. Figure 7. The server also compared the received peaks with predefined warning thresholds and, if these were exceeded, it would also send out warnings. Thresholds were derived individually for each sensor from the peak levels recorded during the first two months of the monitoring campaign.

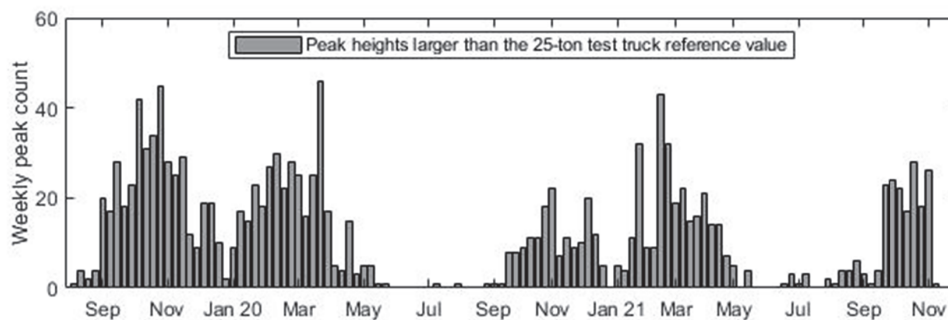
Figure 8: Example of long term evaluation of one sensor by weekly peak count

The peak heights generated by passing trucks did not only depend on the total weight but also on the number and spacing of axles, which means that the exact identification of the weights of these vehicles was not possible. However, up to 100 vehicles per week exceeded the response measured from the 25 t reference truck, which indicated that the imposed weight limit was regularly being exceeded. Consequently, the local road authority enhanced signage for the official diversion route and instructed the police to conduct weight controls in order to emphasise the urgency of the imposed weight limit. The mobility restrictions imposed by the onset of the Covid pandemic in early 2020 was the most successful factor in limiting the number of instances of traffic exceeding load limitations.

Recorded peaks were categorised by their severity with regard to the 12 t and 25 t test trucks' reference values. The number of their occurrences were evaluated on a weekly basis and investigated for possible long-term trends. Recording an increasing number of low peaks, as well as recording increasingly high peak values would have strongly indicated a deterioration of the condition of the

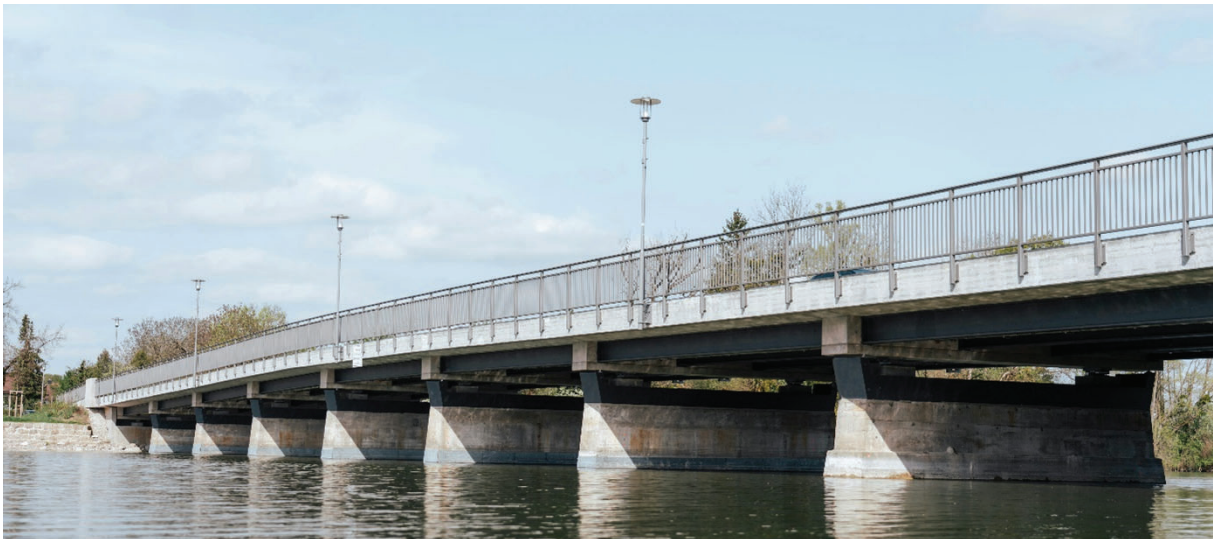
Figure 9: The new Alzbrücke

All in all, the Alzbrücke showed no significant progression of damage within its last 2.5 years of operation. The construction of a new slender steel composite superstructure on the existing piers and abutments started in early 2022 and was completed - as planned - at the end of the same year.
