Assessment of all wide span Timber Structures owned by the City Munich

Summary

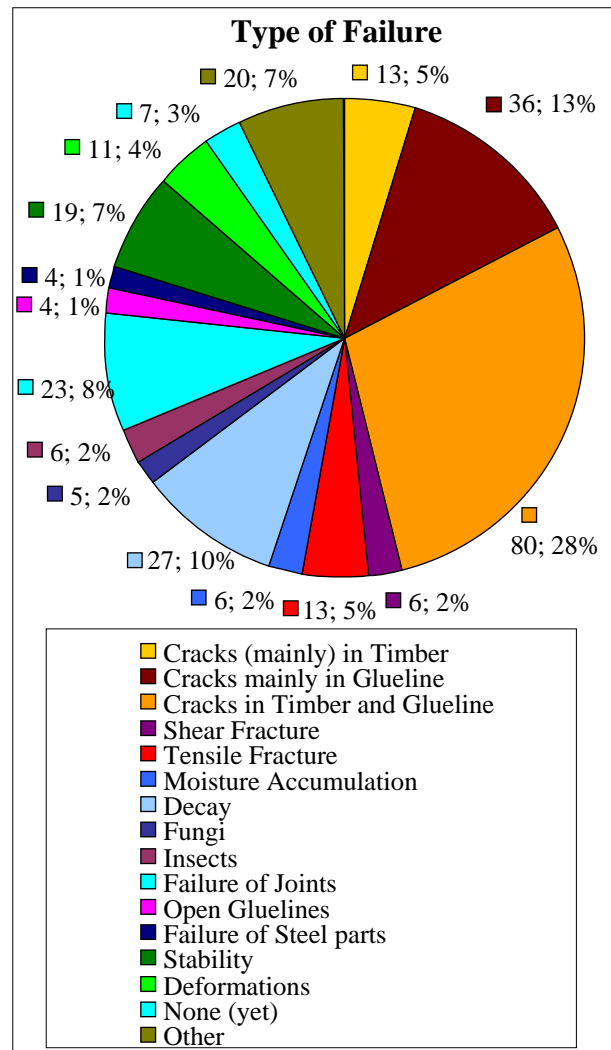
Figure 4: Type of Failure

Figure 4 shows the most common types of failure while Figure 5 highlights their causes. The main type of failure is intense cracking along the grain (46%). The major cause is low or changing moisture content, the second cause being the low tension perpendicular to grain strength of timber, resulting in cracking of e.g. unreinforced curved or pitch cambered beams. The immense influence of moisture (regulated by the environmental conditions) on the performance of timber structures is also highlighted by the considerable amount of failures due to a high moisture content, e.g. due to decay and fungi (14%). But the most frequent influence is by far the drying out and/or intensive change of moisture content of structural timber elements in use.

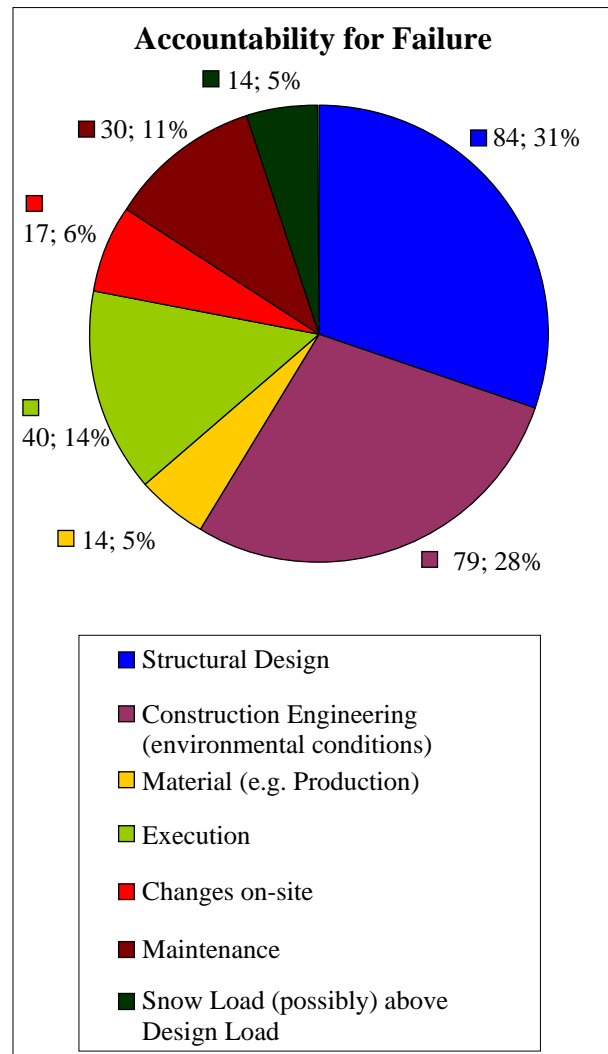
Figure 6: Accountability for Failure

Figure 6 displays the accountabilities/responsibilities for failures. It indicates that the majority of failures result from errors in the planning phase, whereby the wrong estimation of the prospective environmental conditions (28%) accounts for a large portion of future damages. Failures in structural design could oftentimes be linked to missing knowledge or the neglect of the state-of-the-art in timber design at time of planning (e.g. stresses perpendicular to the grain in curved and pitch cambered beams). The quota of failed structures in which the execution differed considerably from checked construction plans and calculations was remarkable.

The given evaluation illustrates clearly, that high snow loads, oftentimes cited as the reason for failure, should in this context be seen as the actuator but rarely the cause for failure.
