Theoretical and experimental investigations about flank breakage in bevel gears
Markus Klein Bernd-Robert Höhn Klaus Michaelis Rainer Annast

Theoretical and experimental investigations about flank breakage in bevel gears

Paper type Research paper

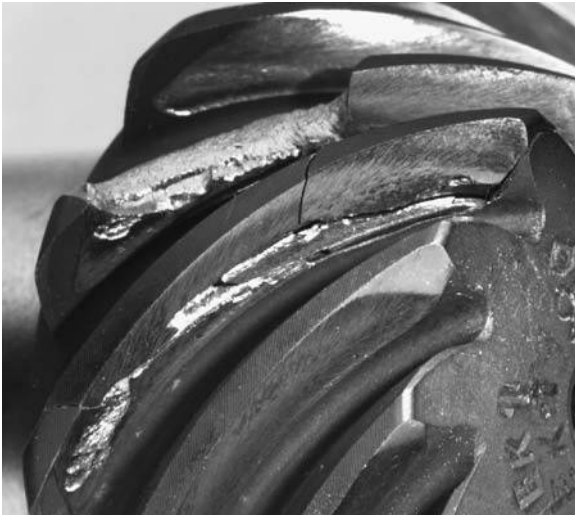
Figure 1 Flank breakage at a test pinion

Flank breakage often appears without any other surface failures (scuffing, pitting, and micropitting), but sometimes also together with such failures on different teeth of a gear (Figure 1). Although normally several teeth are affected by flank breakage, it also can be seen that only one tooth fails.

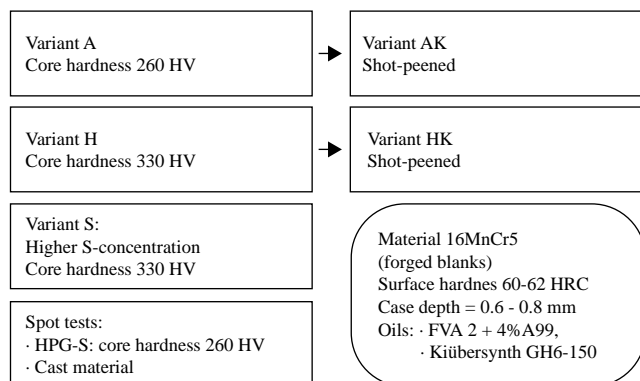
Figure 2 Test gears

In Figure 2, the test gears for the experimental investigations are shown. The main geometry data are: number of teeth $z_1/z_2 = 11/39$; mean normal module $m_{mn} = 3.02$ mm; outer pitch diameter $d_{e2} = 170$ mm; and hypoid offset $a = 15$ mm.

The variants A-S are lapped and then phosphated. Variants A and AK have a relative low core hardness of 260 HV. Variants H, HK, and S were manufactured by usual heat treatment. The pinions of variant S were made of 16MnCr5 with a higher sulfur concentration of 0.05 percent. Variants AK, HK, and S were shot-peened to avoid tooth root breakage. For some spot tests, the influence of the finishing process was investigated with hard cut (HPG-S) and phosphated gears. Additionally, the area reduction ratio of the material was investigated by using cast material instead of forged blanks. All the test results were compared with the test results of Thomas (1998).

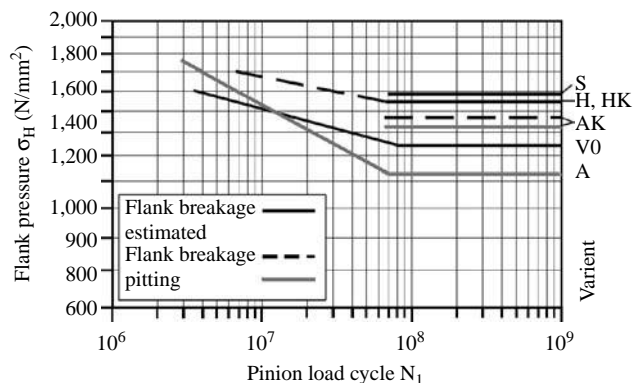
Figure 3 S-N-curves for variants A-S and V0 of Thomas (1998) for 50 percent failure probability

The test results for variants A-S and the variant V0 of Thomas (1998) are shown in Figure 3 for 50 percent failure probability.

The test gears H, HK, and S failed by flank breakage. With few exceptions always the pinions were damaged. The runtime varied up to a factor 8. The variants H (without shot-peening) and HK (with shot-peening) showed a similar load-carrying capacity, and therefore were evaluated together. Because of a high variation of the test results and different failures at higher loads (pitting), the time strength curve was only estimated. For variant S with a higher sulfur concentration, only loads in the high cycle fatigue were run. The results are very similar to the variants with normal sulfur concentration. Thus, the higher amount of sulfur has no influence on the load-carrying capacity.

In the tests with the variants A and AK with lower core hardness, only one flank breakage occurred. The tests with FVA2 + 4%A showed pitting, whereas in the tests with Klübersynth no surface failures appeared. With higher loads,

tooth-root breakage occurred and only variant AK reached the calculated endurance limit. For variant A, a decreased surface hardness was recognized that caused a lower pitting resistance.

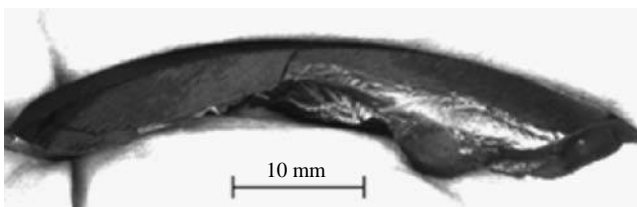
Figure 4 Fraction of variant HK (ME 37536) – crack lies on half of the tooth height of the active flank (heel left side, $T_1 = 550 \text{ Nm}$)

For the evaluation of the test results, only those test gears were taken into consideration that failed without any other surface failures as, e.g. pitting. The area of fraction lies in the active flank. Thus, the failure mode can be distinguished from tooth-root breakages, where the first cracks start in the tooth fillet near the 30° tangent. All tests were run on the drive side flank. All test gears showed the same path of crack propagation as the tests of Thomas (1998). The cracks start below the surface in the active flank, 3–4 mm below the tip of the teeth. They mostly lie parallel, sometimes slightly inclined to the lengthwise direction of the teeth. The cracks range over 50 to 90 percent of the face width and end at the tip of the teeth to the toe and the heel side of the flanks (Figure 4).

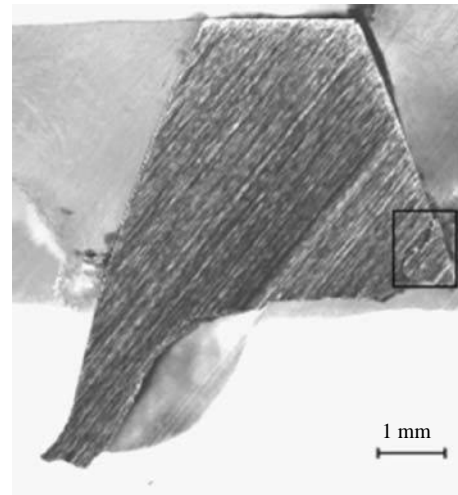
Figure 5 Fraction of variant HK (ME 37536) – normal section, active flank on the right side

The area of fraction has an angle of 40 to 90° to the active flank and runs to the tooth root of the non-working flank (Figure 5). The cracks usually are parallel in the area of fraction. Thus, the starting crack cannot be located exactly.

To determine the path of crack propagation the fraction pieces were cut in a normal section in the area, where the starting crack was assumed. In this section, secondary cracks were investigated; these secondary cracks run typically in the same direction as the primary crack propagation. Figure 6 shows an enlarged part of Figure 5 that shows the secondary cracks on a fraction piece of variant HK. These secondary cracks indicate that the main crack propagated from below the surface to the active flank.

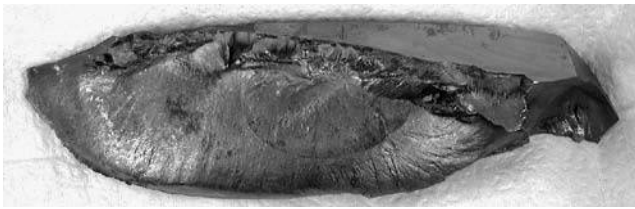
Figure 7 Flank breakage at a wheel of a marine gear unit

Figure 7 shows exemplarily the fraction piece of a marine gear ($m_{mn} = 14.3 \text{ mm}$) with flank breakage on five teeth of the wheel.

The fraction pattern shows that the crack started approximately 5 mm below the surface of the active flank in the centre of the half-ellipse. The inspection of this area in a scanning electron microscope showed that the material was strongly deformed in this area. Therefore, it was not possible to identify exactly the crack initiation. Further on, no material impurities were found. Several parallel cracks can be seen in direction to the

Note: Topview on the fraction pattern, active flank upside, starting crack in the centre of the half-ellipse

flank surface. They also started below the surface. The assumed starting crack lies 18 mm below the tip of the tooth, and thus exactly on half-height of the active flank.

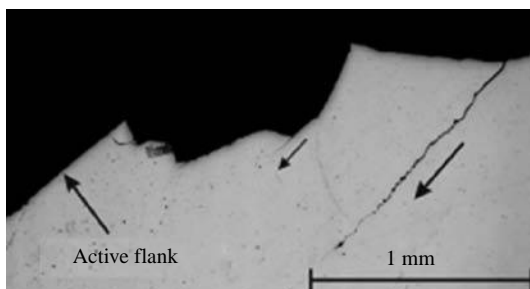
Figure 8 Marine gear: secondary cracks in direction to the active flank

To analyse the secondary cracks the fraction piece was cut in a normal section. Figure 8 shows that up to a depth of 3.6 mm, below the surface, the crack propagated in direction to the surface, in a depth of more than 5 mm in direction to the core (Figure 9). Thus, the starting crack initiated in 3.6–5 mm depth below the surface.

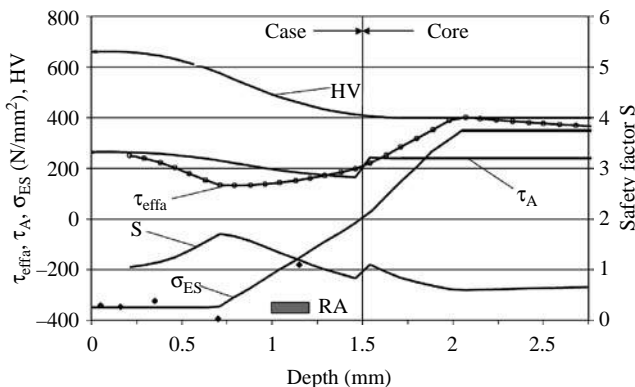
Figure 10 Gradient of the local stress, strength and safety factor for the test gear variants H and HK considering the enduringly transmittable load torque

gear variants H and HK, the gradient of the local safety factor was calculated considering the continuously transmittable load torque and the measured residual stresses (Figure 10). The local safety factor in the core is estimated.

The minimum safety factor is reached in the region between case and core, and thus is well correlating with the damage patterns of variant H and HK as discussed before. For variant S, the initiating crack could not be located exactly because of the row-like structure of the material in this region. The investigated practical gears show a very flat gradient of the local safety factor inside the tooth without a distinctive minimum.

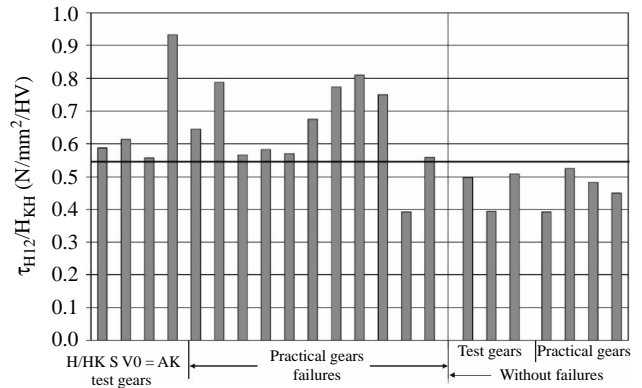
Figure 11 Ratio $\tau_{H1,2}/H_{KH}$ at the transition from case to core for the test and practical gears

The described calculation method was applied to the test gears as well as to the gears from practical applications (module $m_{mn} = 10.6 \dots 19.5$) (Figure 11). The calculation was made in the mid of the face width on half of the tooth height.

To derive the critical value of the ratio $\tau_{H1,2}/H_{KH}$ the test gears were calculated with the continuously transmittable load torque derived from the test results and the measured hardness patterns and case depths. The test gears that failed by flank breakage show a ratio $\tau_{H1,2}/H_{KH}$ of $0.6 \text{ N/mm}^2/\text{HV}$, only variant AK with an unusual heat treatment lies far above. The practical gears were calculated with the load torques of their application together with usual application factors of $KA = 2$ for

the power plant gears and $KA = 1.3$ for the marine gears, respectively. For the practical gears with failures the measured hardness patterns and case depths were introduced into the calculation. For the practical gears without failure a case depth of $0.15 \cdot m_{mn}$, a core hardness of 400 HV , and a depth of the transition from case to core of $y = 1.85 \cdot \text{case depth}$ was assumed. The practical gears with failure show a ratio $\tau_{H1,2}/H_{KH}$ greater than $0.55 \text{ N/mm}^2/\text{HV}$ with one exception. All gears without failure are below this ratio. The comparison of the calculation results showed that the simplified calculation method shows a good correlation of test and practical gears. For new gears, it is advised to design the geometry and heat treatment not to exceed a ratio $\tau_{H1,2}/H_{KH} = 0.55$.
