FIRENWOOD

Improved fire design of engineered wood systems in buildings

Sub report D3.4 Test series 4

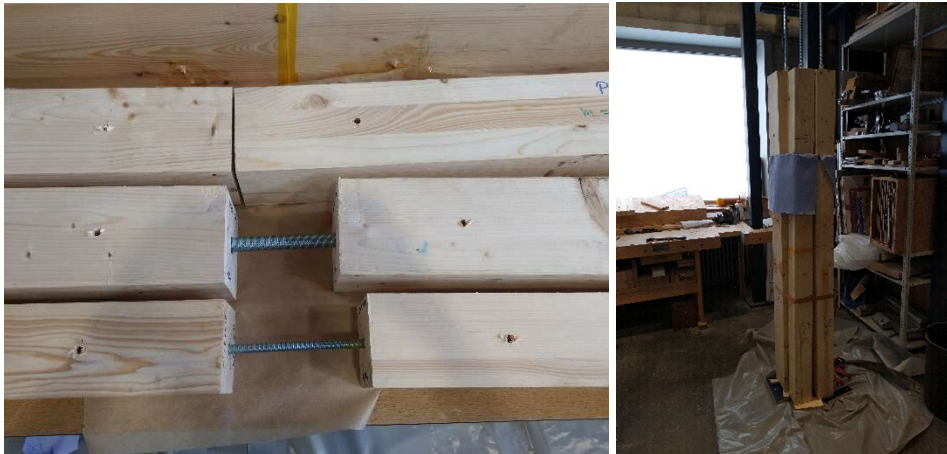
Figure 2. Inserting of the middle rod (left), Gluing process of the outer rods (right)

The rods were glued in the same order starting with the connection in the middle of the two GLT halves. The glue line thickness for each specimen was 1 mm. Therefore, a borehole with a 2 mm thicker diameter than the rod was drilled. Augerbits and a drill stand were used to ensure a borehole as straight as possible. After finishing the boreholes for the rods, additional holes with a diameter of 8 mm were drilled on the side of each specimen. These additional holes were placed 10 mm above each borehole end. For the middle connection one hole was to fill in the adhesive the other one was used as the ventilation hole. Before the gluing process could start, the boreholes were cleaned with compressed air. The two types of adhesives were mixed with the help of static mixers placed on double cartridges with resin and hardener, which guaranteed the mixing ratio specified by the manufacturer. In order to guarantee only a small joint between the two GLT halves, they were pressed together with screw clamps (see Figure 2). The bonding took place under normal climatic conditions. After seven days of drying time the top and the bottom rods were glued in. Only one side hole at the bottom of the borehole was drilled for the filling in of the adhesive. The opening of the borehole into which the threaded rod was inserted served as a ventilation opening.

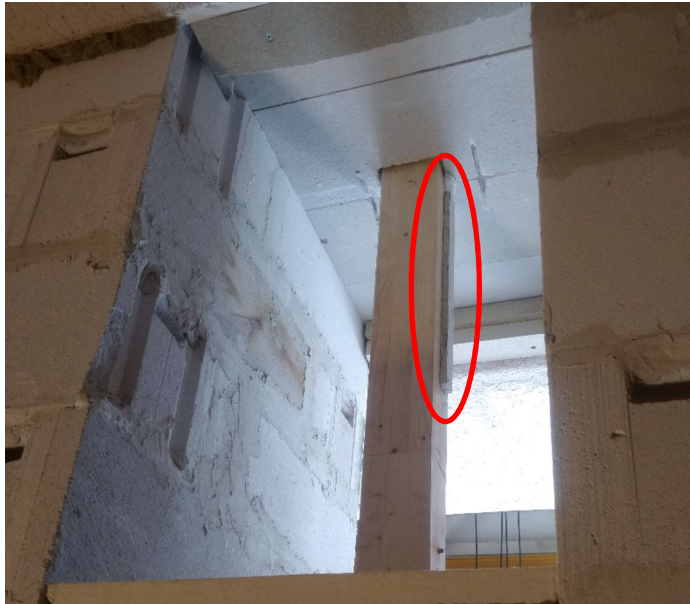
Figure 3: Protection and position of the sheathed thermocouple for the measurement of the rod temperature

To measure the temperature inside the glue line two different methods were used. Since the test specimens were mechanically loaded, it was mandatory that no weakening of the cross section or glue line should appear. Therefore, only one sheathed thermocouple was installed perpendicular to the grain direction. It was inserted at the ventilation hole to measure the temperature of the rod during the test. The tip was in contact with the rod. The wire was guided along the surface of the specimen and covered by a gypsum plasterboard to prevent additional heat transfer through the thermocouple (see Figure 3).

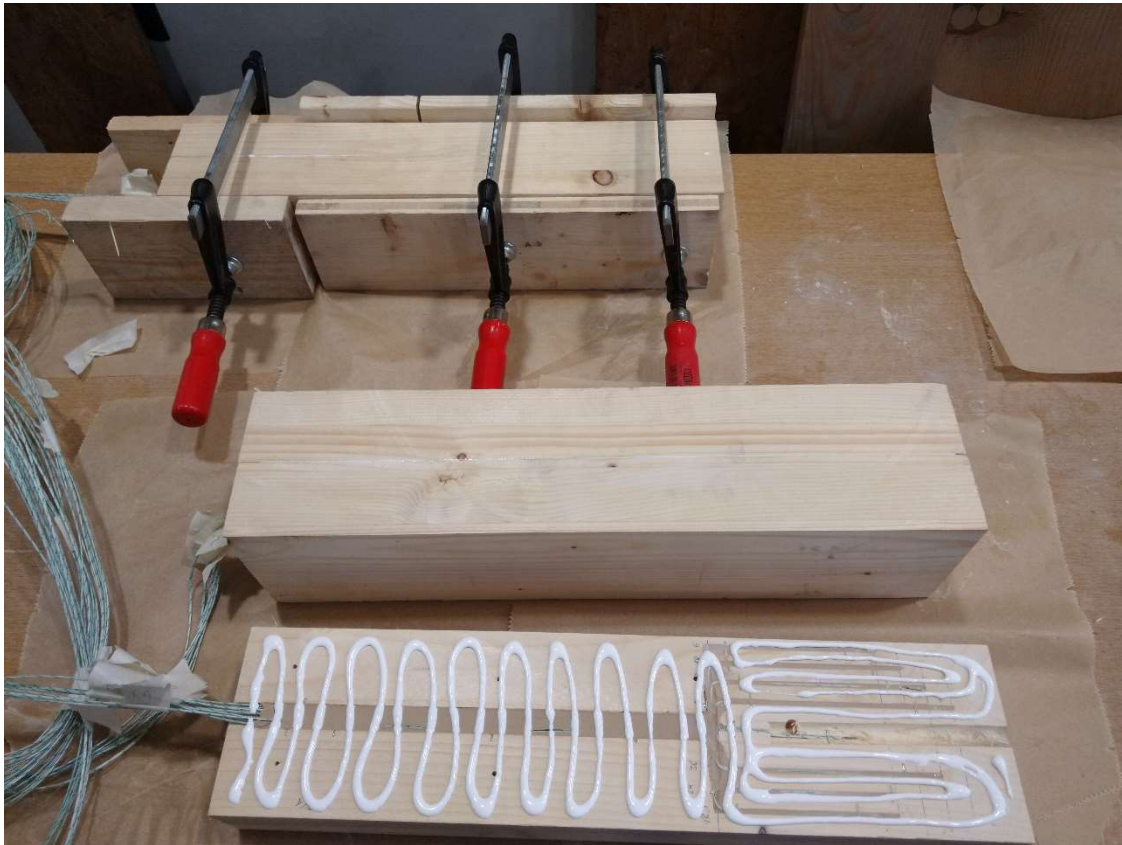
Figure 5: Inserting of thermocouples and Conlit in the reference specimen (top), Gluing of the two specimen halves of the reference specimen (bottom)

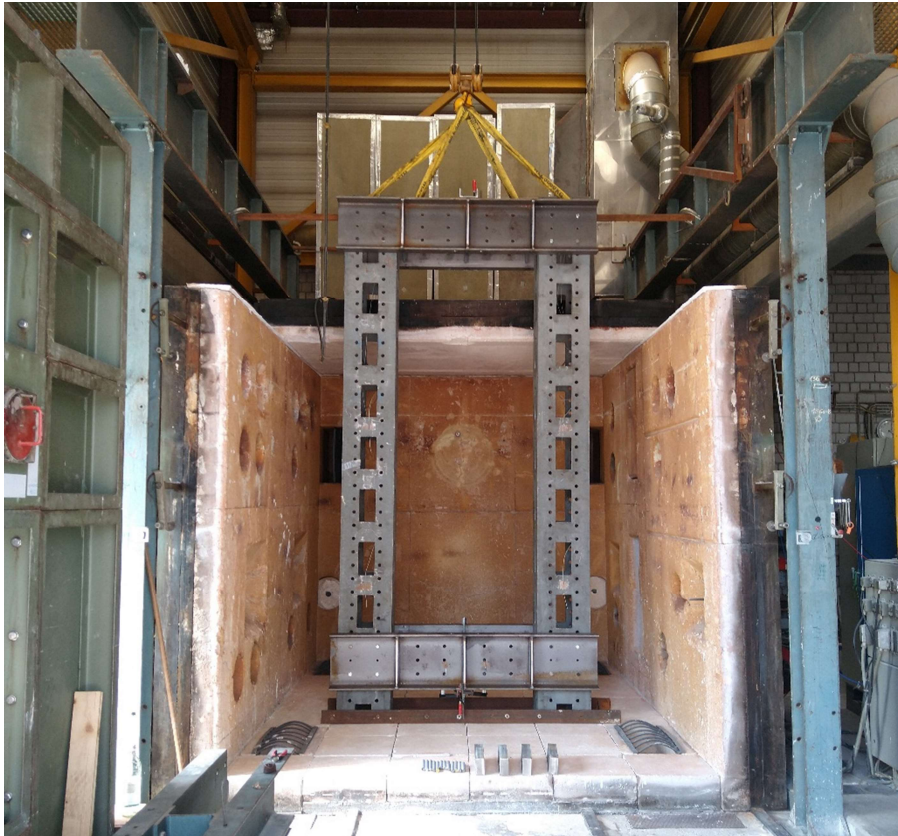
Figure 7: Positioning of the steel frame in the furnace

The furnace dimensions used for the fire tests were 3 m x 3 m x 4 m (width x height x depth). For the load application a portal steel frame was used (see Figure 7).

This frame was placed inside the furnace and had to be thermally protected. The plans are shown in Appendix D. For the fire protection of the steel frame aerated concrete blocks were used. They covered the bottom crossbeam as well as the vertical columns and were walled up to the ceiling of the furnace. The specimens were clamped between the two steel columns. The wall was bricked so high that only the middle part of the specimen with the intended rod was thermally loaded.

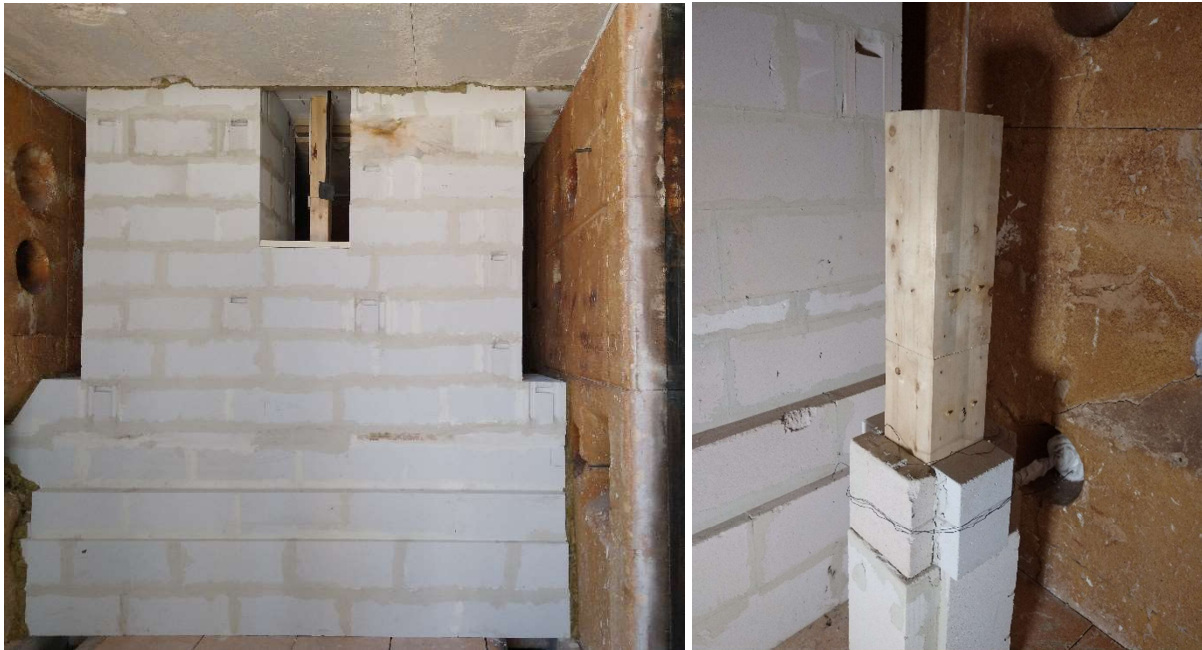
Figure 8: Installed specimen 1 (left), View of reference specimen 3 (right)

The reference specimens were placed next to the steel frame on a walled platform. On the left and the right side there were ventilation holes next to the frame to ensure a better air circulation during the test. But since the width was very small it was considered impractical to install the reference specimens in this area. It was assumed that only lower temperatures than for the area with the test specimen would be reached because of the small width and the location at the edge of the furnace (see also Figure 8).

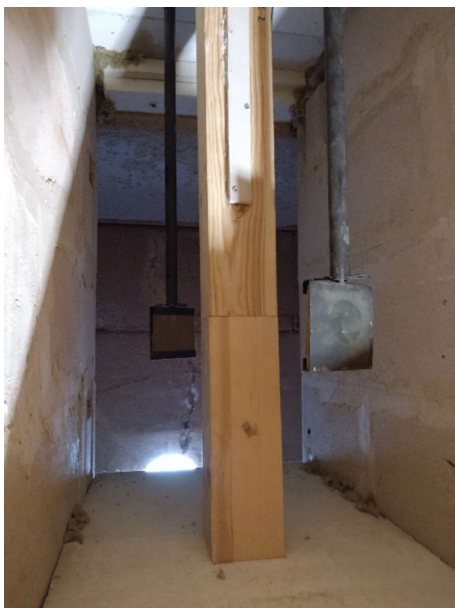
Figure 9: Positioning of thermo plates

In order to measure the air temperature in the furnace two thermo plates were installed diagonally facing the specimen. The height was on the same level as the joint of the specimen. The distance for all tests was about 15 cm (see Figure 9) from the specimen surface. The temperature inside the furnace was controlled according to these plates.

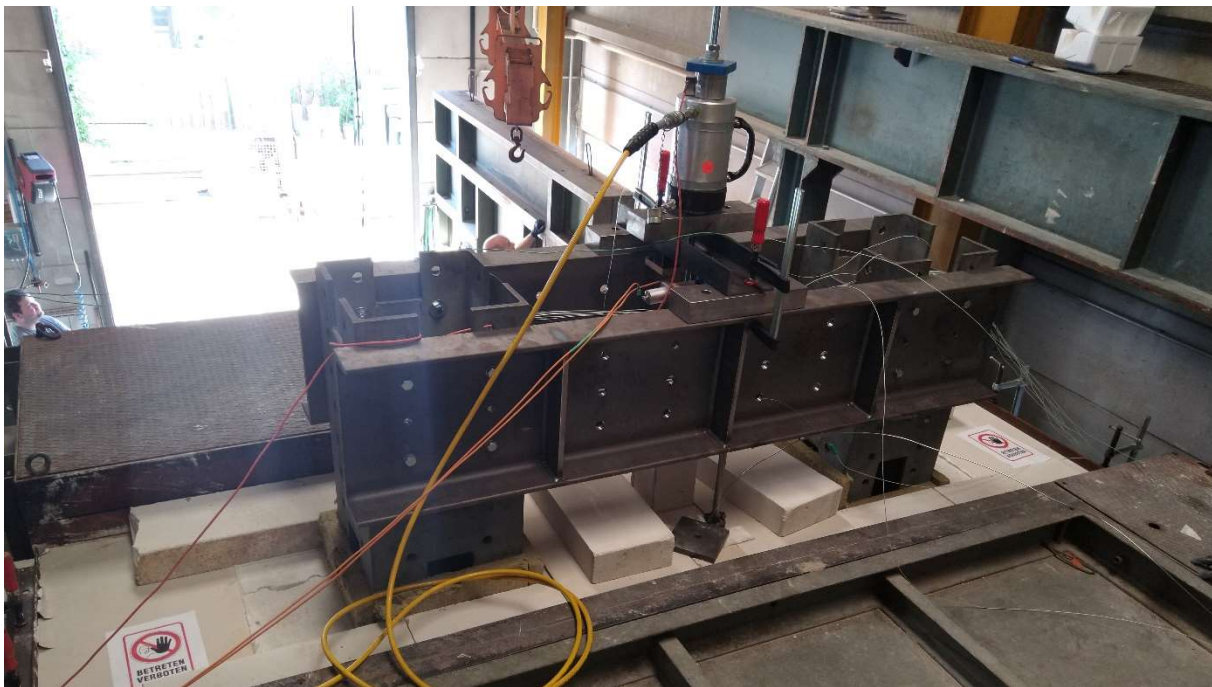
Figure 10: Top of the steel frame with measurement

The deformation of the whole specimen was measured using two WayCon SX50 draw-wire sensors. They were placed on the top cross-sectional area of each specimen. The edge distance in the diagonal was set to 2 cm. Here it should be verified simultaneously whether a misalignment occurs due to the deformation of the specimen. Due to the complicated structure of the test setup, an attachment for deformation measurements in the area of the fire exposed connection was not possible (see Figure 10).

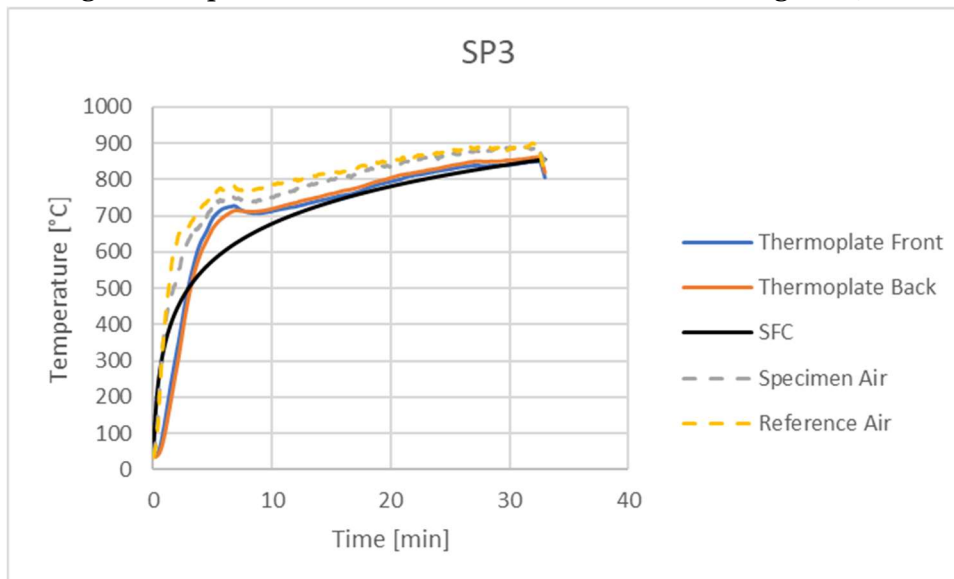
Figure 13: Air temperature measured for test 3 and in comparison to the Standard Fire Curve

In test 3 the measured temperature shows a slightly higher deviation from the SFC between minute six to minute eight. The specifications from EN 1363-1 are nevertheless met. The same temperature rise can be seen for the temperatures measured at the specimens. Both of them show slightly higher temperatures than the thermo plates. The reference specimen has the highest temperatures for the whole test duration (see Figure 13).

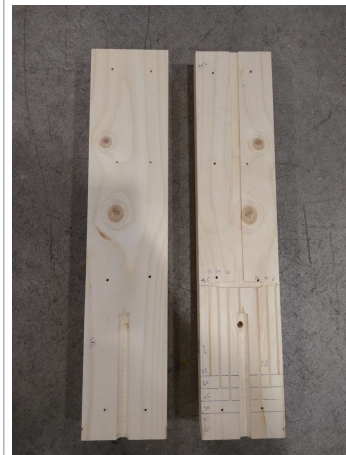
Figure 19: Temperature development for all reference specimens in a measurement depth of 30 mm and section of reference specimen 2

In a depth of 30 mm a plateau at the 100 °C - isotherm can be seen for all specimens for a time between 17 and 23 minutes (see Figure 19). Afterwards the temperature rises for specimen 1 and 2 are the fastest. It is plausible for specimen 1 since the measured air temperature was the highest. Reference specimen 2 shows no wood errors in the area of the thermocouples. Therefore, the reason for the faster temperature rise may be the uneven combustion of timber. Experience shows that there are always some fluctuations present.

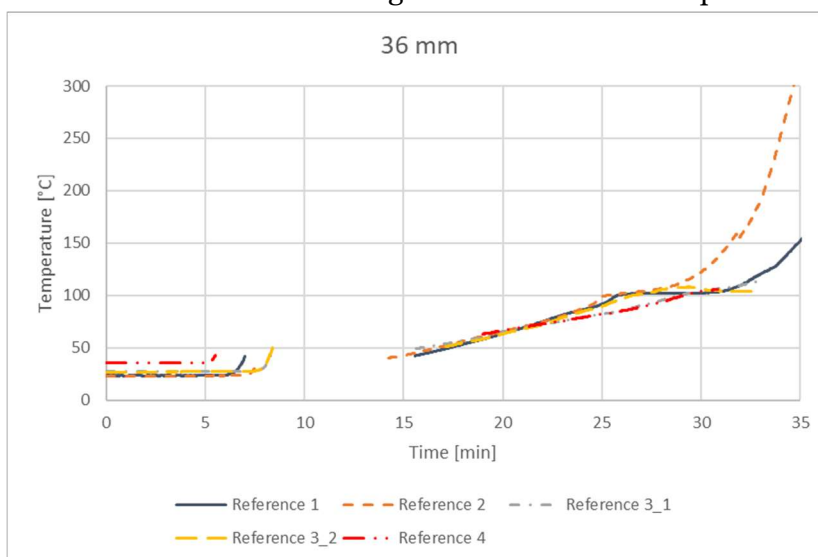
Figure 20: Temperature development for all reference specimens in a measurement depth of 36 mm

For a measurement depth of 36 mm most of the temperature curves show a slow heating to 100 °C until minute 25. Afterwards only reference specimen 2 reaches the 300 °C charring limit. Reference specimen 1 shows a rise of 50 °C until the failure of the respective test specimen. All other reference specimens didn't show a rise of temperature above 100 °C. It can also be said that until reaching 100 °C the curves are quite uniform (see Figure 20).

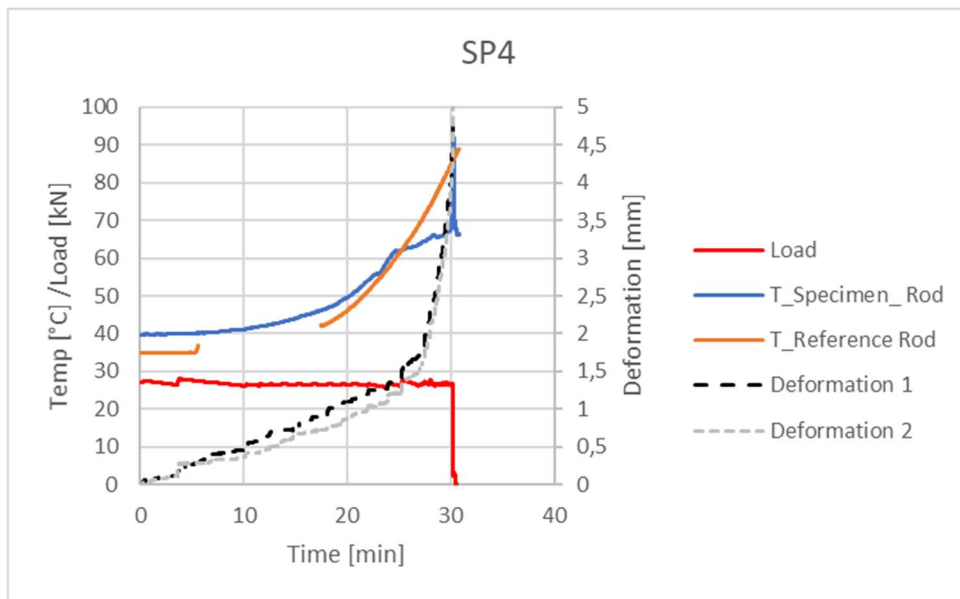
Figure 25: Load / Temperature / Displacement curves for test 4

Reference specimen 4 was the only test where higher temperatures were measured in the reference specimen than for the mechanically loaded specimen. The failure occurred after 30.1 minutes with a glue line temperature of 68.2 °C in the test specimen (see Figure 25).

The deformation is almost linear until minute 27. After that a steep rise was measured. The total deformation before failure occurred was rather big with about 4.5 mm. The reason for this could be the increased shear surface of the adhesive for the rod with a larger diameter of 20 mm. However, further tests would be necessary to prove a correlation between these parameters.

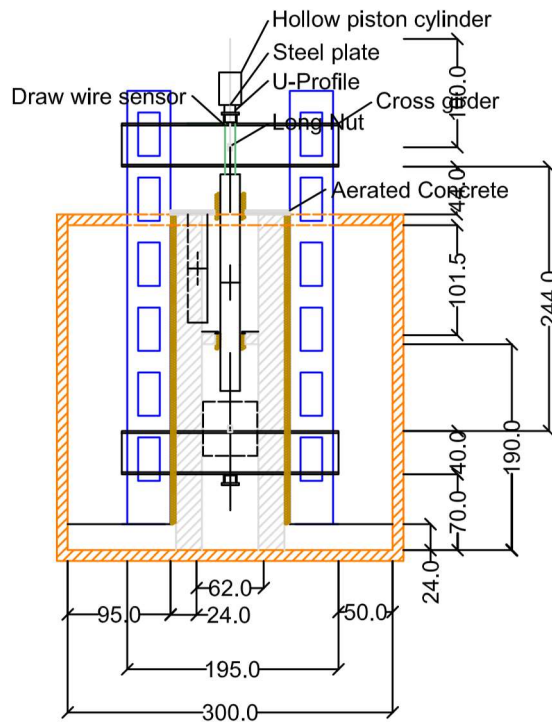
Figure 27: Section A of steel frame in furnace (M: 1:20)

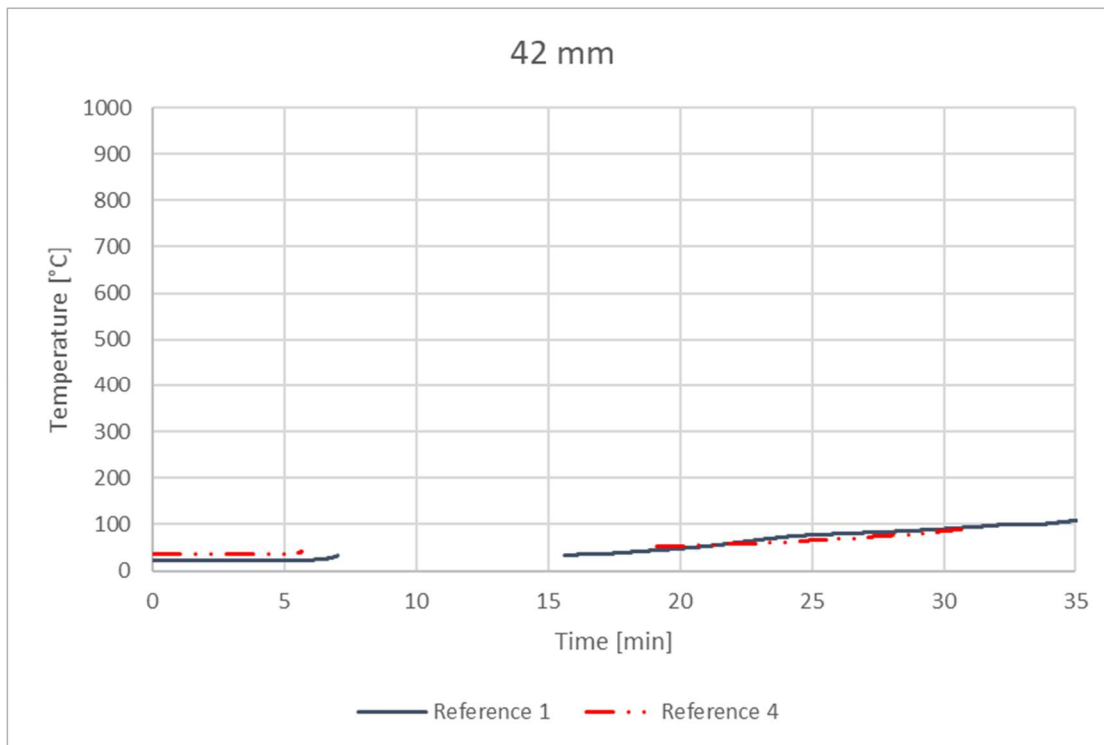
Figure 36: Temperature development for all reference specimens in a measurement depth of 42 mm

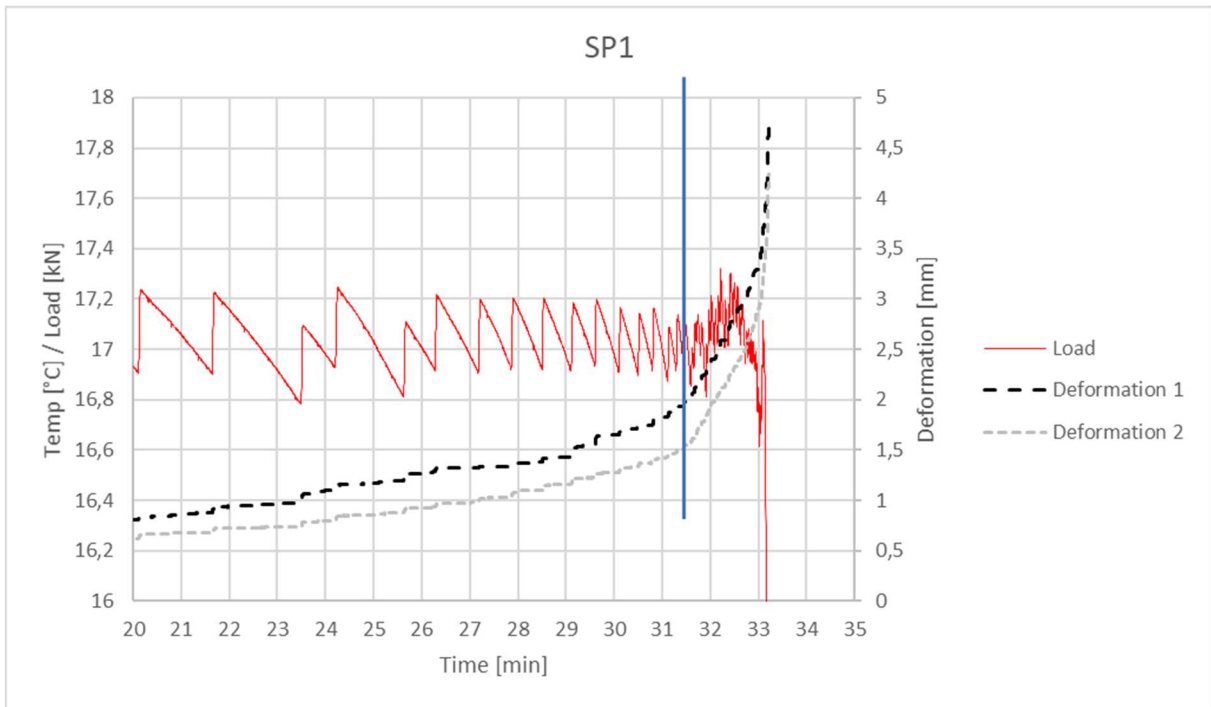
Figure 37: Load-deformation curves for specimen 1

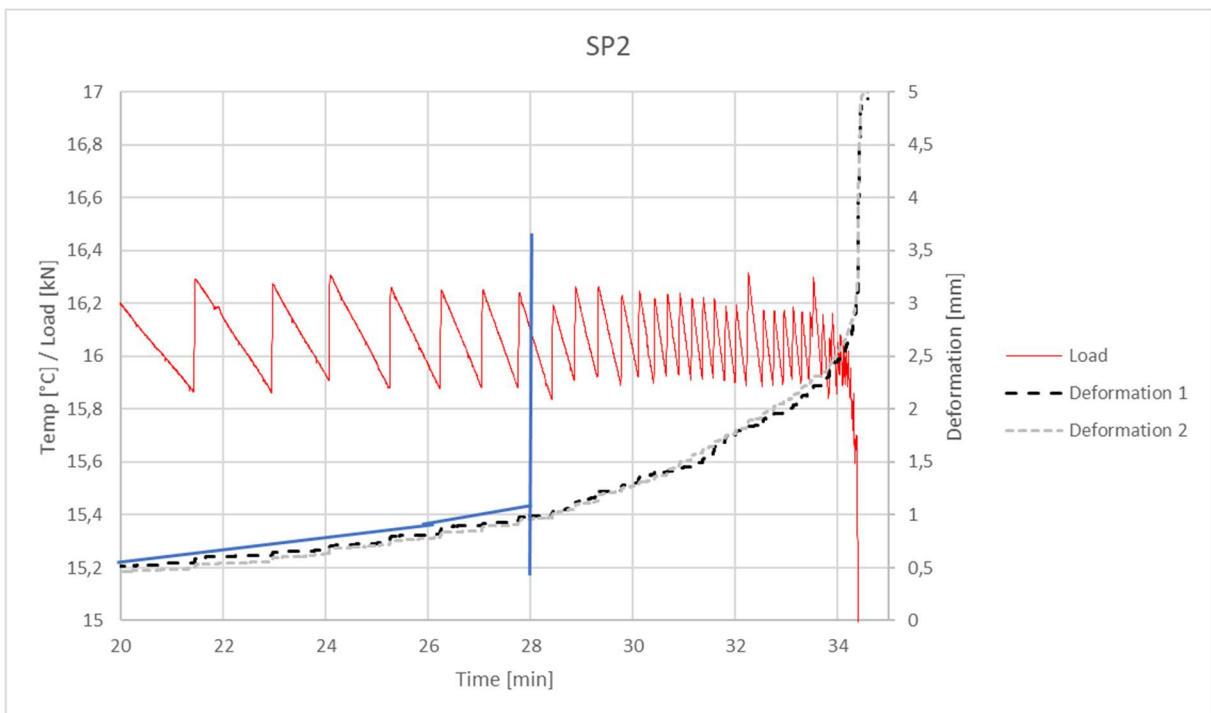
Figure 38: Load-deformation curve for specimen 2

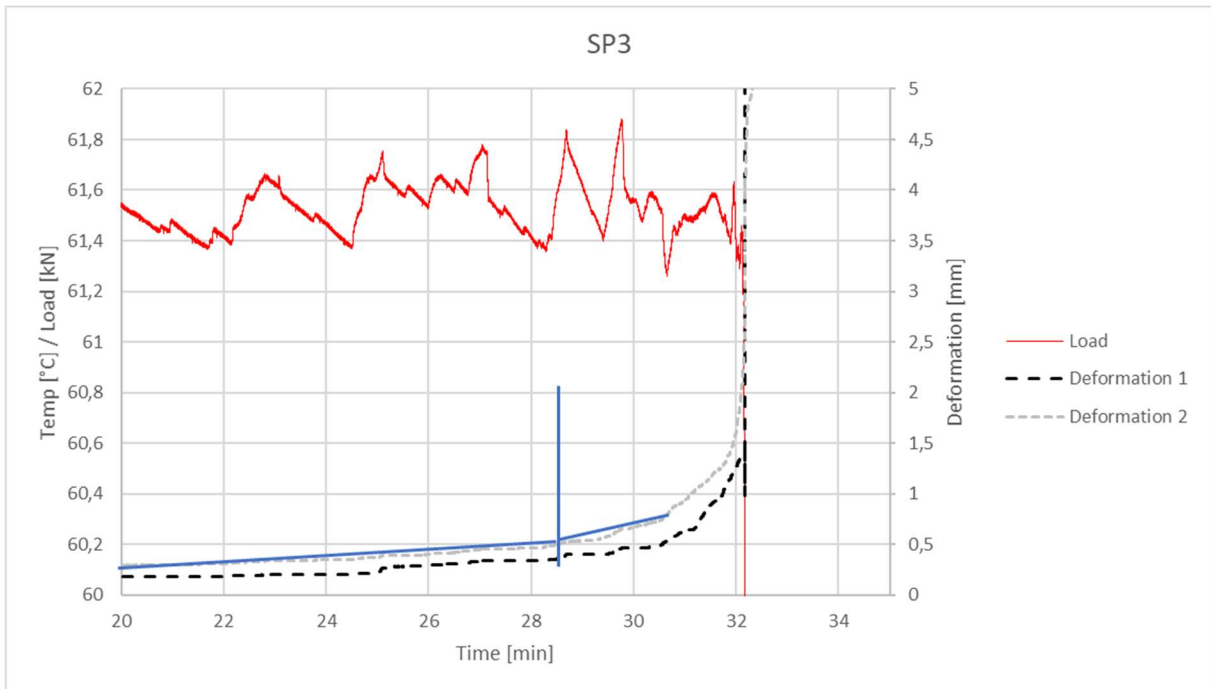
Figure 39: Load-deformation curve for specimen 3

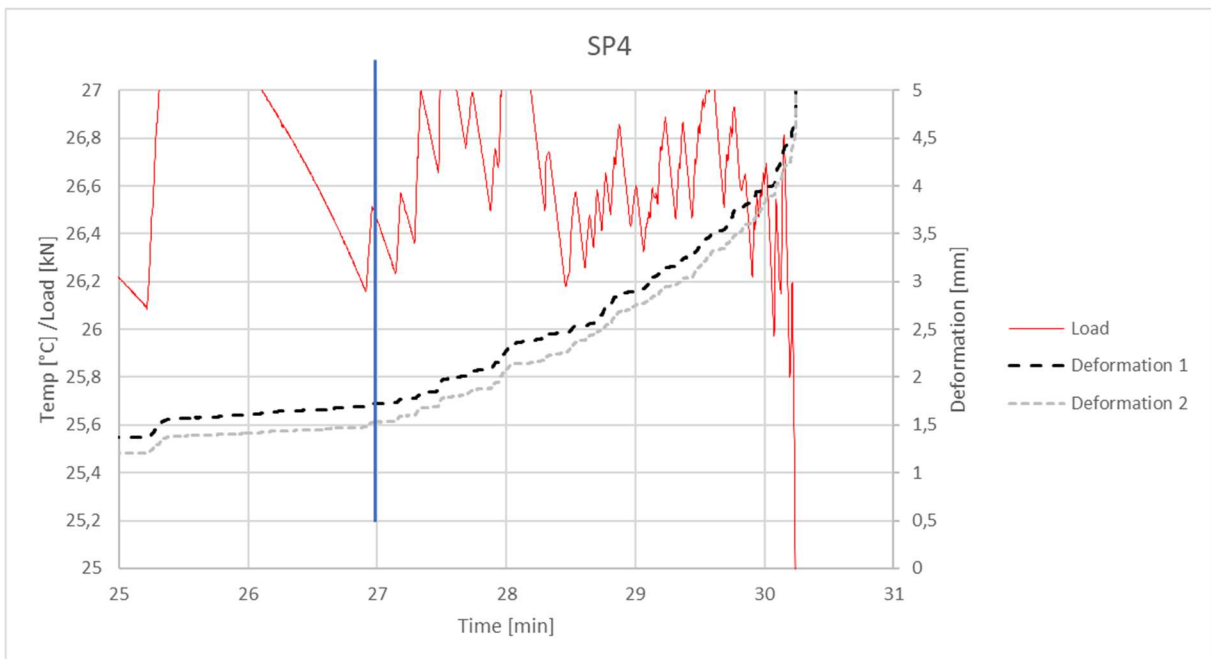
Figure 40: Load-deformation curve for specimen 4
