Strengthening of the Inn Bridge Obernberg-Egglfing

Balancing Act Between Preservation and New Construction

Florian Keil ¹ ✉, Hermann Weiher ¹
✉ e-mail:

¹ matrices engineering GmbH, Munich, Germany

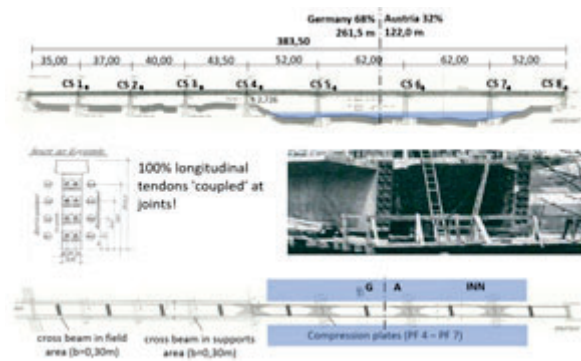
Figure 1: Longitudinal section and plan view

The structure was built between 1963 and 1965 in eight construction phases on a falsework. The superstructure is a longitudinally prestressed double-T beam with a reinforced concrete slab. In the support areas, there is a haunched compression plate, resulting in a box girder at the piers. The spans are 35,00 – 37,00 – 40,00 – 43,50 – 52,00 – 2x 62,00 – 52,00 m with a total length of 383,50 m.

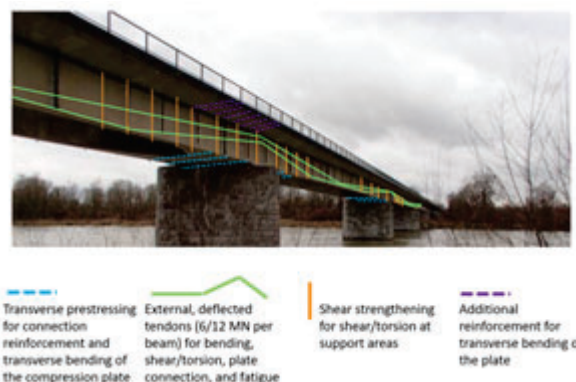
Figure 3: Overview of the strengthening concept for BK60

A comprehensive strengthening to meet all requirements according to Level 2 would have involved a substantial intervention in the structure, combined with compensatory measures and a usage restriction of 20 years, see Fig. 3. Ultimately, this measure was dismissed as uneconomical due to the high costs.

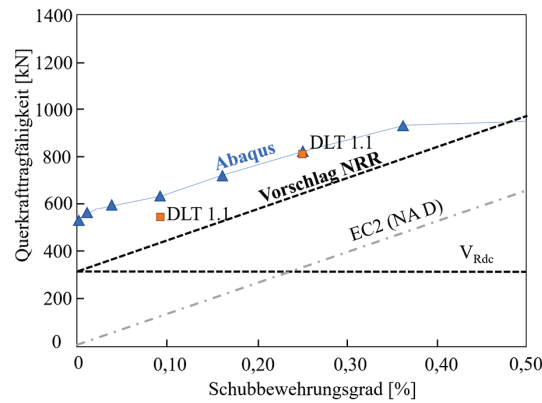
Figure 4: Shear capacity as a function of the shear reinforcement ratio. FE parameter study on test DLT 1.1, [3]

Based on experimental observations [4], the design procedure is based on a truss model (in accordance with EC2) but includes an additive concrete load-bearing component, which can primarily be attributed to the shear capacity of the uncracked concrete compression zone, see Fig. 4.

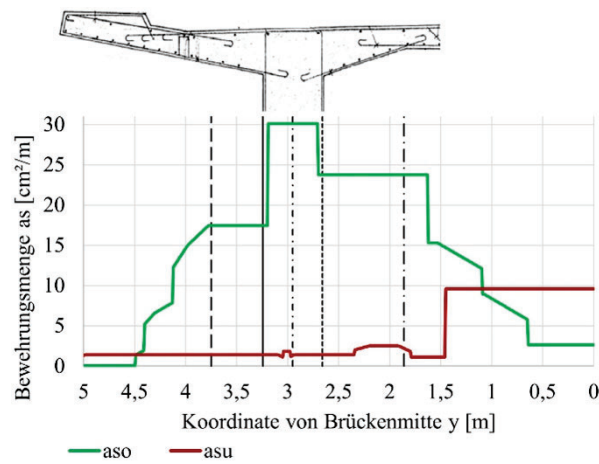
Figure 5: Distribution of the existing upper (green) and lower (red) flange connection reinforcement

Another special design feature of the structure was the asymmetrical arrangement of the transverse reinforcement of the deck slab on the upper and lower sides, see Fig. 5.

According to DIN Technical Report 102, Section 4.3.2.5, the required reinforcement should be distributed equally between the bottom and the top (without more detailed verification). This approach is not effective for large areas and resulted in significant deficits according to Level 2. In Level 4, the procedure according to Bachmann [6], [7] was therefore used, taking into account the interaction between longitudinal shear and transverse bending. The centrally acting transverse tensile force according to the flange truss $Z = a_{sw,erf} * f_{yd}$ and the transverse bending moment m_{yy} , along with the associated normal force n_{yy} are considered as acting together. The cross-section is designed accordingly. Thus, on the compression side, the longitudinal shear reinforcement can be

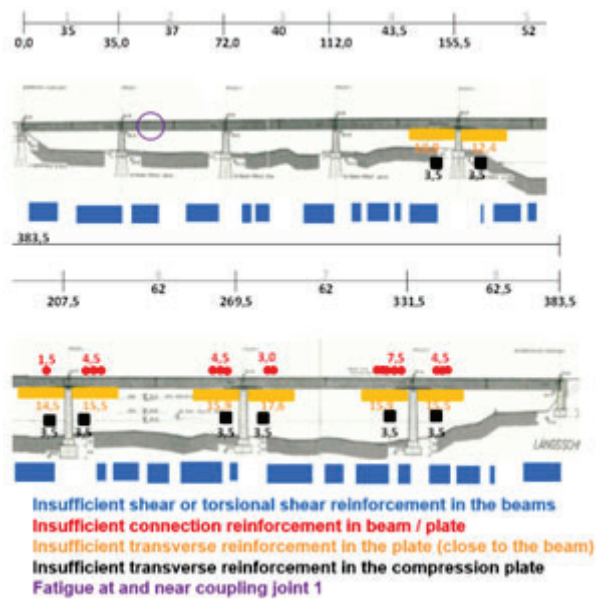
Figure 7: Deficiencies of the recalculation according to Stage 4

Overall, the deficiencies of the recalculation could be significantly reduced in magnitude and strongly limited locally through the approaches in Level 4, Fig 7.

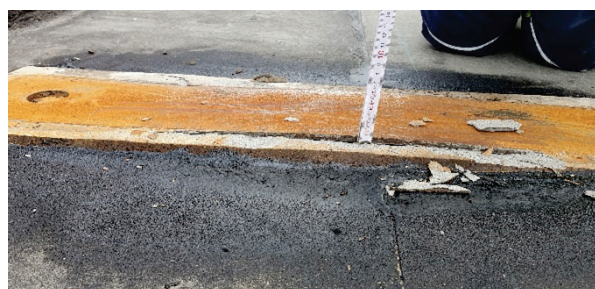
Figure 9: Distorted connection plate without a central anchor bolt after experimental heating.

The high loading of the upper transverse reinforcement required that any tensile forces, arising from the inclination of the compression strut between the anchor plate and the beam, be short-circuited by an additional plate between the two top anchor plates. This tension plate was precisely welded to the anchor plates with fillet welds after the installation of the anchor plates, and subsequently, the anchor plates and the plate were grouted with mortar. However, since the plate only actually acts as a tension band in ultimate limit state, strong compressive forces occurred during the installation of the up to 200°C hot mastic asphalt due to the thermal expansion of the plate being hindered by the simultaneous fixation on both sides. To prevent buckling of the plates, they were secured downwards using bolt anchors. The required number of bolts was determined experimentally. The installation of the mastic asphalt was simulated by heating the plates with burners, see Fig. 9.

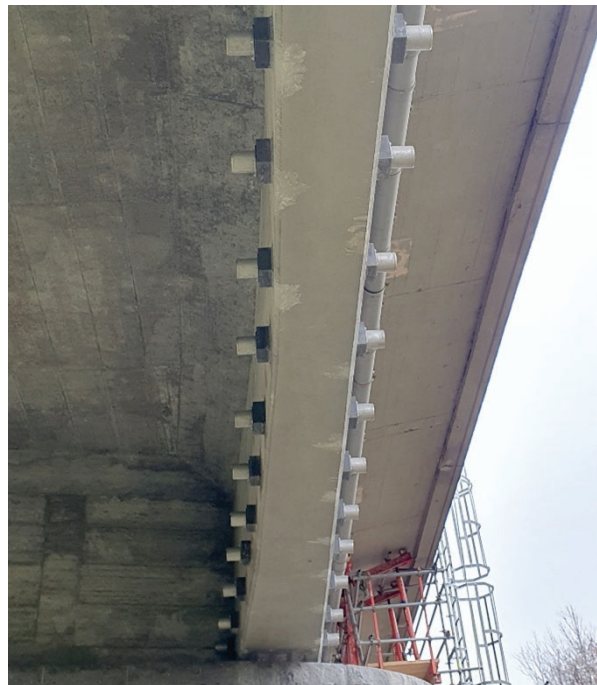
Figure 10: Hybrid anchor plates with inclination corresponding to the alignment of the existing structure

In the entire project, the load introduction of the tendons onto the existing structure was carried out using anchor plates made of ultra-high-performance concrete (UHPC), referred to as hybrid anchors. These were manufactured according to the various required angles, with a slope of up to 13.5° , thus compensating for the angles between the existing structure and tendon axis (see Fig. 10). In addition to their lower weight compared to steel plates, hybrid anchor plates do not require corrosion protection.

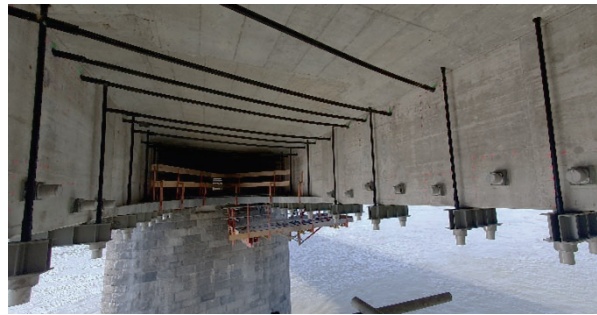
Figure 11: View into the box girder area field 8

In the support areas with box section, high shear forces must be transferred between the flanges and the beams. In the recalculation, this verification of the flange connection for the cantilever could be provided, while in the box girder areas, deficiencies occur at both the connection of the deck slab and the compression slab.

To strengthen this horizontal shear load capacity, both girders were prestressed using external tendons that run between the beams. The alignment of the boreholes for the tendons follows the structure's angle of 76.5° . The necessary holes through the beam were drilled starting alternatively

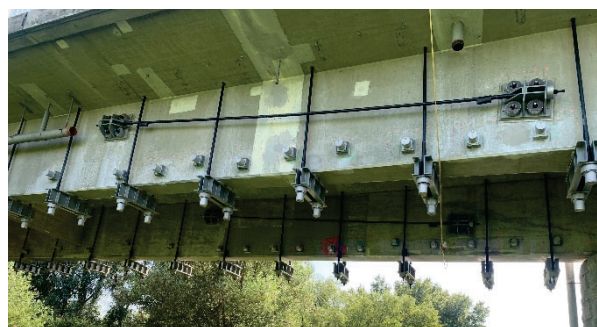
Figure 12: Longitudinal prestressing at the coupling joint 1

The lack of fatigue strength at coupling joint 1 could be established with an additional centric prestressing of 1.0 MN. In order to guarantee this in the long term, prestressing was applied with two external \varnothing 32 mm bar tendons per beam.

The approximately 8.5-meter-long tendons were tensioned to the beams using steel construction elements and four cross tendons (similar to the torsional reinforcement afterwards grouted bore-holes). Due to the alignment of the tendons and the stirrup reinforcement in the existing structure, the tendons were installed at an angle of 4.2° to the horizontal.
