Structural safety and rehabilitation of connections in wide-span timber structures - two exemplary truss systems

1. Expertise 1

2. Expertise 2

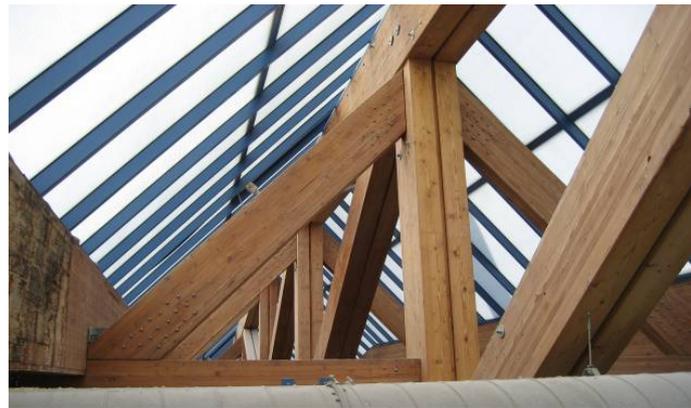
Fig.13: inclined Bar of the Secondary System

During the inspection, large cracks in the tension joints of the inclined trusses of the secondary system were identified. The deepest cracks had developed between the single joints of the steel-plate connection. Marking of the cracks, as it is demonstrated in Fig. 14, is generally done using the following systematic: depth – width - length of the crack.

Due to reasons of organisation it was decided to reinforce the structure temporarily for one winter period while allowing just a minimum of snow load. For this first step the joints of the inclined trusses were reinforced by screws with continuous threads, positioned perpendicular to the grain and the axe of the fasteners (see Fig. 16). To verify the strength of the reinforced connection, experimental investigations became necessary. Thereby, wooden components of a back-built ice arena were used as test pieces to take into account the influence of elements, which had already been stressed by load and changing climate conditions stressed. With these components, the inclined trusses including the steel-plate connections were replicated. Different crack patterns were simulated by cuts with a circular saw. These test pieces were reinforced by screws with continuous threads as demonstrated in figure 16, taking into account the unsymmetrical connection on both sides of the truss.

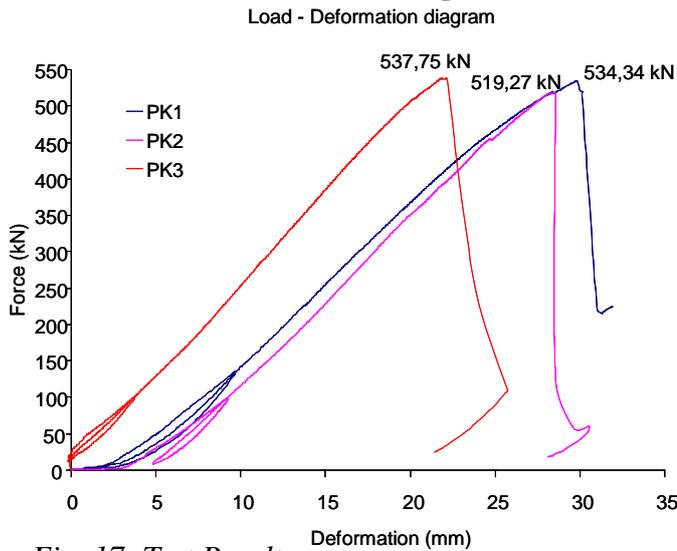
Fig. 17: Test Results

The test results of the three test pieces are demonstrated in the following diagram.
