# CINEMATIC VISUALIZATION OF FAILURE MECHANISMS IN TIMBER STRUCTURES

**ABSTRACT:** The objective of the project presented was to visualize typical failure mechanisms in timber by using highly developed media technology, e.g a high-speed camera to show brittle failure mechanisms. In some cases, the film recordings were combined with contact-free measurements and finite-element analysis to better visualize the stress distribution in the test specimen.

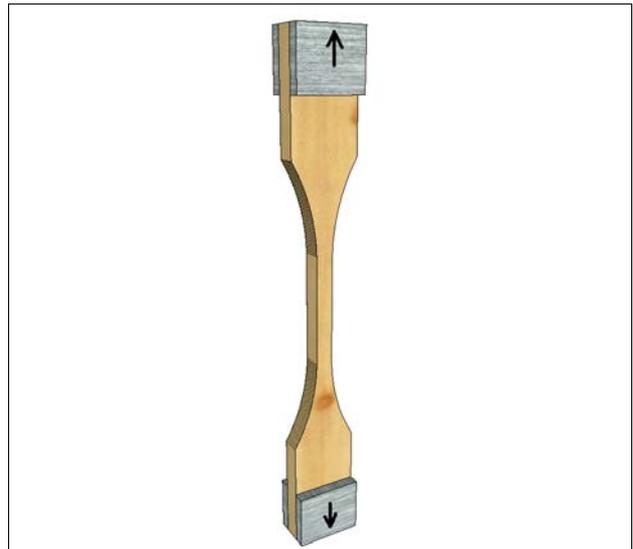
Failure in tension parallel to the grain was tested and shown on a tapered tension member which was held by two clamping devices of the testing machine (Figure 1).

**Figure 1: Specimen and Configuration of Experiment for Failure in Tension parallel to the Grain**

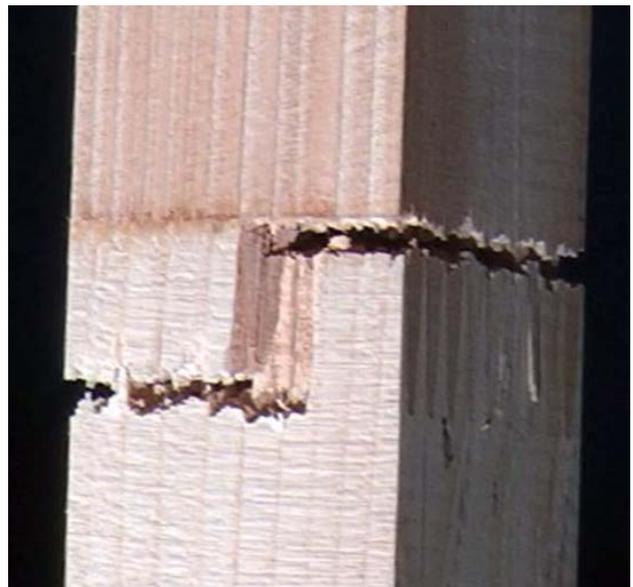
Figure 2 shows the failure mechanism including the effect of the finger joint, tension failure parallel to the grain at areas of local weakening (tips of the finger joint).

**Figure 2: Detail of Specimen failing in Tension parallel to the Grain at the Tips of the Finger Joint**

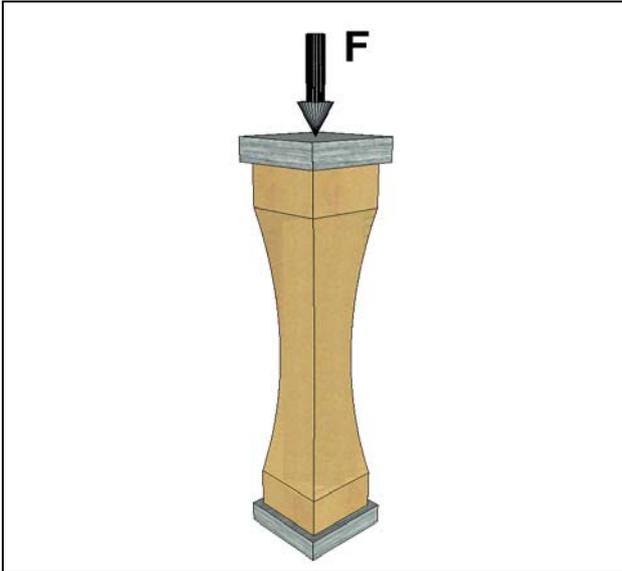
Failure in compression parallel to the grain was tested and shown on a tapered stud column (Figure 3).

**Figure 3:** Specimen and Configuration of Experiment for Failure in Compression parallel to the Grain

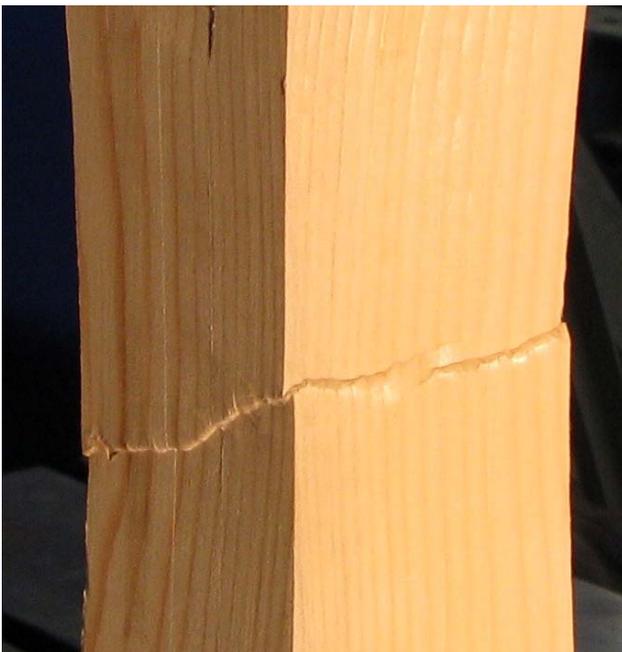
Figure 4 shows that the anticipated failure mechanism, local buckling of a row of fibres, could well be demonstrated.

**Figure 4:** Detail of Specimen failing in Compression parallel to the Grain

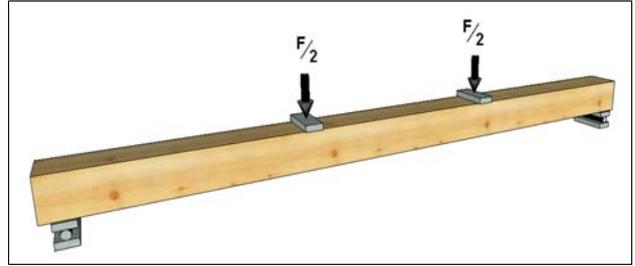
The bending strength was determined by a four-point bending test, the configuration is displayed in Figure 5. This experiment was filmed with a high-speed camera.

**Figure 5:** Specimen and Configuration of Experiment for Failure in Bending

This experiment was selected to exemplify show the application of contact-free measurement technique to measure deflection of a beam in bending (see Figure 7). The configuration of the experiment complied with the configuration shown in Figure 5 except that the member side was coated with a white primer, followed by the application of a stochastic pattern realized by black dots (see Chapter 2.3)

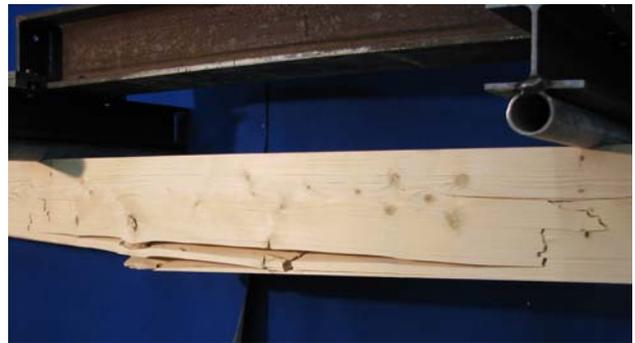
The detail shows the typical failure of a timber member in bending, triggered by failure in tension parallel to the grain in the tension zone of the member (see Figure 6).

**Figure 6:** Detail of Specimen failing in Bending (Tension failure parallel to Grain)

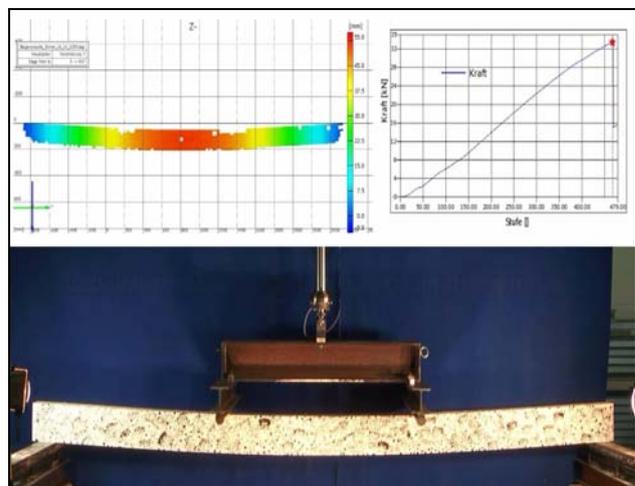
**Figure 7:** Excerpts of Report from contact-free Measurement System (Display of Deflection, Load-Slip Curve and Member in Bending with Stochastic Pattern)

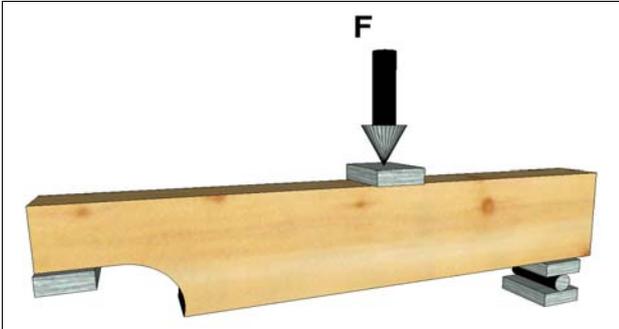
The effect of a rounded end notch on a beam in bending was tested and shown by a three-point bending test as illustrated in Figure 8.

**Figure 8:** Specimen with rounded End-Notch in three-point Bending Test

The experiment to exemplify the effect of a rounded hole at mid-span of a member in bending complied with the test configuration given in Figure 8.

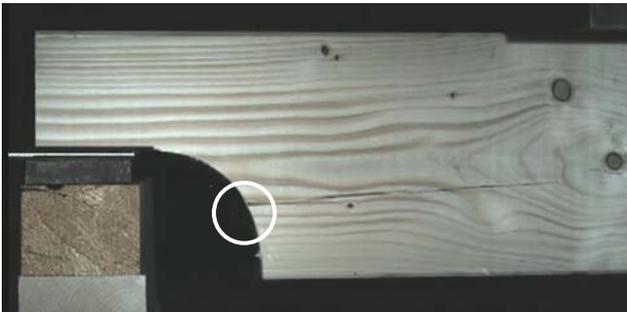
The failure occurred in the middle of the rounded part ( $\sim 40^\circ$ ), followed by a crack propagation along the grain as shown in Figure 9. This figure was extracted from the high-speed film. The necessity of illumination is clearly visible.

**Figure 9:** Detail of Timber Member fractured at rounded End-Notch (marked by circle)

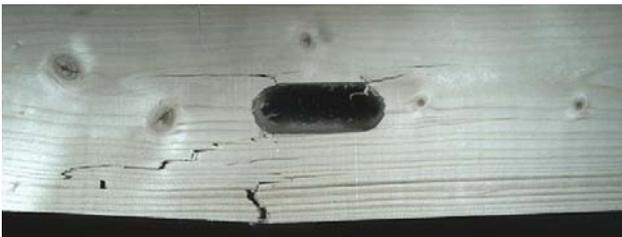
Figure 10, which was extracted from the high-speed film shows that the crack onset from the upper edges of the hole occurred at the same time as failure in tension in grain direction due to exceeded bending stresses.

**Figure 10:** Detail of failed Timber Member in Bending with rounded Hole at Mid-Span

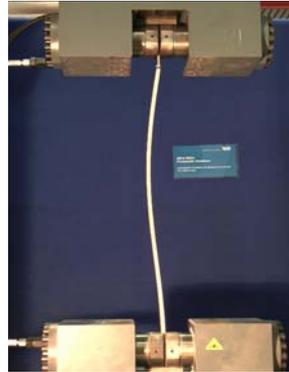
Stability failure, e.g. Euler case 3 was shown on very slender timber columns. Depending on the bearing situation, these were either put between the clamps of the testing machine or placed on the head of a small steel bolt to realize a pinned connection. The configuration of the experiment as well as the deformation figure at failure is given in Figure 11.

**Figure 11:** Configuration of Experiment and failure of Timber Column in flexural Buckling (Euler case 3)

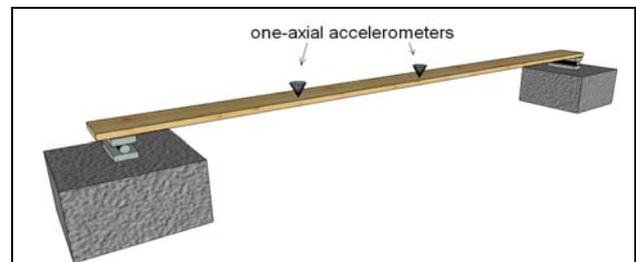
The dynamic response of a single span timber beam (timber lamella) was measured by two one-axial accelerometers, placed at mid span and in  $\frac{1}{4}$  of the span as shown in Figure 12. The member was accelerated by an impulse load (hammer).

**Figure 12:** Configuration of Experiment for Vibration Test on single span Timber Beam

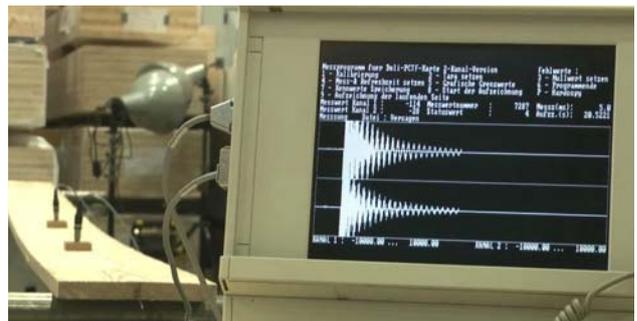
The output of the vibrometer in form of an oscillation curve (see Figure 13) was filmed, followed by a picture of the computed natural frequency.

**Figure 13:** Vibration test on single span Timber Team (lamella) and Oscillation Curves

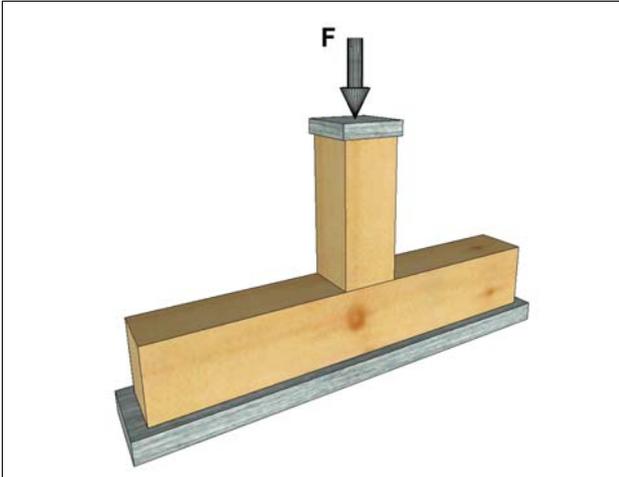
Failure in compression perpendicular to the grain of a member on a discrete support was tested and shown on two butt-jointed rectangular timber pieces, as illustrated in Figure 14.

**Figure 14:** Specimen and Configuration of Experiment for Failure in Compression perpendicular to the Grain (Butt-jointed Members on Discrete Support)

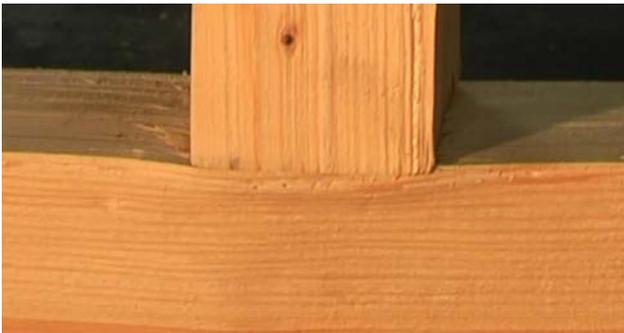
Figure 15 shows a detail of the member failing due to local compression of the fibres. The rope effect between the loaded and the unloaded part of the fibres can be seen as well.

**Figure 15:** Detail of Specimen failing in Compression perpendicular to the Grain

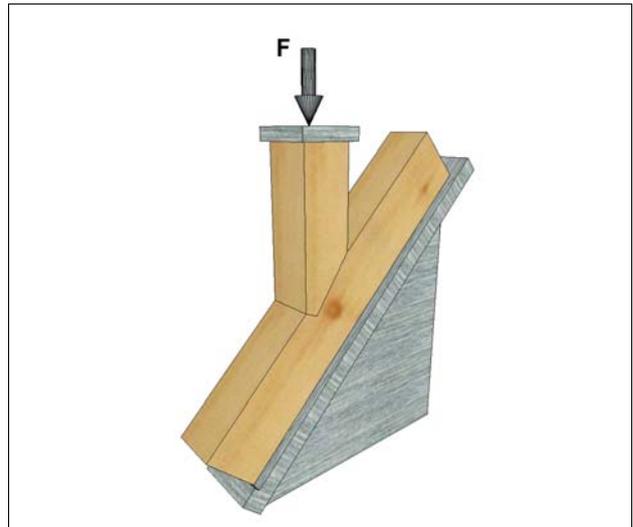
The reproduction of a typical step joint in an experimental configuration was a little bit more challenging, since one member had to be supported and fixed at an angle of  $45^\circ$ . The configuration of the experiment is shown in Figure 16.

**Figure 16:** Specimen and Configuration of Experiment for Step Joints (Failure in Compression at an Angle  $\alpha$  to the grain)

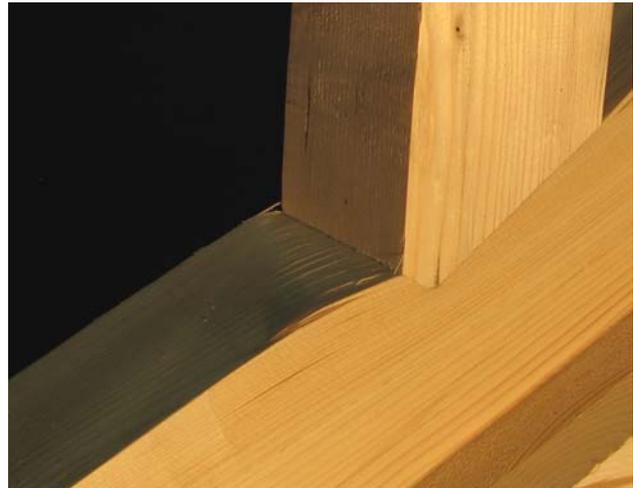
The failure mechanism of a step joint, failure in compression at an angle  $\alpha$  to the grain is illustrated in Figure 17.

**Figure 17:** Detail of Step Joint failing in Compression at an Angle  $\alpha$  to the grain

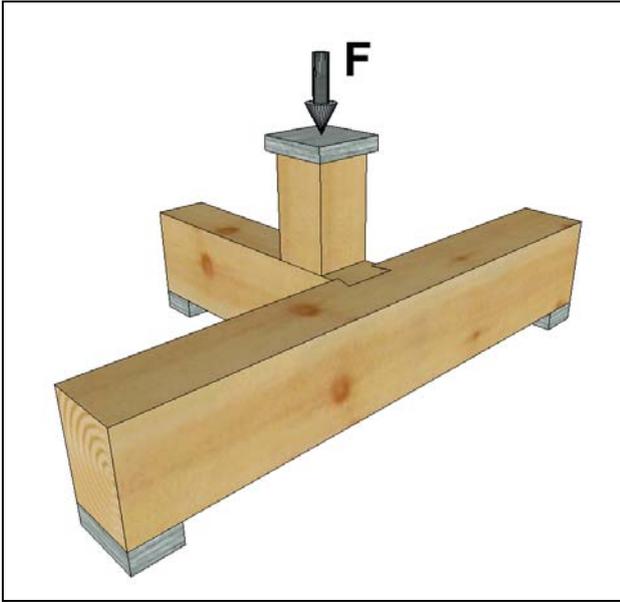
Nowadays, the dovetail connection is mostly used for secondary beam – main beam connections in residential buildings. Therefore, the configuration of the experiment was designed to reproduce that connection type (see Figure 18)

**Figure 18:** Specimen and Configuration of Experiment for Dovetail Connection

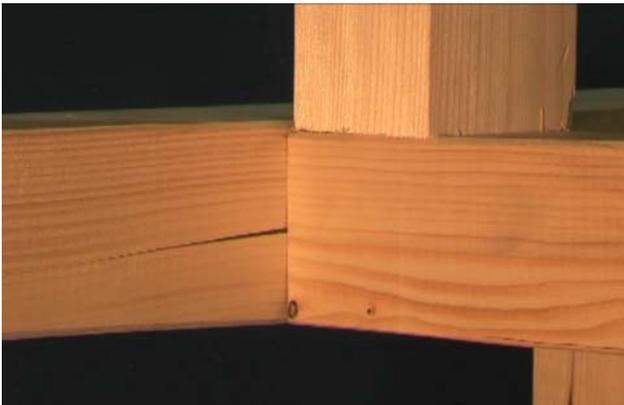
The failure of the dovetail connection, failure in tension perpendicular to the grain in the main beam is shown in Figure 19.

**Figure 19:** Detail of Dovetail Connection failing in Tension perpendicular to the Grain in the Main Beam

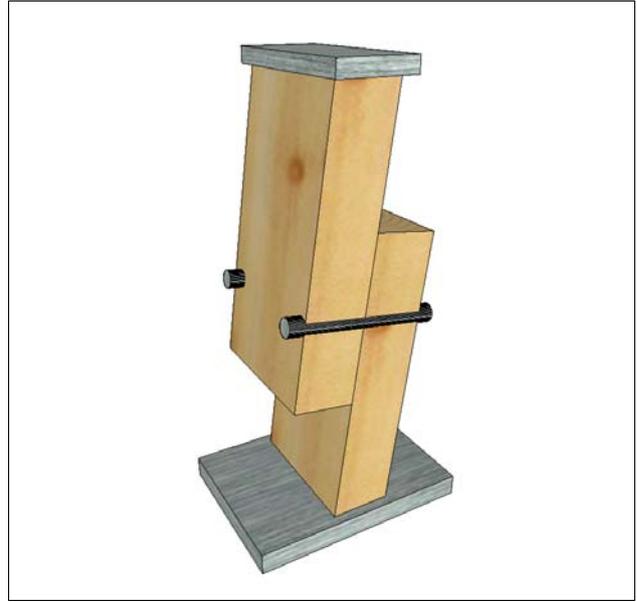
To reproduce an embedment strength failure in a single shear connection, a dowel with a very low slenderness had to be used. The chosen configuration for the experiment is given in Figure 20

**Figure 20:** Configuration of Experiment for Embedment Strength failure in a Single-Shear Connection

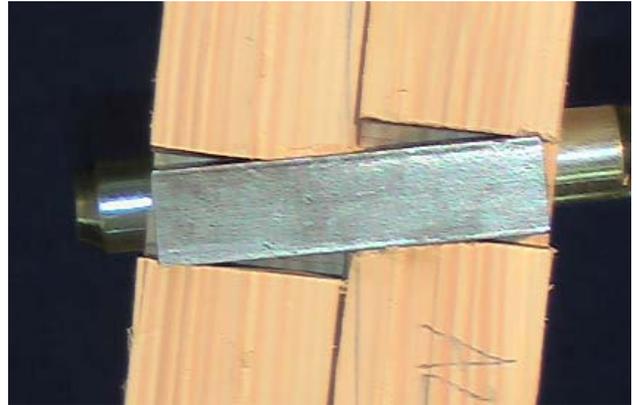
The failure of this connection, embedment strength failure in conjunction with rotation of the dowel (Failure Mode 1a) can be observed in Figure 21.

**Figure 21:** Detail of Embedment Strength failure in a Single-Shear Connection

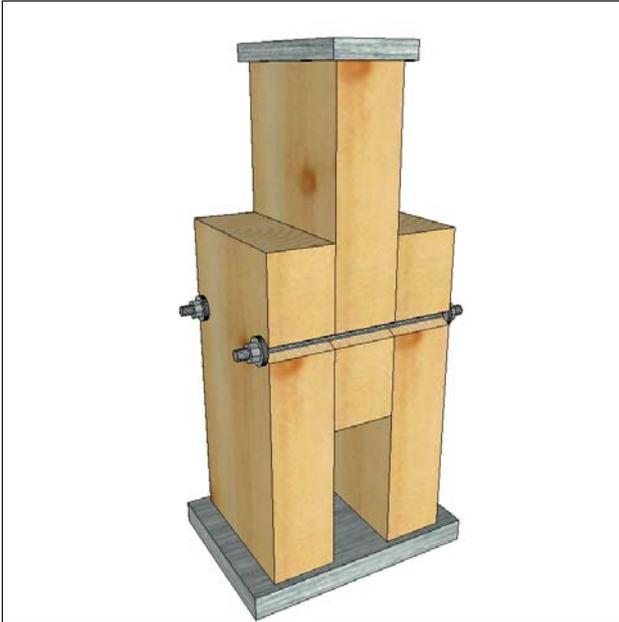
Inversely to the connection setup in 4.4.1, very slender bolts were used to reproduce yielding failure of the bolts. Larger washers were utilized to induce a visible rope effect (see Figure 22)

**Figure 22:** Configuration of Experiment for Yielding Failure of Bolts in a Double-Shear Connection including the Rope Effect

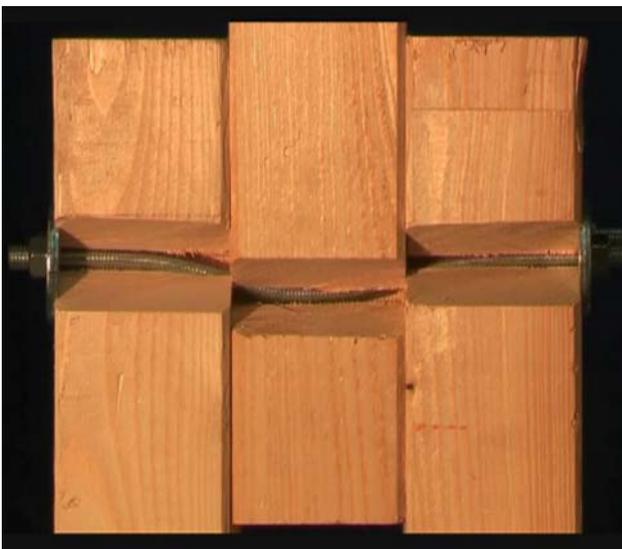
Figure 23 shows the failed connection, the yielded bolt (Failure Mode 3) as well as the rope effect (indentations of washers into timber).

**Figure 23:** Detail of Failed Double-Shear Connection – Yielded Bolt and Rope Effect
